# **East Sussex Vegetated Shingle Management Plan**

**T. Smith.**

**2009**

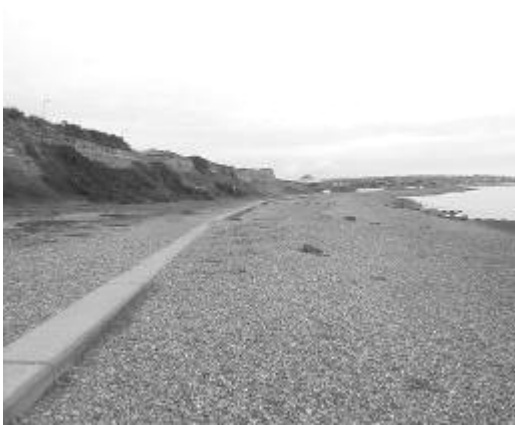
Figure 3.1 Fringing shingle beach - Bulverhythe, East Sussex (Tim Smith © 2008).

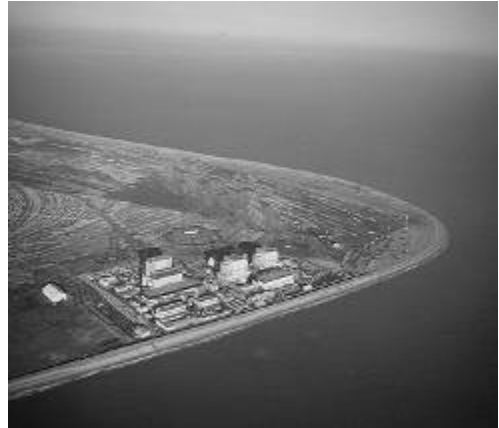
Figure 3.2 Cuspate foreland - Dungeness, Kent & East Sussex (courtesy of Henry Law © 2005).

Cusped forelands are much larger masses of shingle, forming triangular protrusions which extend seawards (see figure 3.2). Cusped forelands are generally formed in areas where bi-directional wave action pushes shingle to a point where it converges into one structure. One of the best examples of a cusped foreland can be found at Dungeness (Kent & East Sussex).

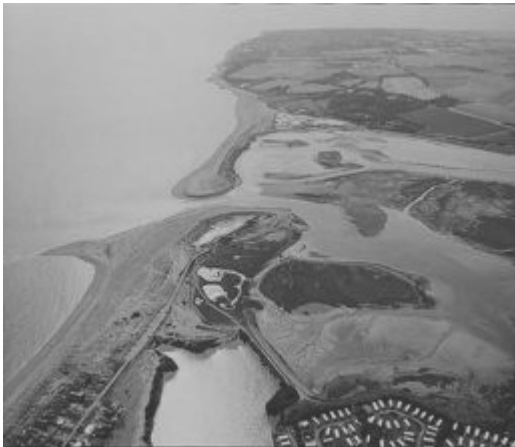
Figure 3.3 Shingle spit - Paghham Harbour, West Sussex (courtesy of the South Downs Coastal Group).

A spit (see figure 3.3) is a strip of shingle which develops outwards from the coast, in areas where the coastline changes direction suddenly. Spits often display recurved hooks at their distal ends, which is an indication of bi-directional wave action impacting the structure. Shingle spits can frequently be found in the vicinity of harbours (Pagham, West Sussex) and estuaries, where abrupt direction changes are common.

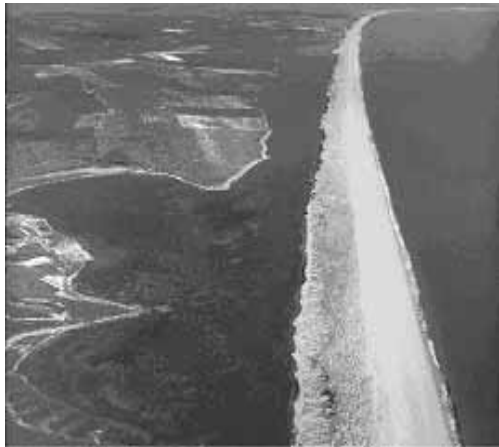
Figure 3.4 Bar/Barrier - Chesil Beach, Dorset (adaptation of press image, courtesy of Dr Ian West).

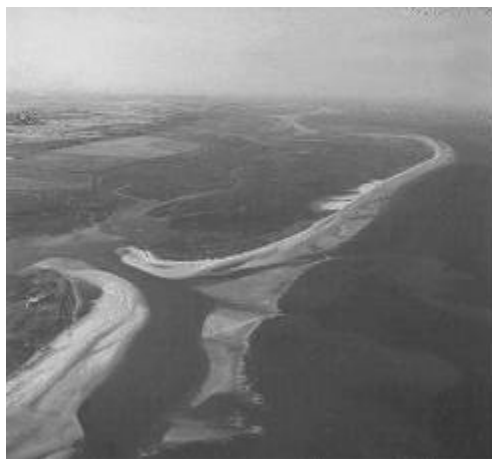
Figure 3.5 Offshore Barrier Island - Scolt Head, Norfolk (courtesy of the National Education Network).

Offshore barrier islands are formed in areas where a large accumulation of shingle material is deposited offshore (see figure 3.5), and may be a precursor to the formation of a sand dune system. Examples of this type of structure can be found at Culbin Bar (Morayshire) and Scolt Head (Norfolk).

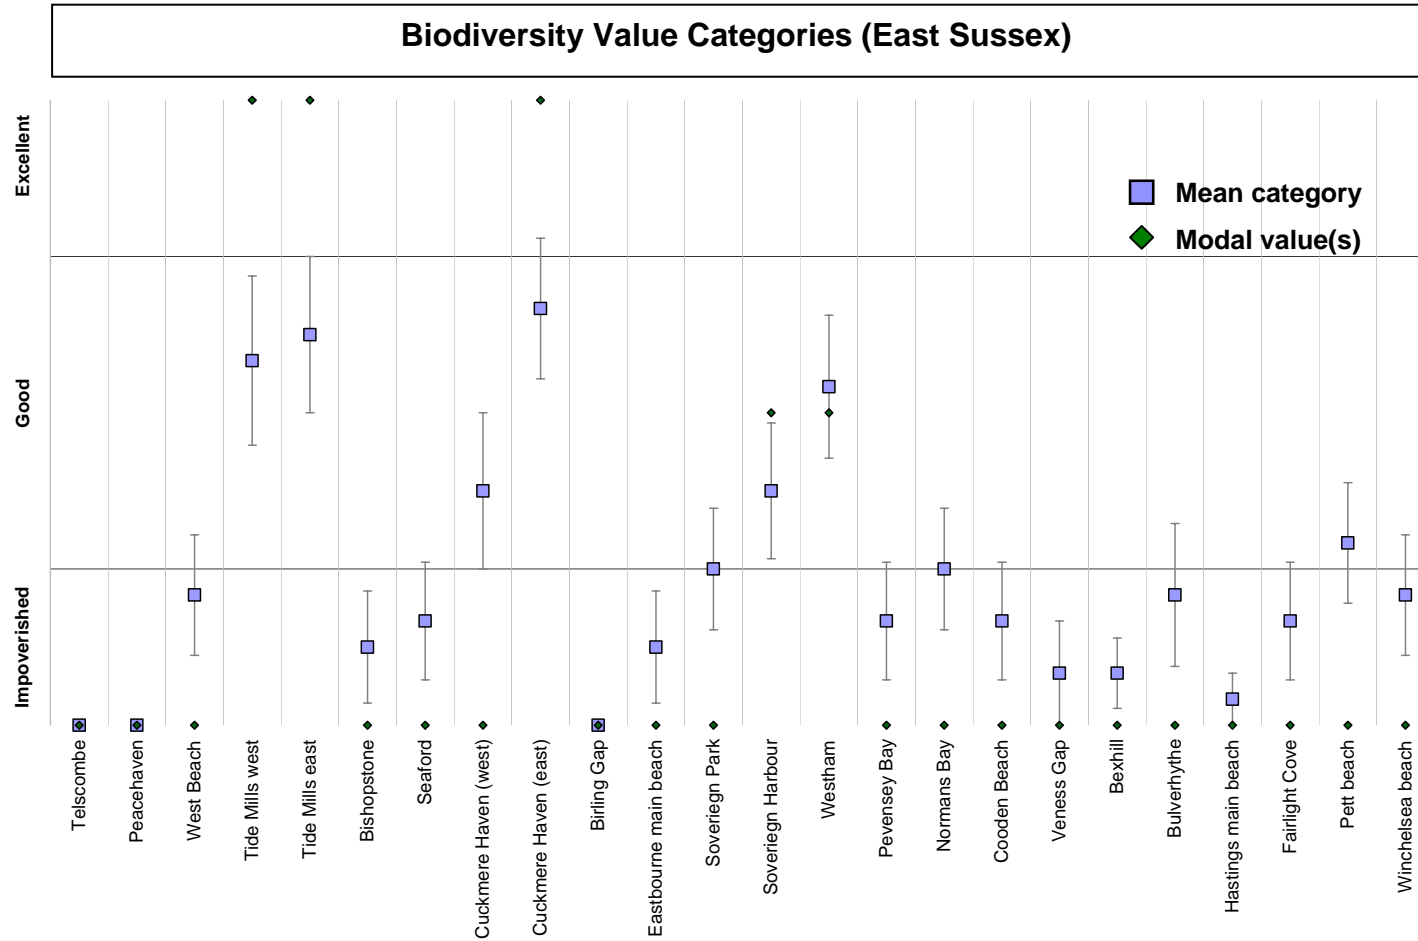
Figure 9.1.1 Biodiversity values for shingle sites across East Sussex including mean category  $\pm$  SEM and modal value(s)

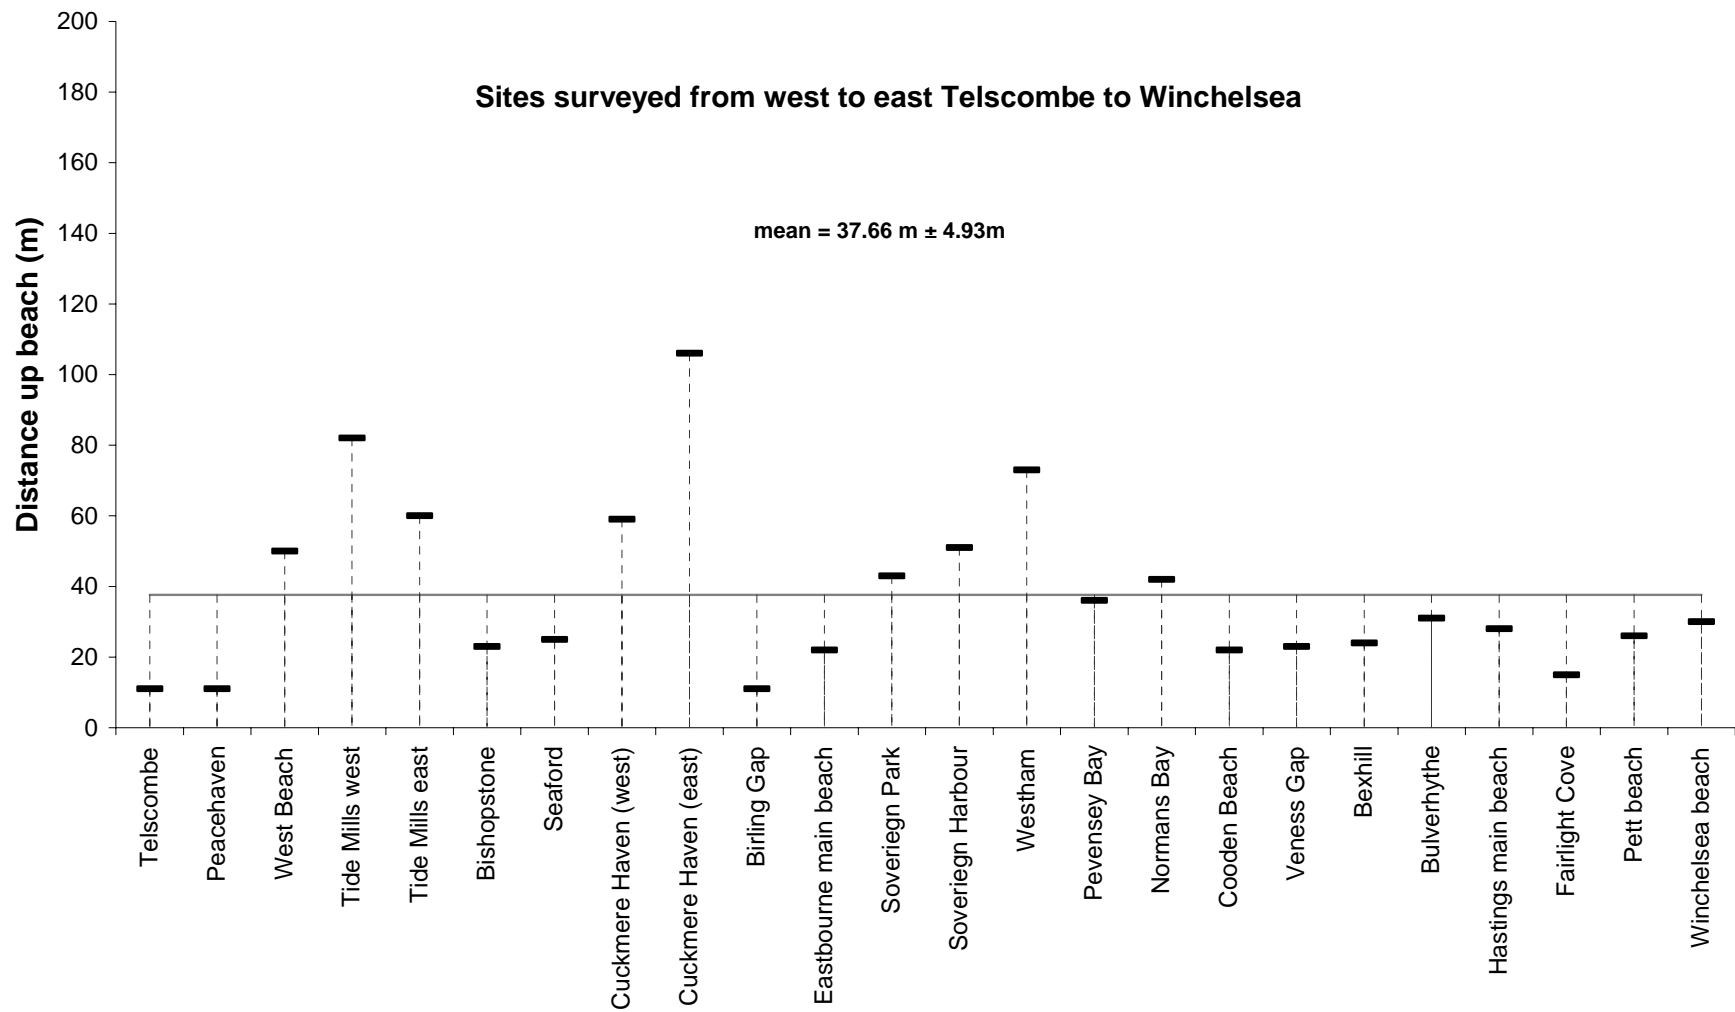
Figure 9.1.2 Shows mean transect lengths for shingle sites across East Sussex.
