Appendix C - Guidelines for Good Practice when working on beaches with Vegetated Shingle

Guidelines for Good Practice when working on beaches with Vegetated Shingle

Appendix D - Shingle beach “Cab Cards”

Appendix E - Site evaluation data (graphical representation)

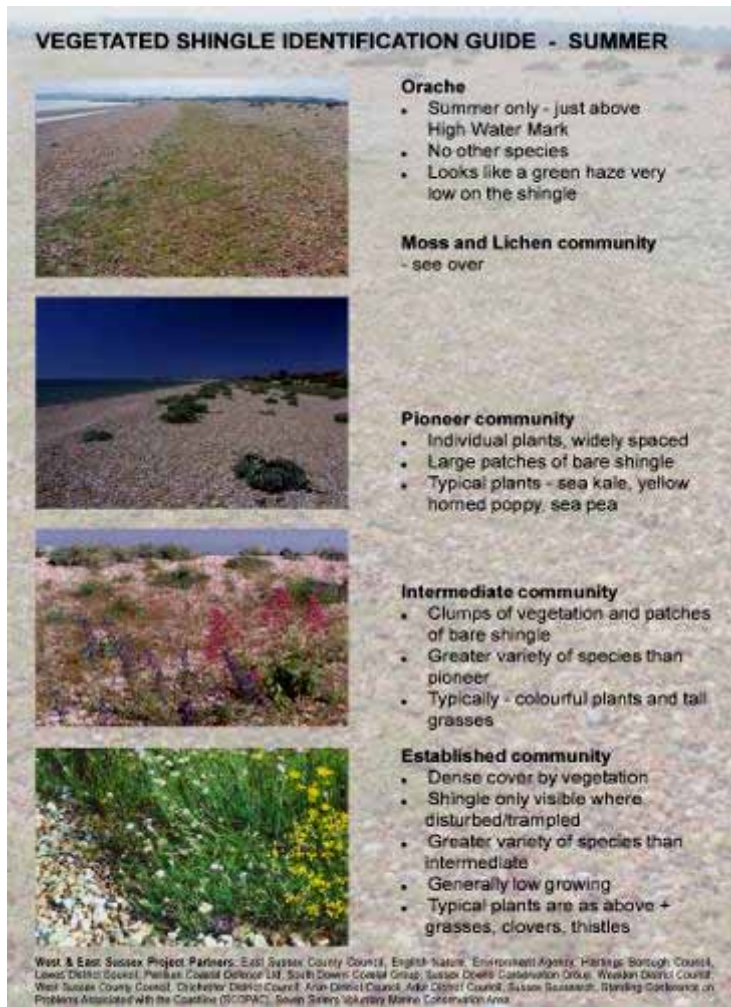
Figure D1.1 Summer information sheet (cab card) for shingle contractors.

Below (see figures D1.1 and D1.2) are examples of the habitat identification information currently being used across Sussex. These identification sheets or ‘cab cards’ can be handed out to workers and used to protect areas of shingle which display important geomorphologic and/or ecologic features. Originally produced in collaboration between East & West Sussex County Councils, these sheets are an extremely useful tool.

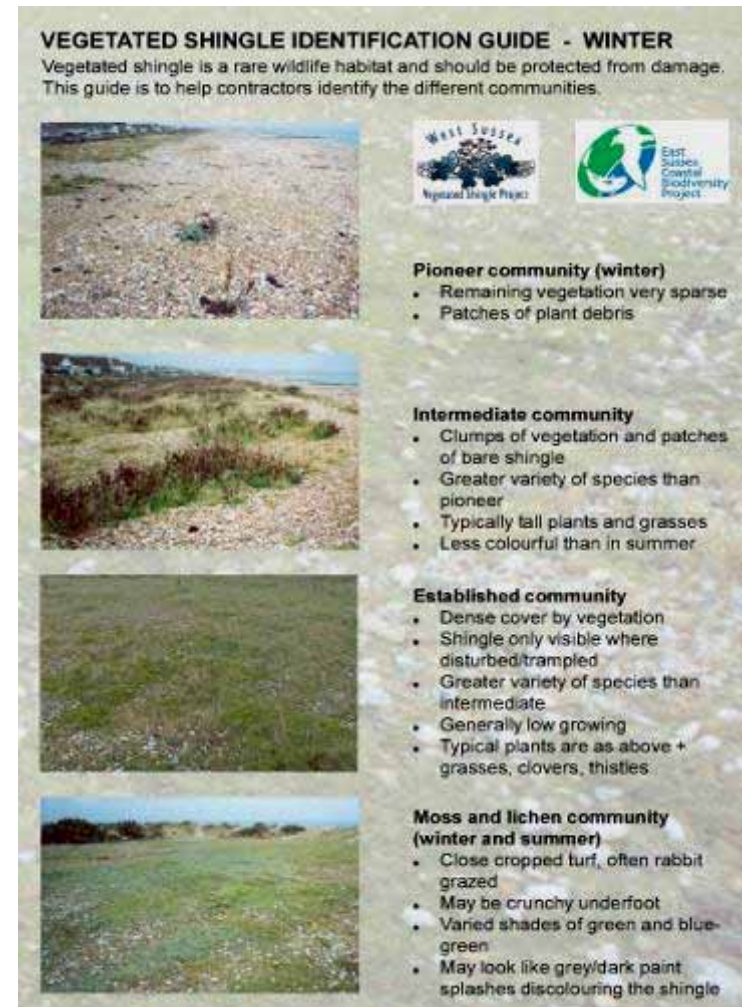
Figure D1.2 Winter information sheet (cab card) for shingle contractors.

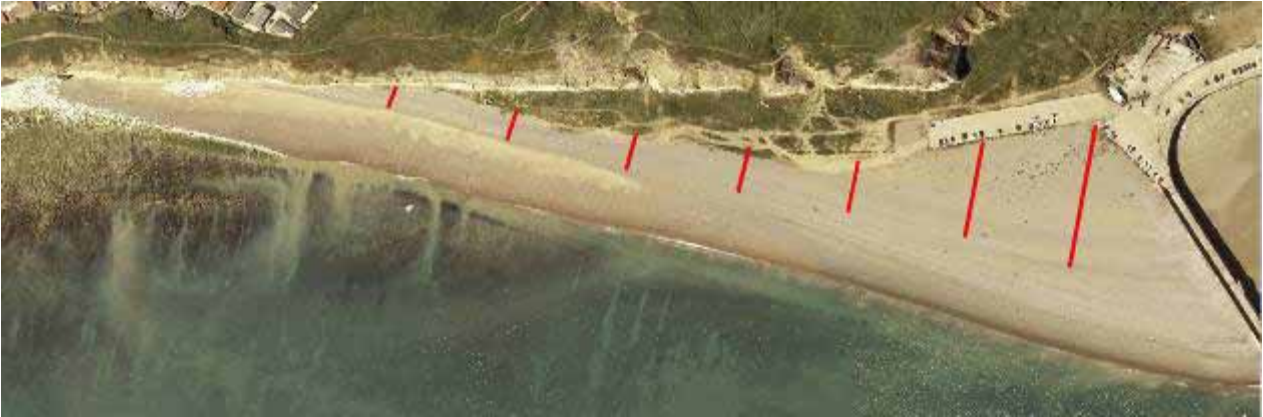
Figure E1.1 Shows the locations of the 2008 transect surveys carried out at West Beach, Newhaven.

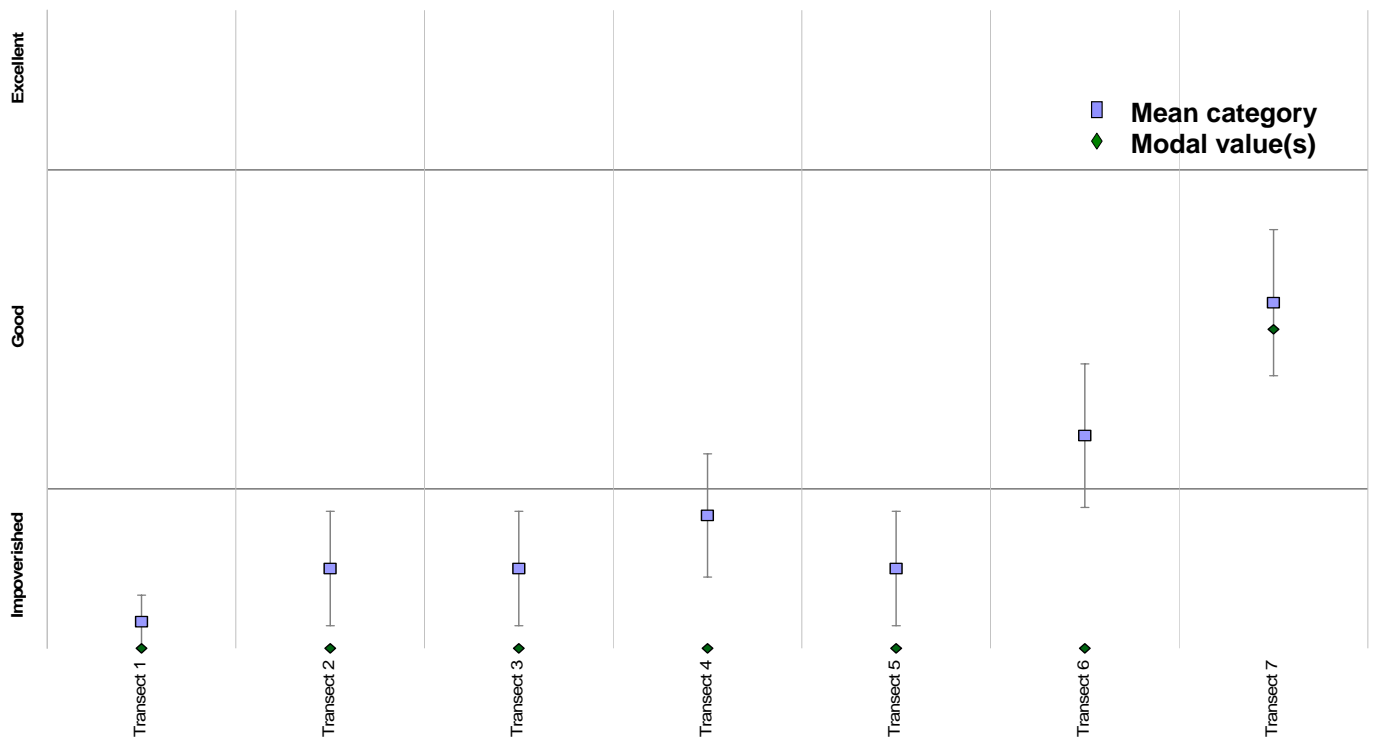
Figure E1.2 Biodiversity values for West Beach (Newhaven) including mean category \pm SEM and modal value(s).

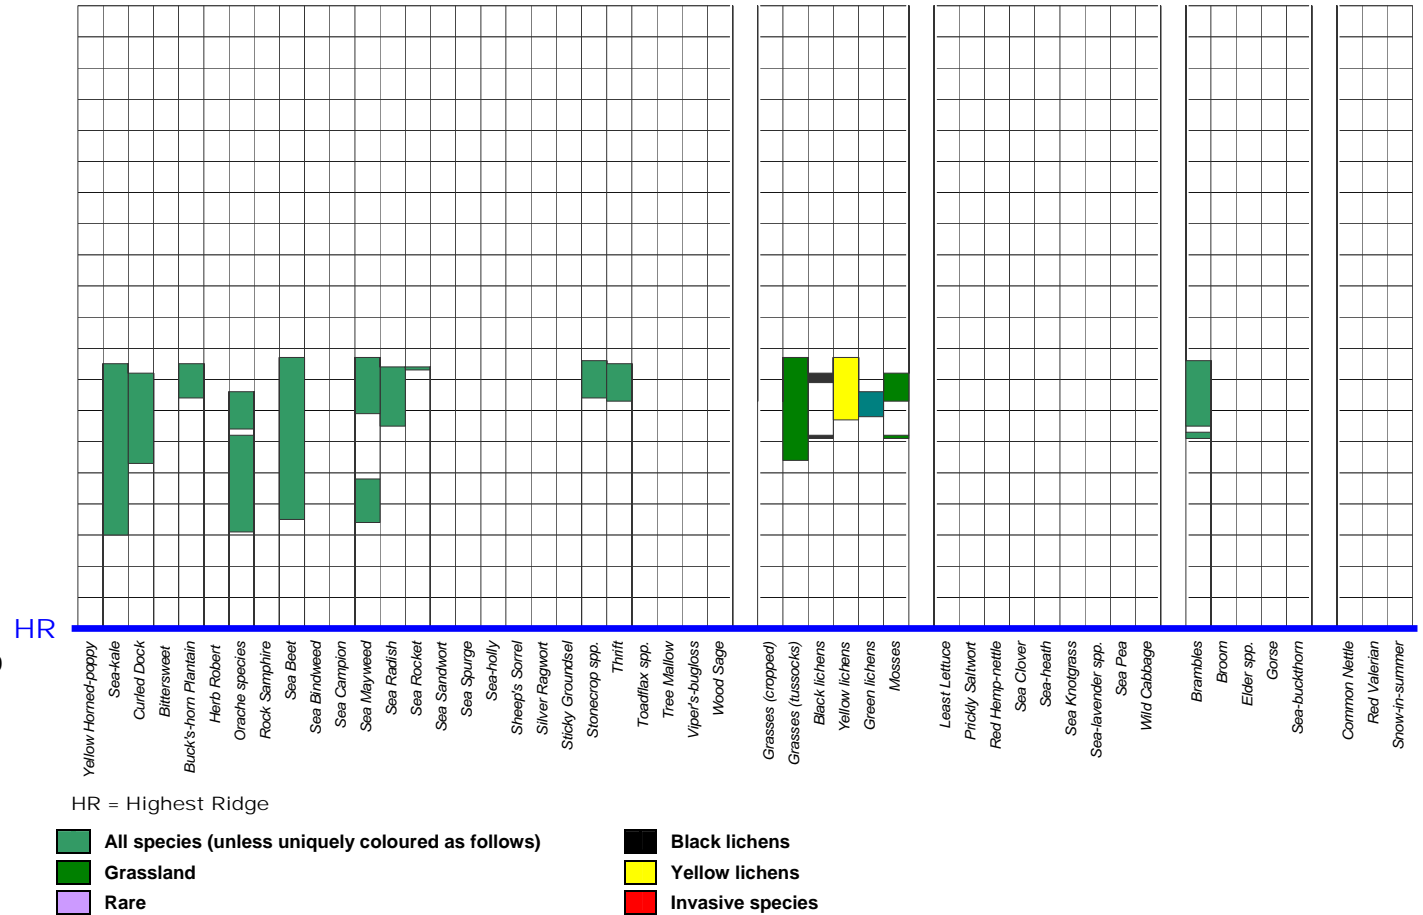
Figure E1.4 Distribution of species in 10m sections from seaward to landward side (transect information collected on 11/06/2008).

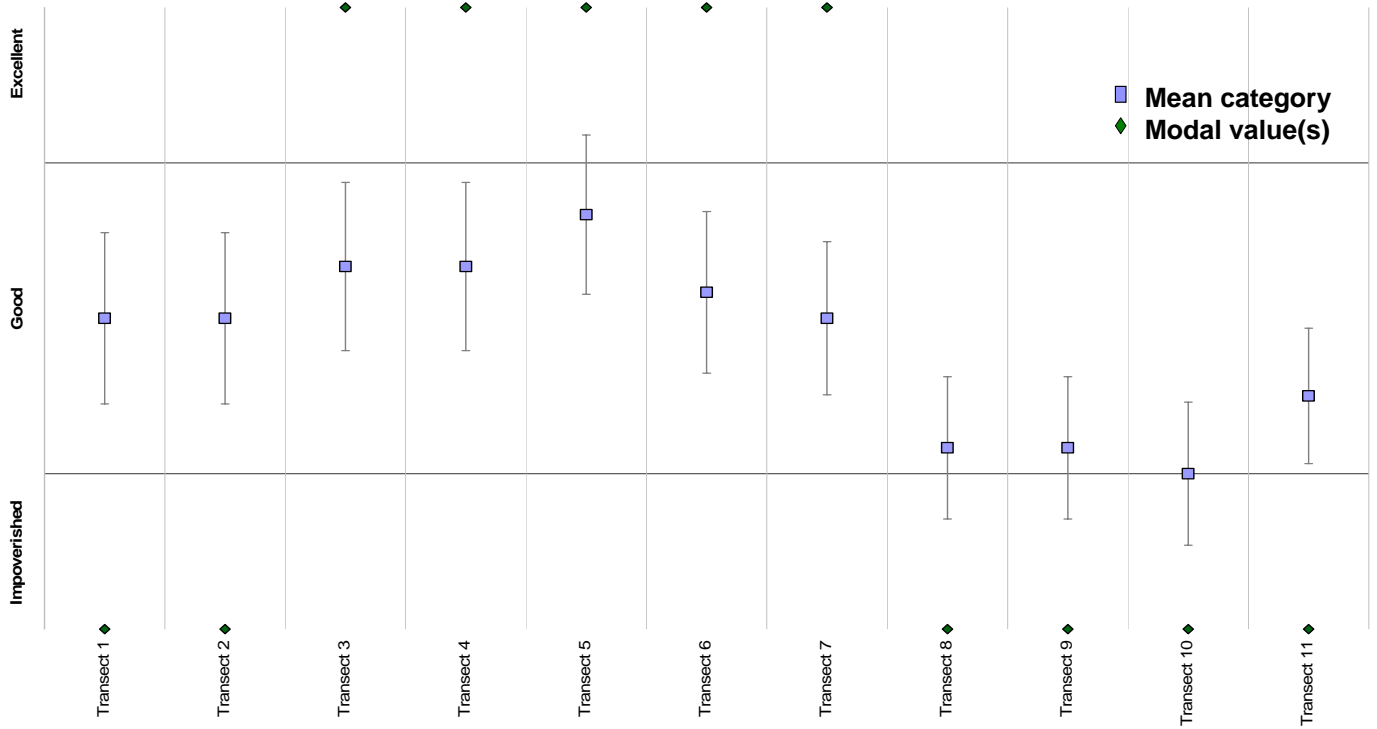
Figure E2.2 Biodiversity values for Tide Mills west shingle beach (Newhaven) including mean category \pm SEM and modal value(s).

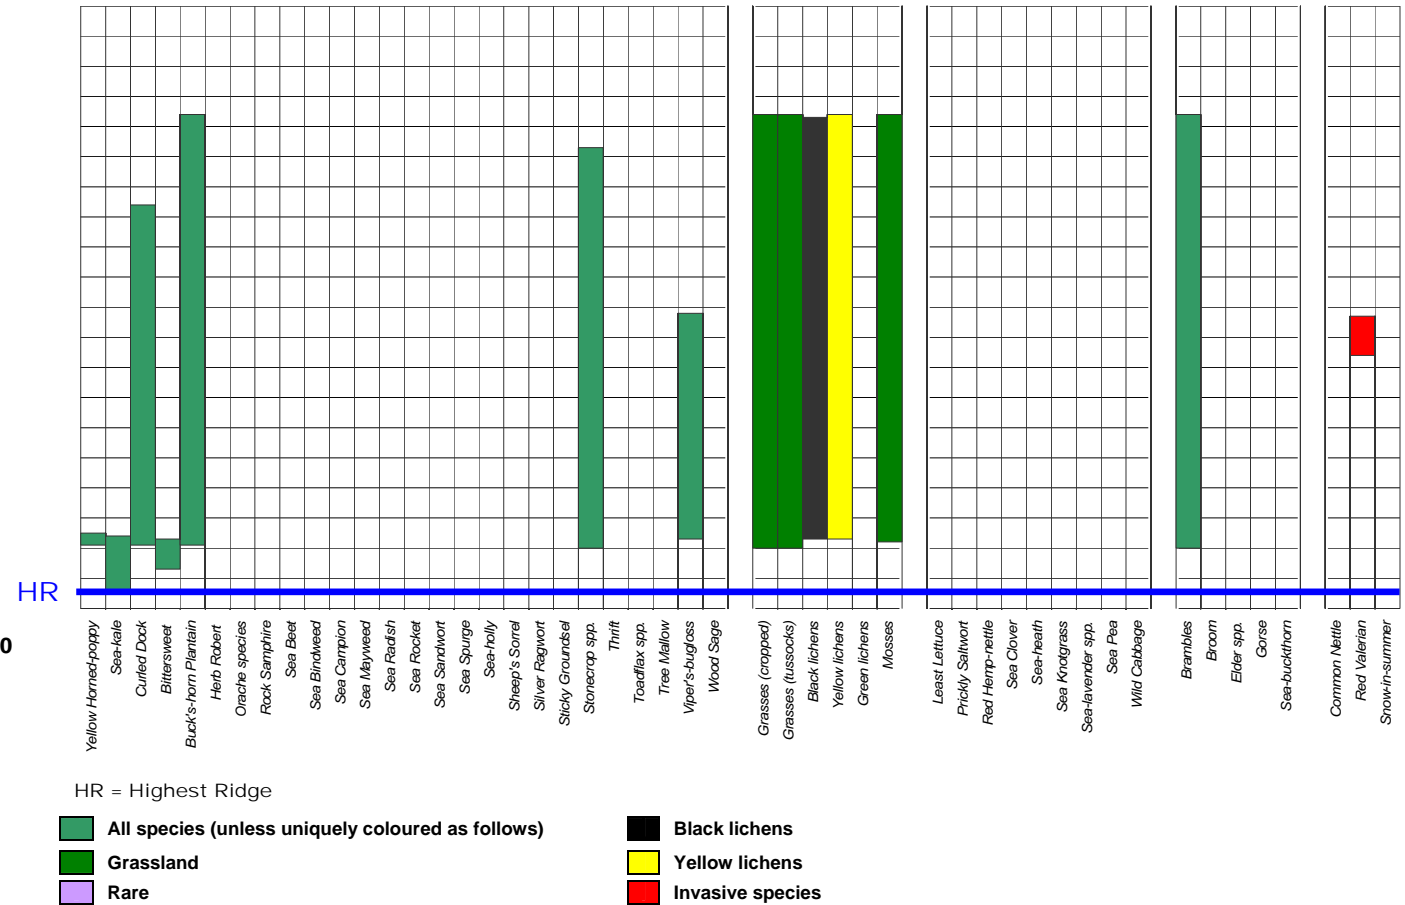
Figure E2.4 Distribution of species in 10m sections from seaward to landward side (transect information collected on 11/07/2008).

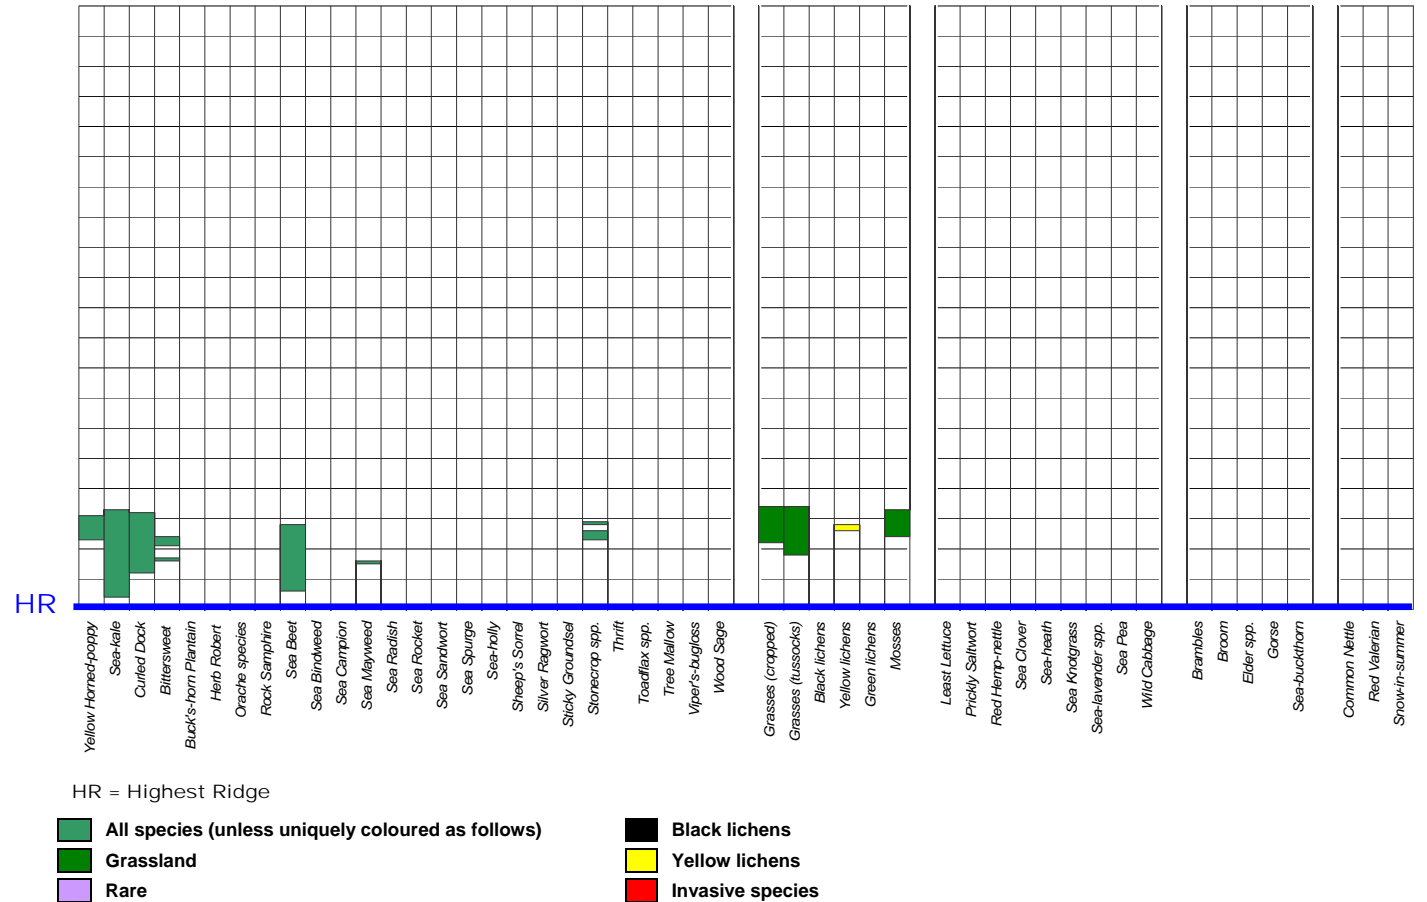
Figure E2.6 Distribution of species in 10m sections from seaward to landward side (transect information collected on 16/04/2008).

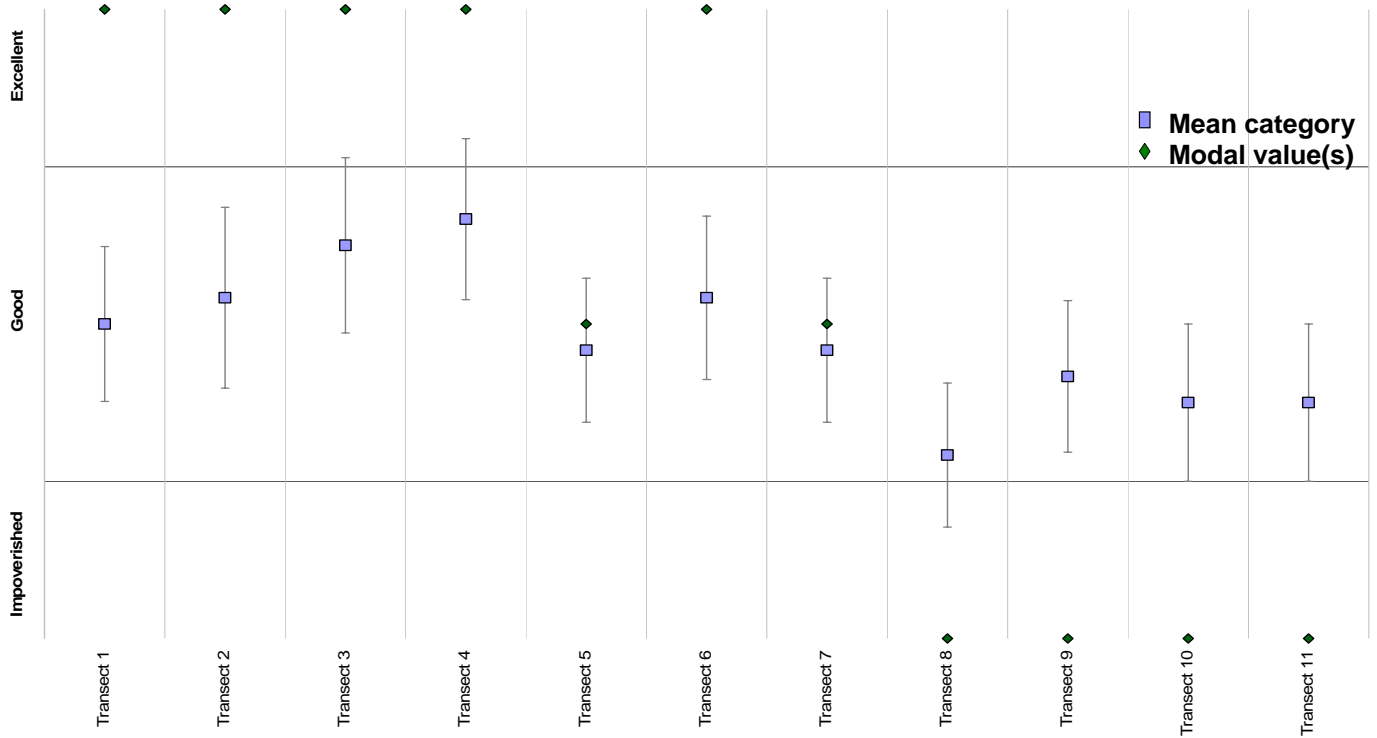
Figure E3.2 Biodiversity values for Tide Mills east shingle beach (Seaford) including mean category \pm SEM and modal value(s).

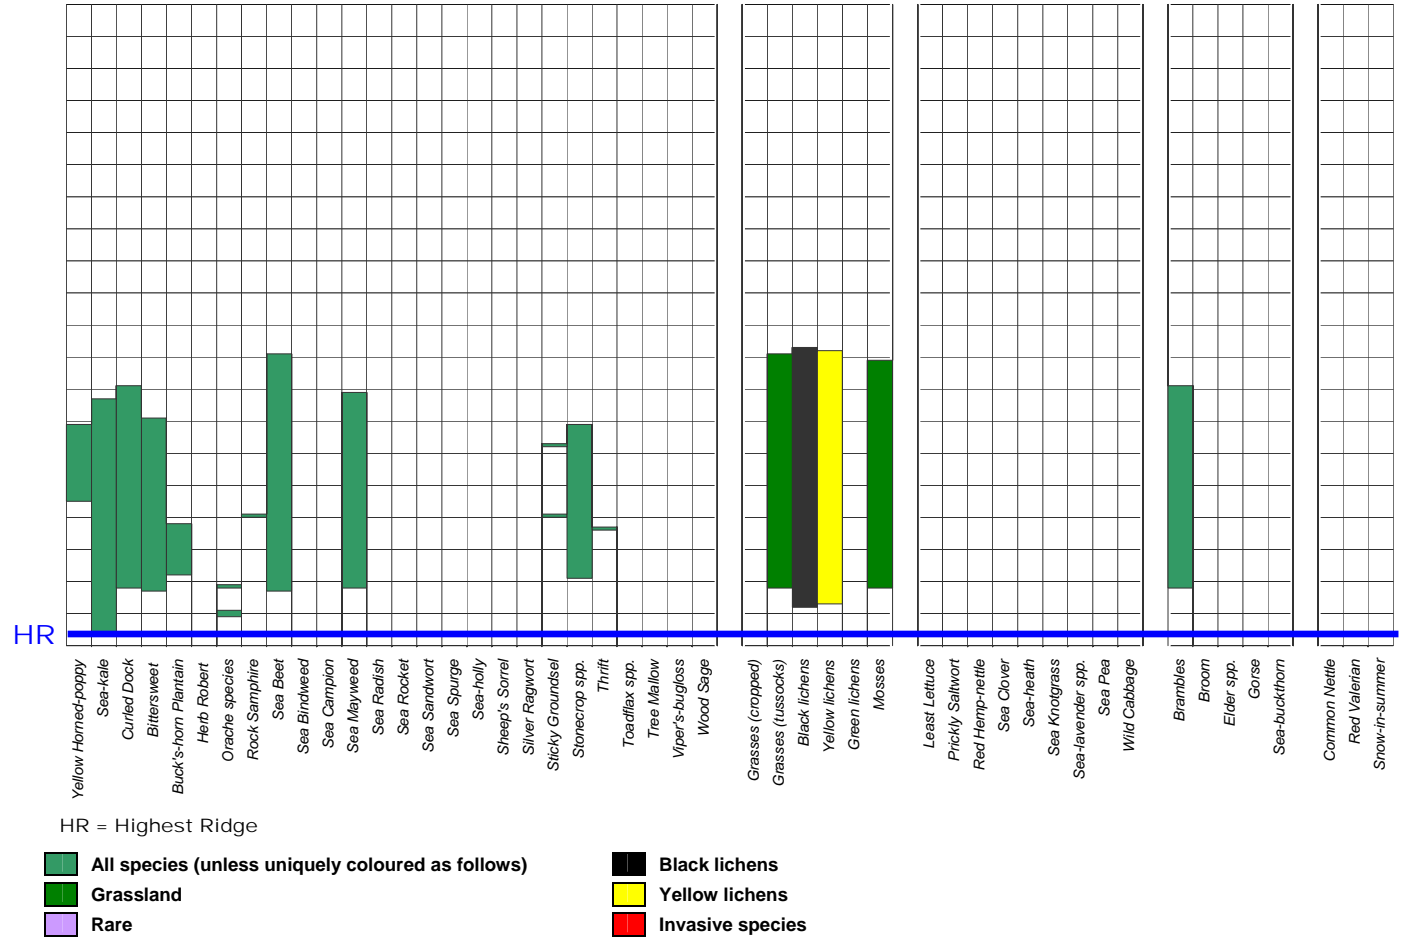
Figure E3.4 Distribution of species in 10m sections from seaward to landward side (transect information collected on 02/07/2008).

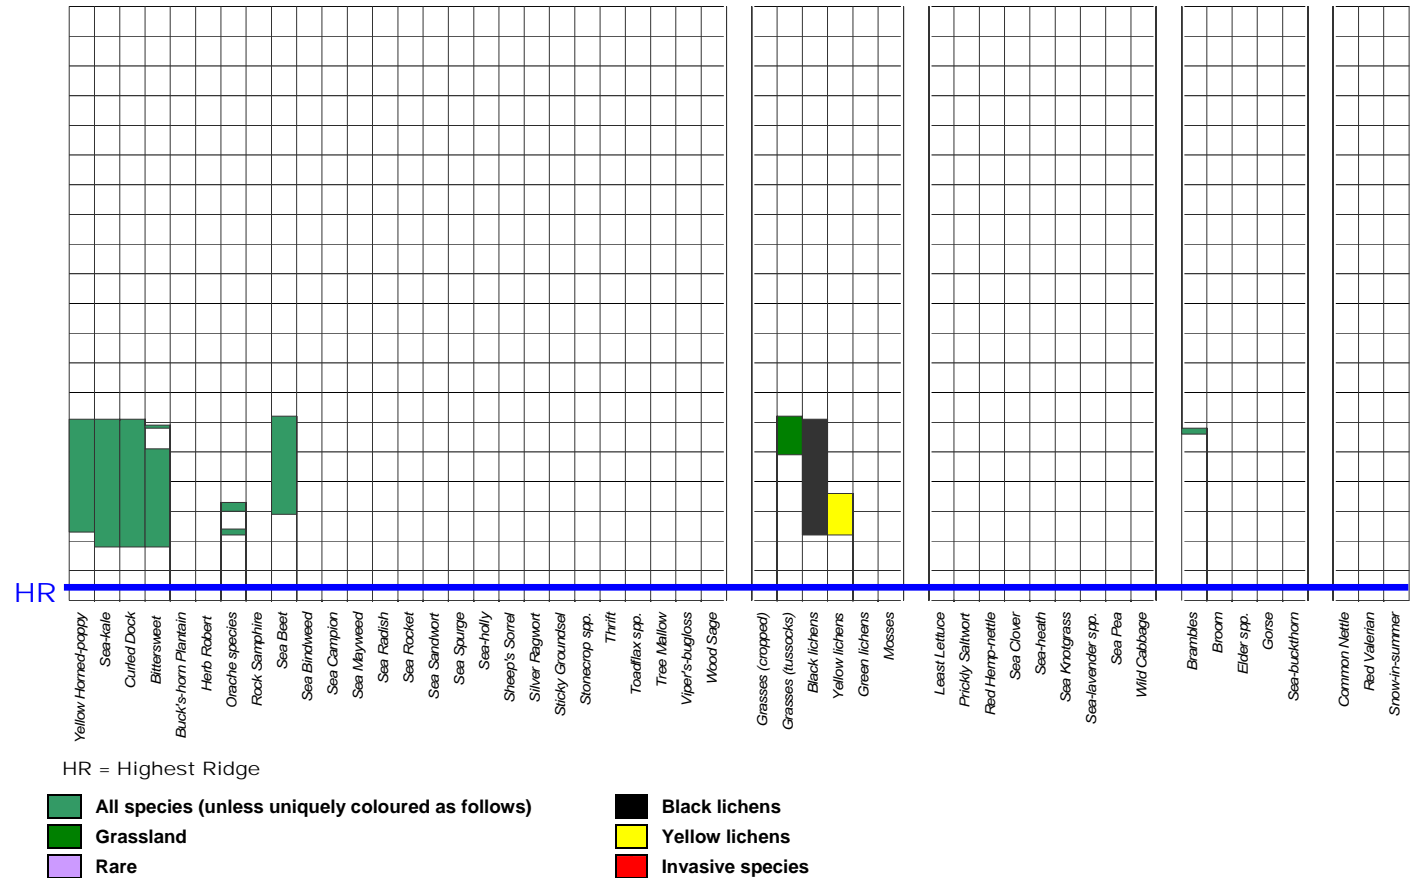
Figure E3.6 Distribution of species in 10m sections from seaward to landward side (transect information collected on 14/07/2008).

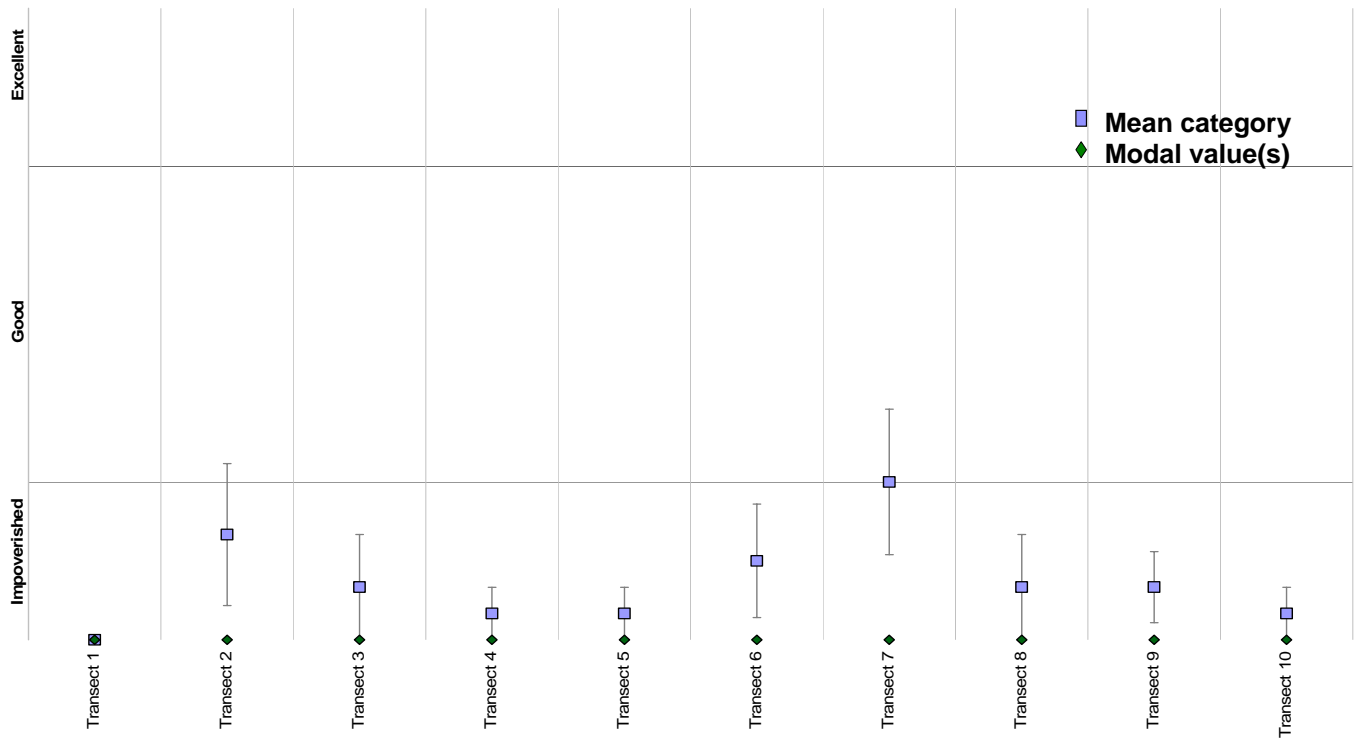
Figure E4.2 Biodiversity values for Bishopstone shingle beach (Seaford) including mean category \pm SEM and modal value(s).

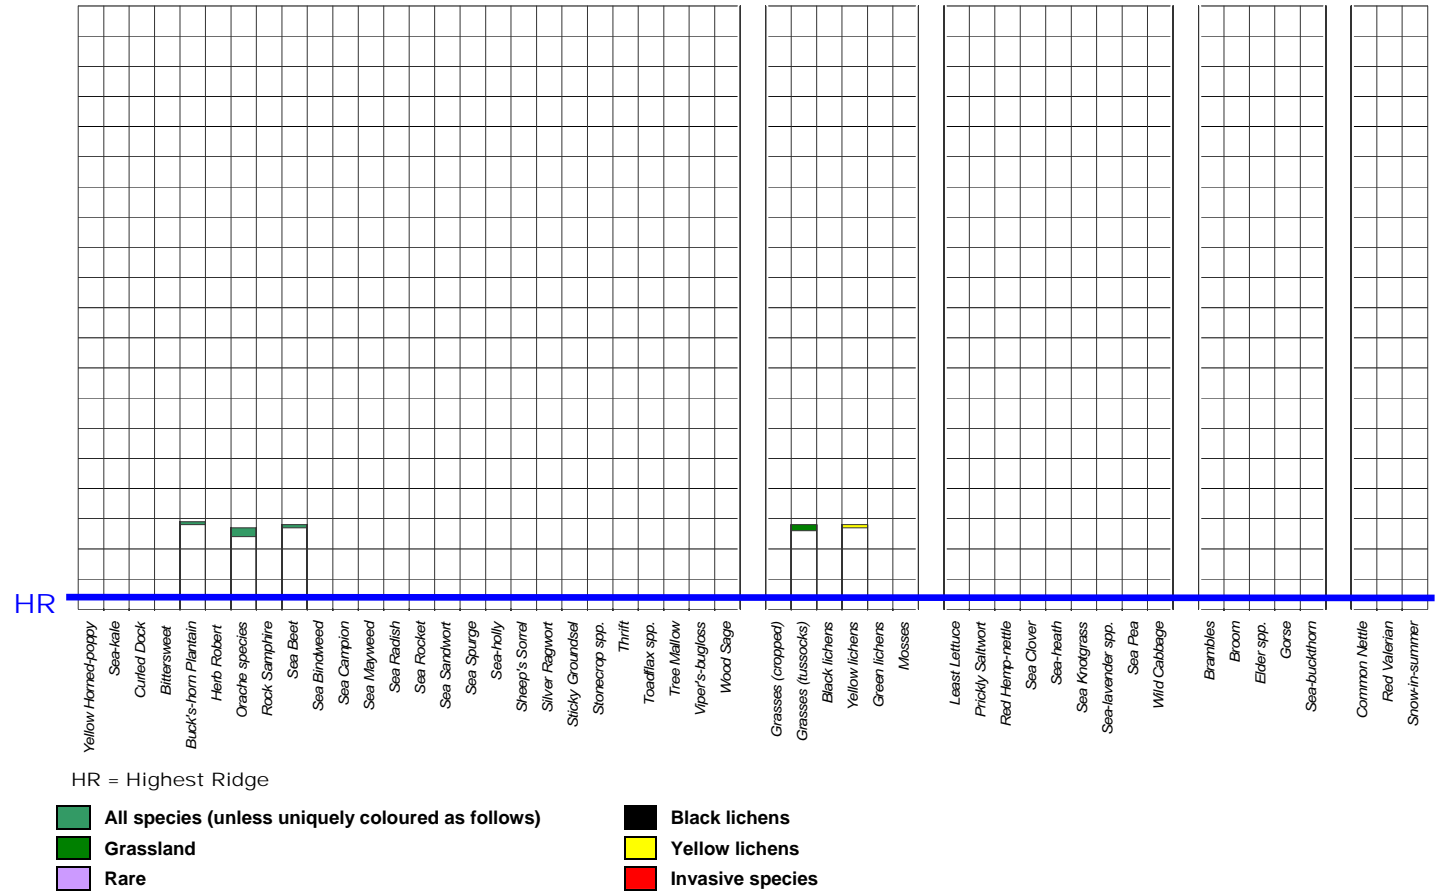
Figure E4.4 Distribution of species in 10m sections from seaward to landward side (transect information collected on 22/05/2008).

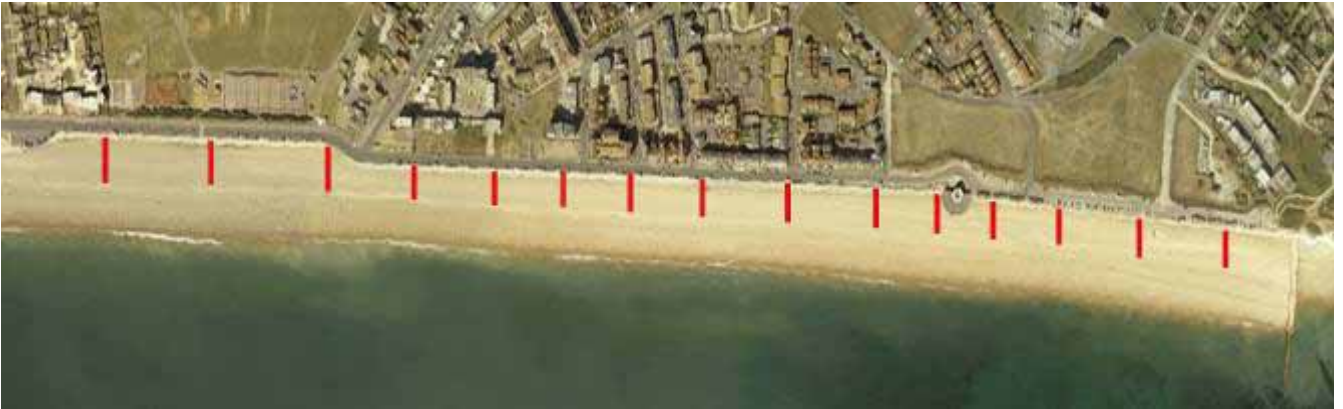
Figure E5.1 Shows the locations of the 2008 transect surveys carried out on Seaford beach.

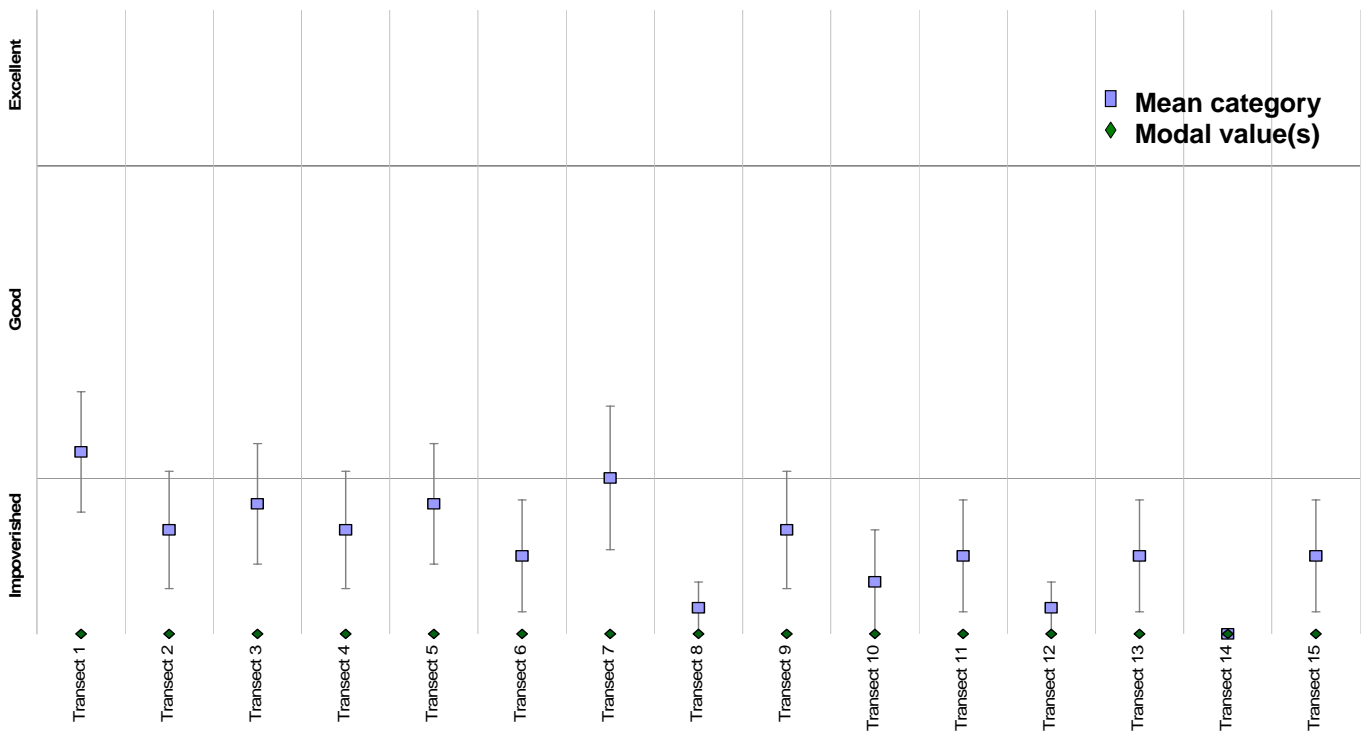
Figure E5.2 Biodiversity values for Seaford shingle beach including mean category \pm SEM and modal value(s).

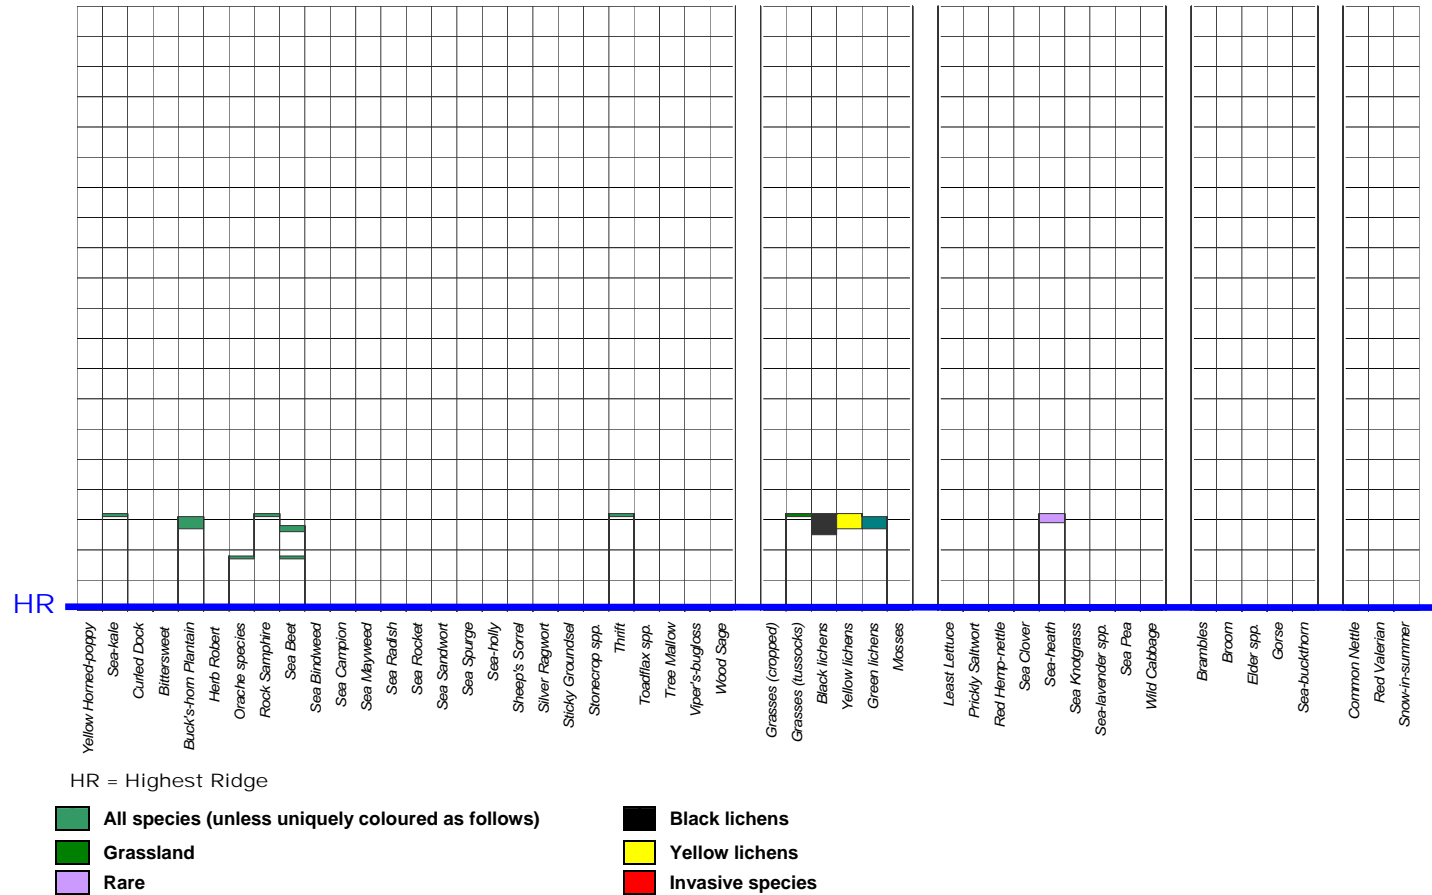
Figure E5.4 Distribution of species in 10m sections from seaward to landward side (transect information collected on 12/05/2008).

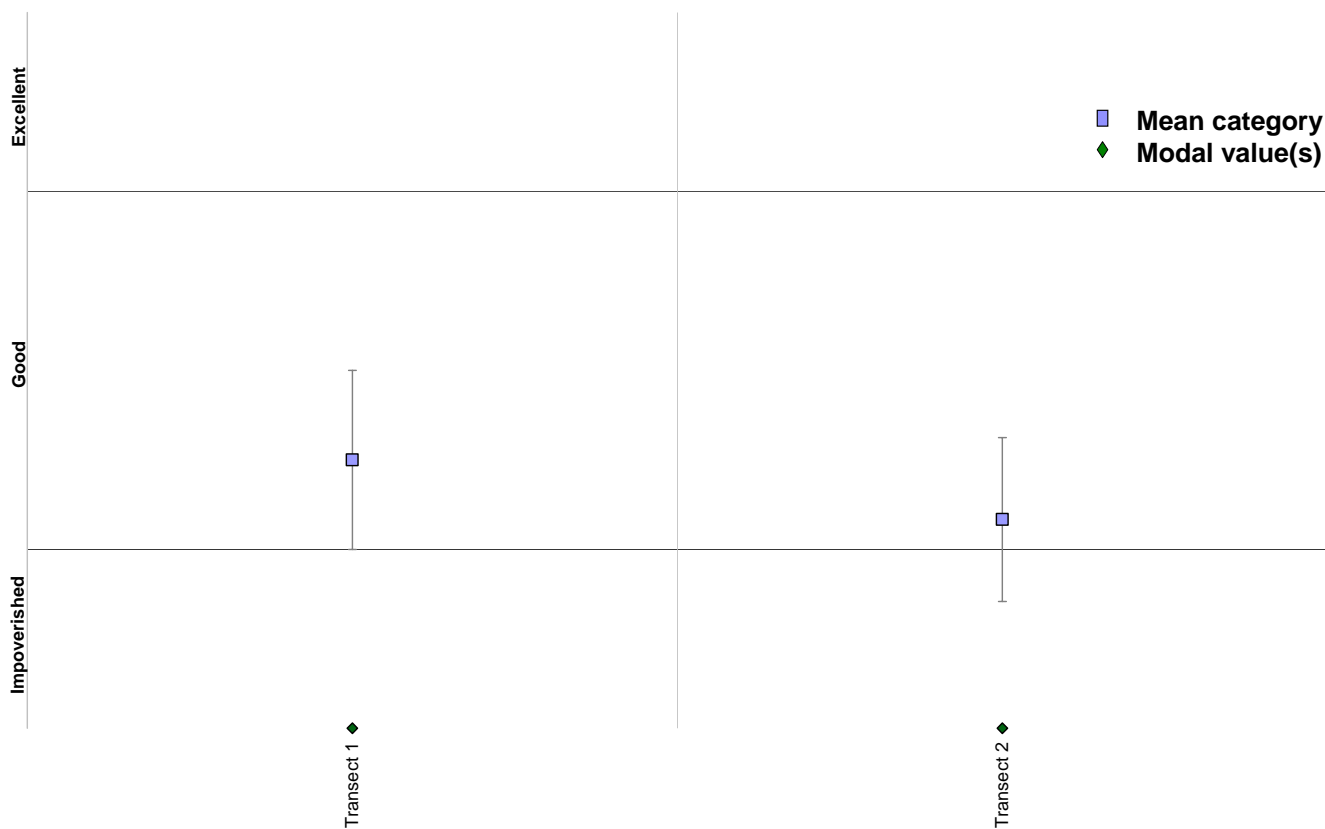
Figure E6.2 Biodiversity values for Cuckmere Haven’s western shingle beach (Seaford) including mean category ± SEM and modal value(s).

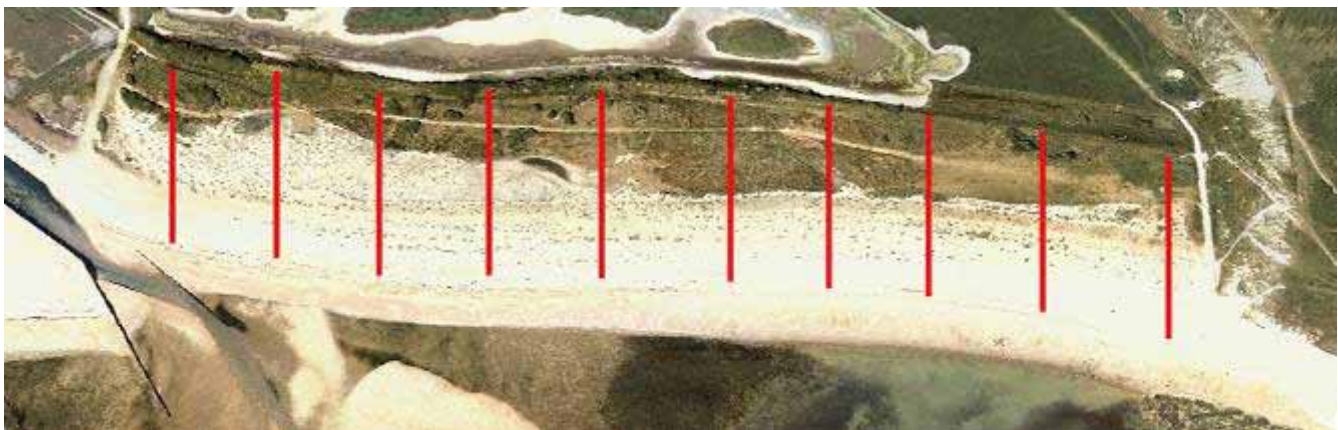
Figure E7.1 Shows the locations of the 2008 transect surveys carried out on Cuckmere Haven (east beach).

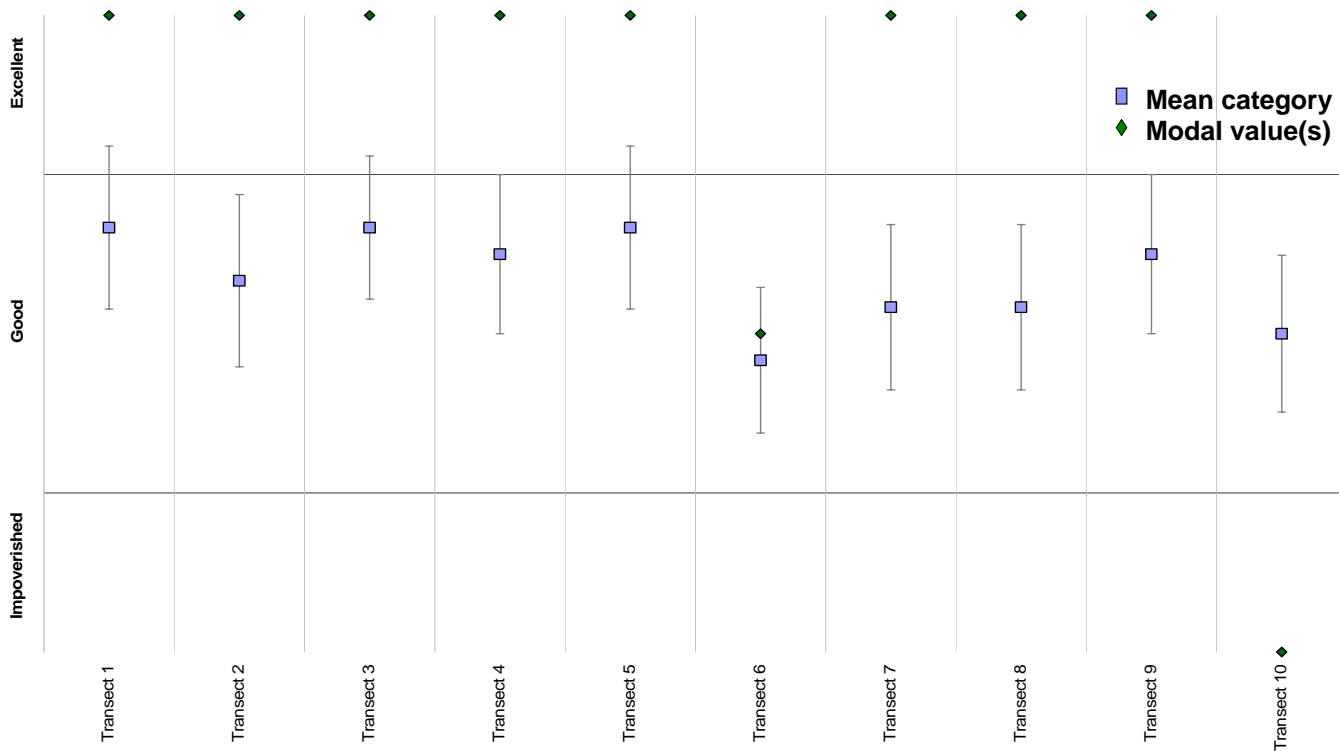
Figure E7.2 Biodiversity values for Cuckmere Haven’s eastern shingle beach (Cuckmere Valley) including mean category ± SEM and modal value(s).

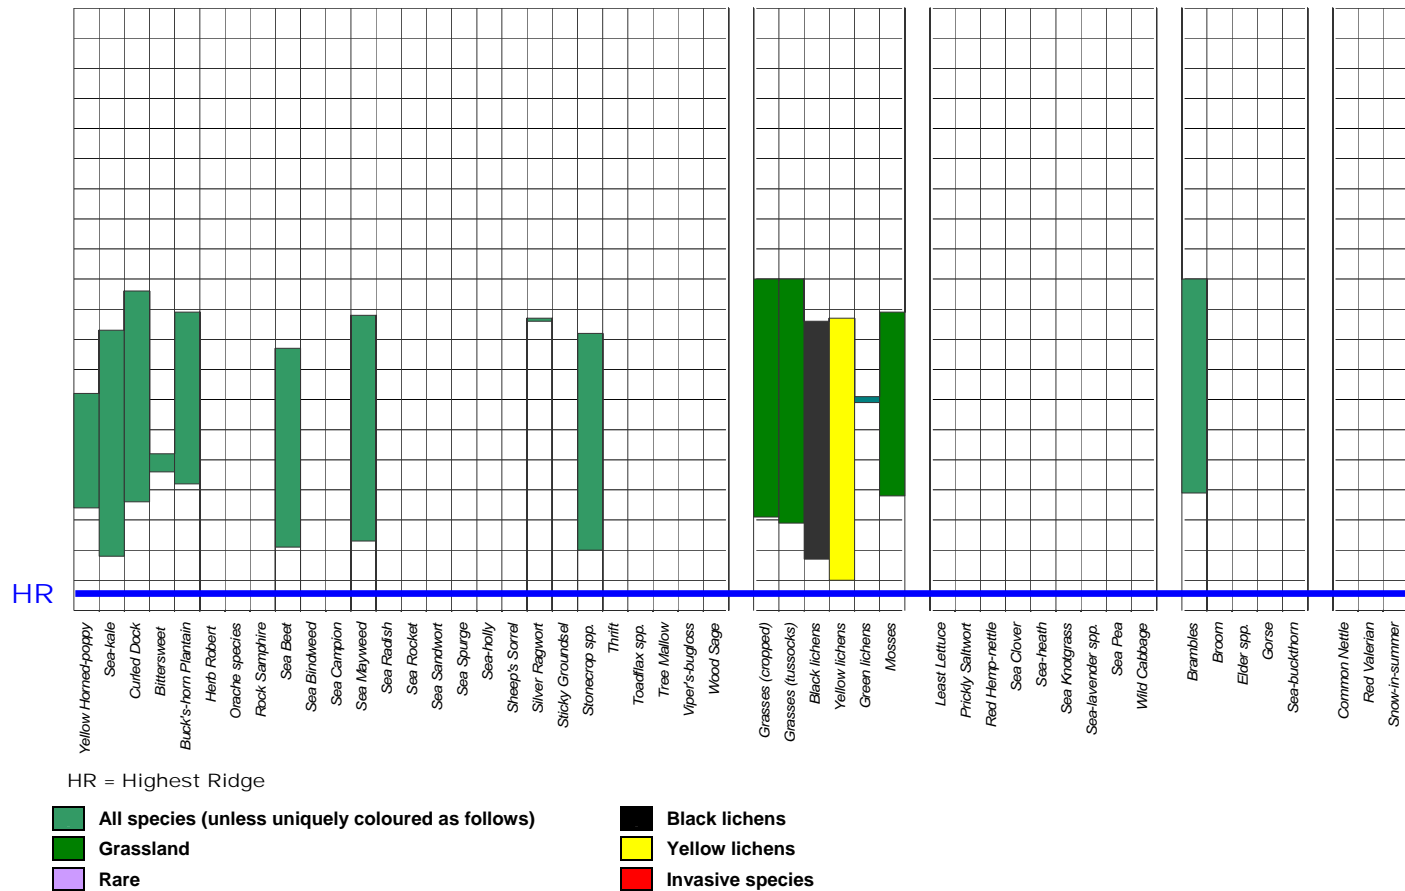
Figure E7.4 Distribution of species in 10m sections from seaward to landward side (transect information collected on 14/07/2008).

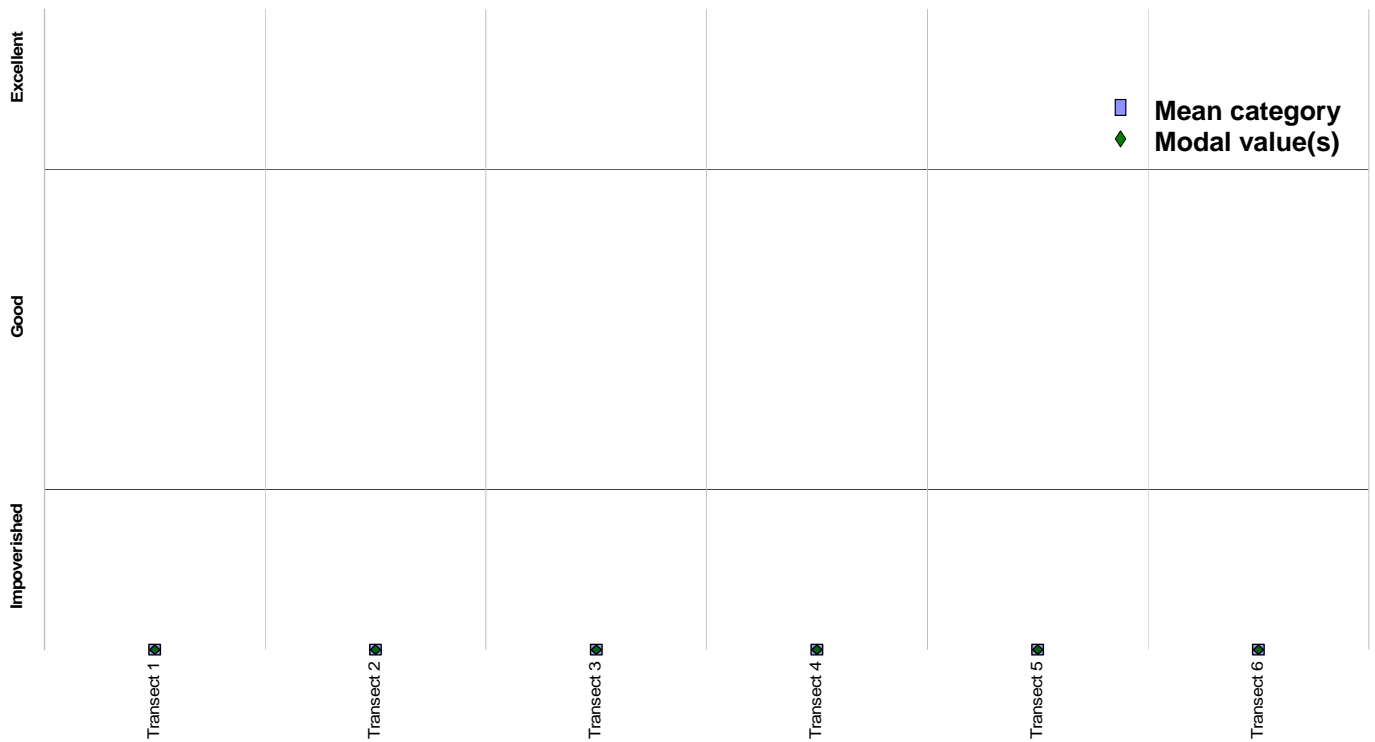
Figure E8.2 Biodiversity values for Birling Gap shingle beach (East Dean & Friston) including mean category \pm SEM and modal value(s).
