Appendix C - Guidelines for Good Practice when working on beaches with Vegetated Shingle

Guidelines for Good Practice when working on beaches with Vegetated Shingle

Appendix D - Shingle beach “Cab Cards”

Appendix E - Site evaluation data (graphical representation)

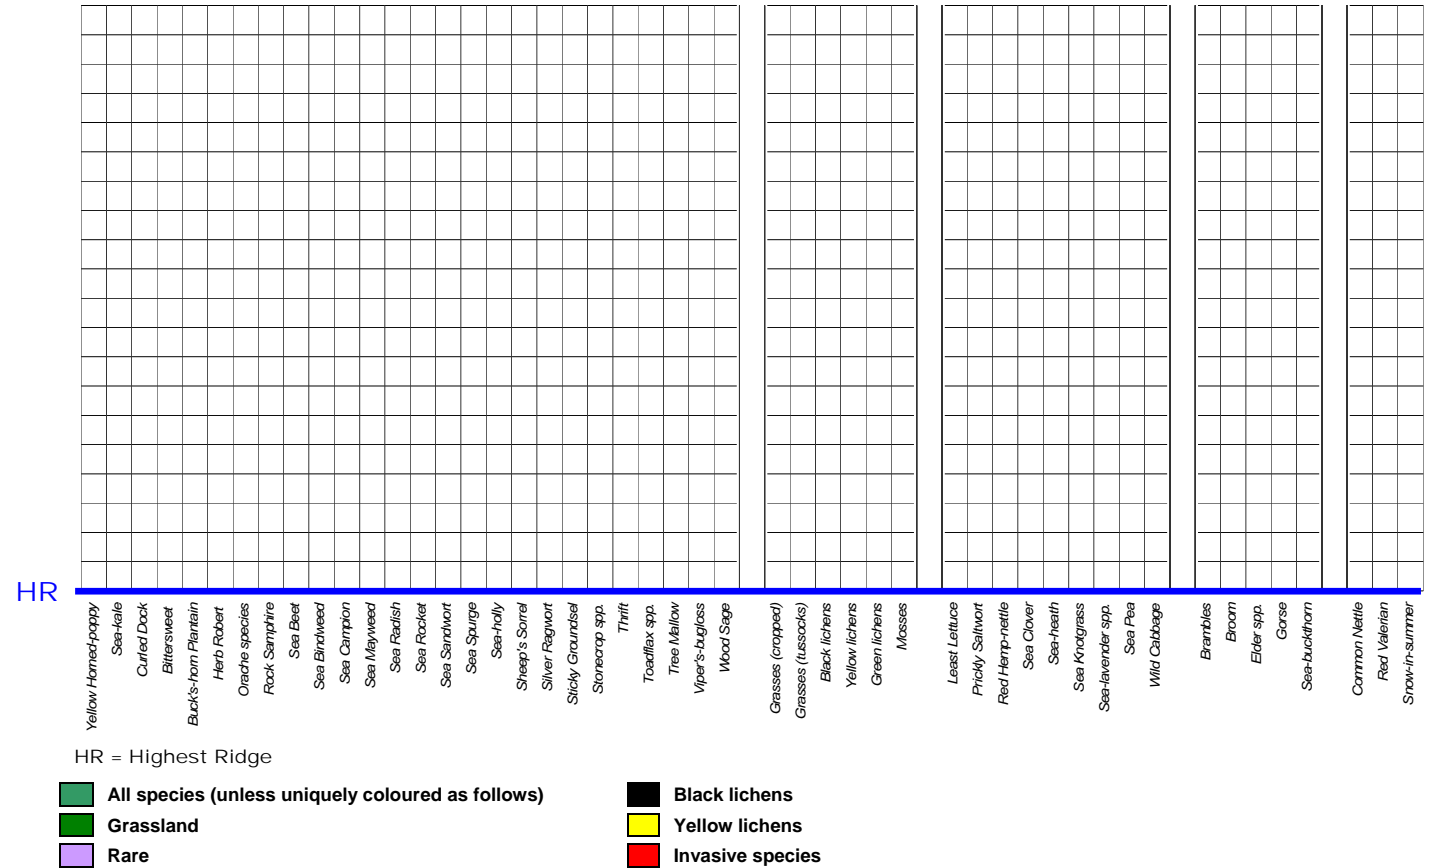
Figure E8.4 Distribution of species in 10m sections from seaward to landward side (transect information collected on 29/07/2008).

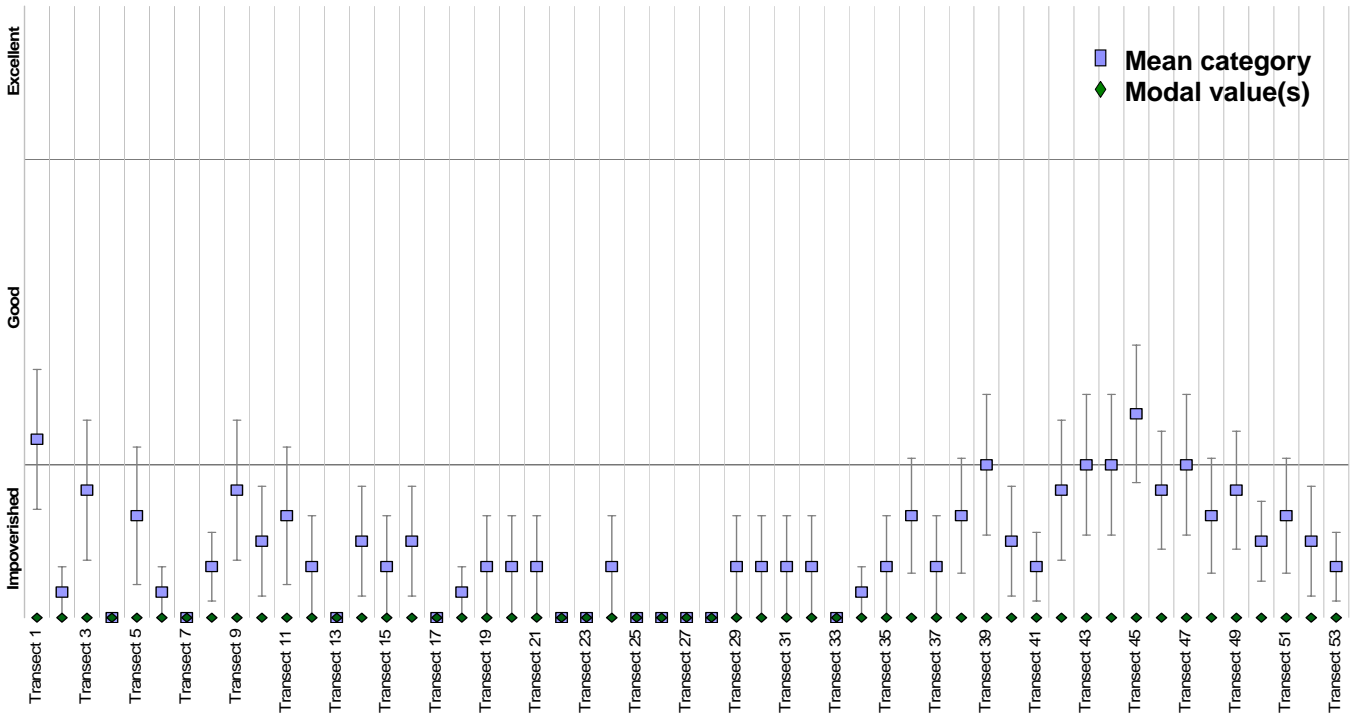
Figure E9.2 Biodiversity values for the shingle beach at Eastbourne including mean category \pm SEM and modal value(s).

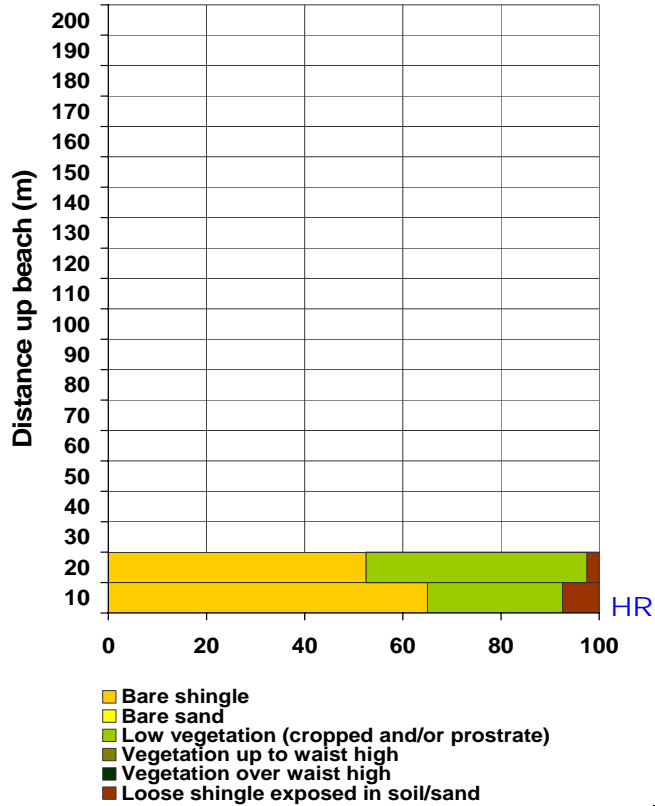
Figure E9.3 Percentage of shingle, sand and vegetation cover in 10m sections from seaward to landward side.

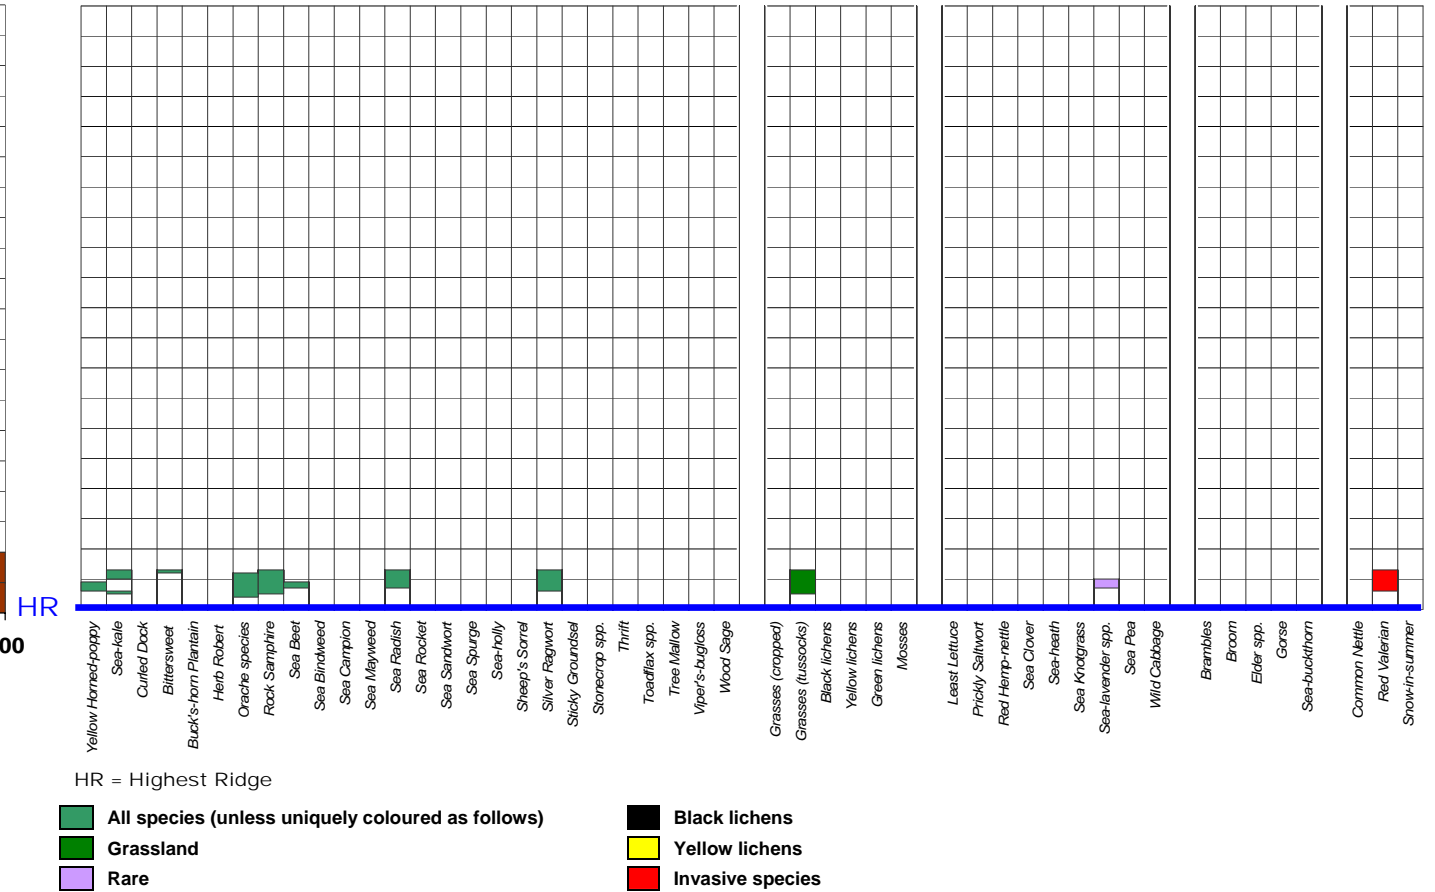
Figure E9.4 Distribution of species in 10m sections from seaward to landward side (transect information collected on 30/06/2008, and 28/07/2008).

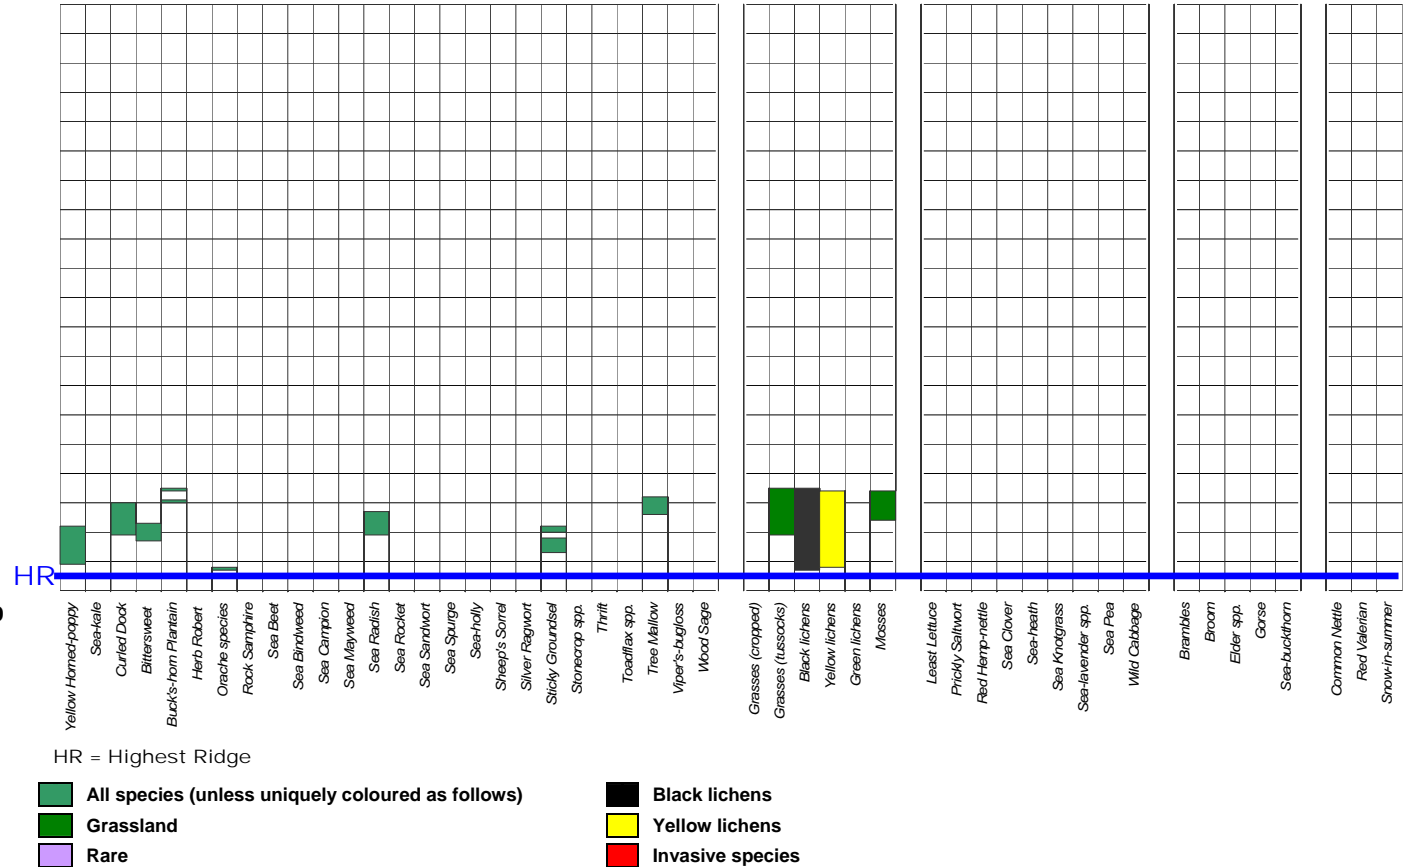
Figure E9.6 Distribution of species in 10m sections from seaward to landward side (transect information collected on 15/07/2008).

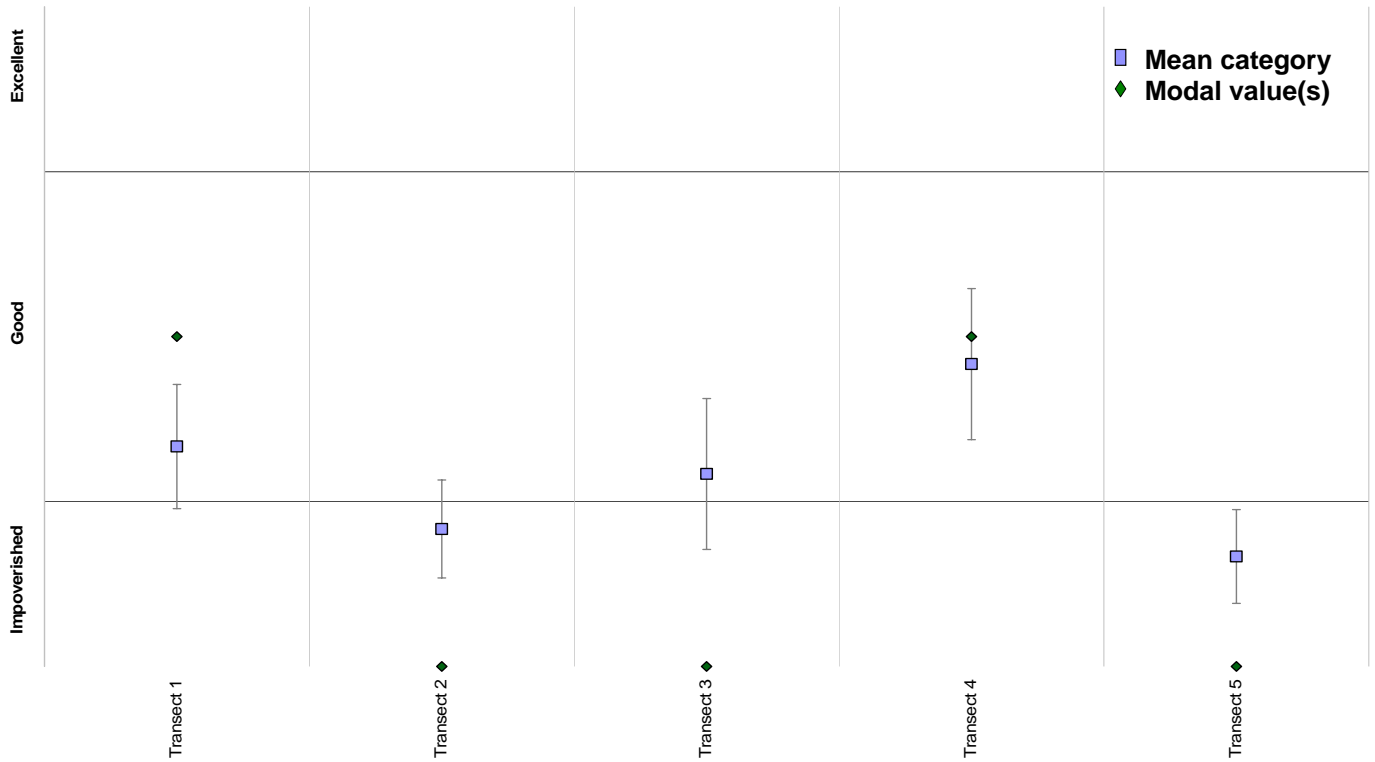
Figure E10.2 Biodiversity values for Sovereign Park shingle site (Eastbourne) including mean category \pm SEM and modal value(s).

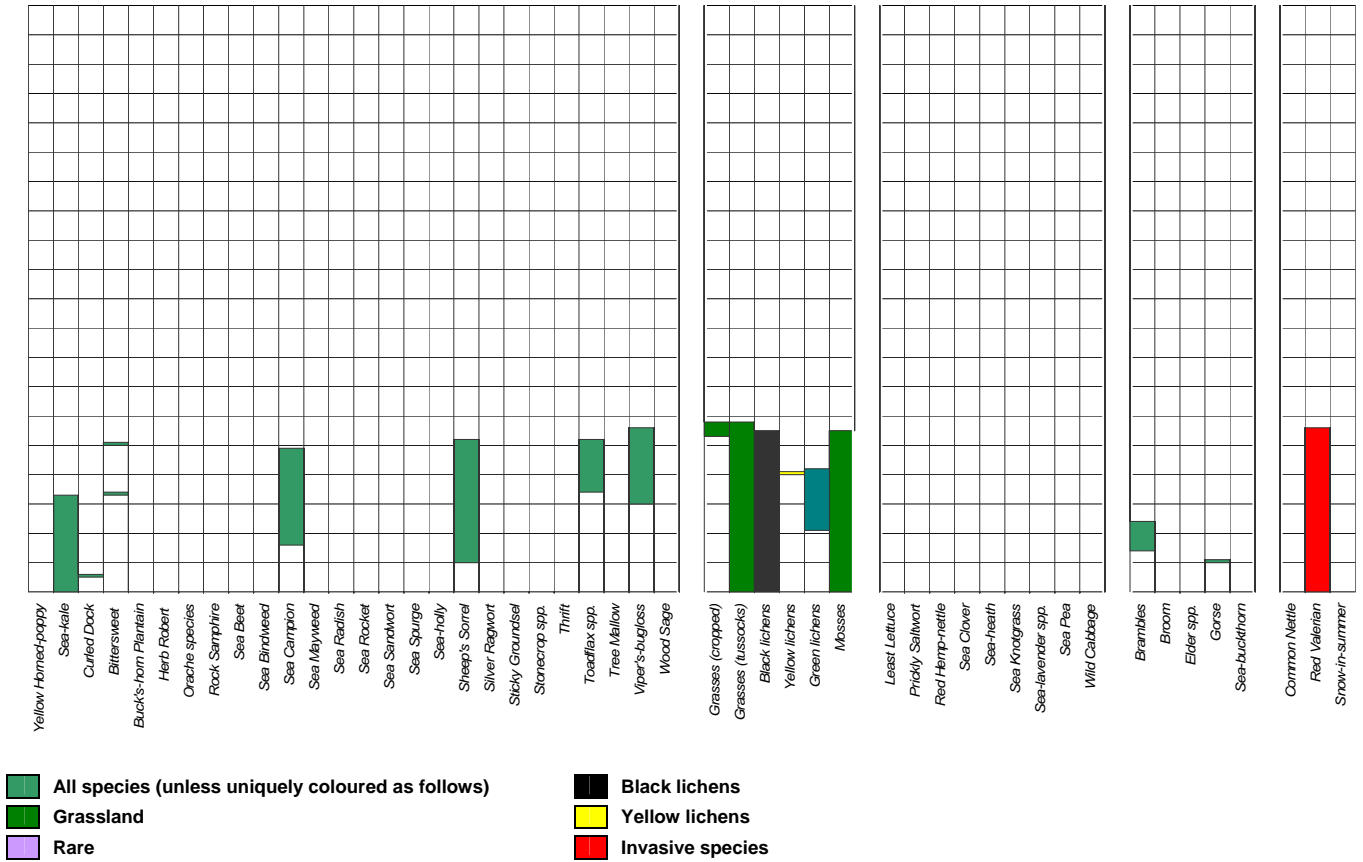
Figure E10.4 Distribution of species in 10m sections from seaward to landward side (transect information collected on 17/07/2008).

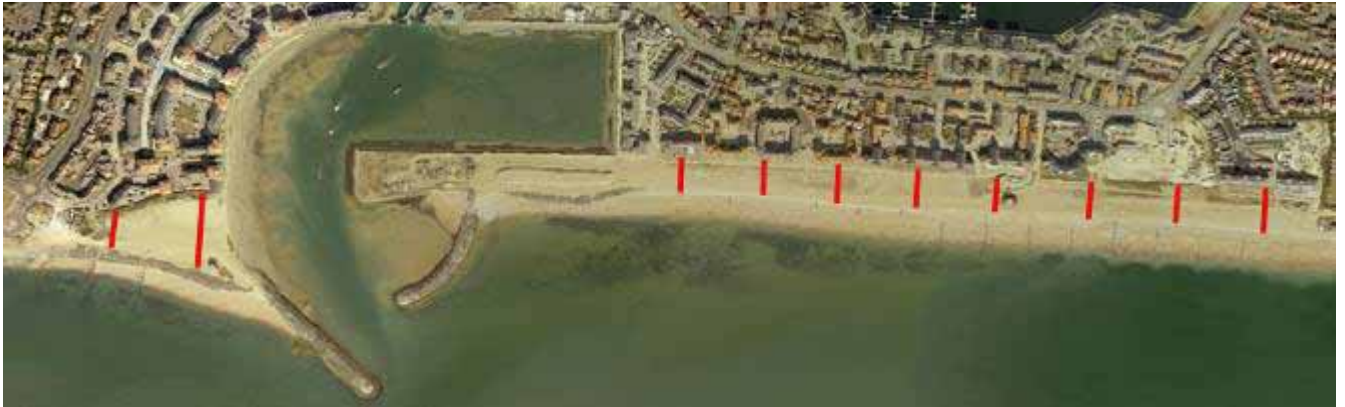
Figure E11.1 Shows the locations of the 2008 transect surveys carried out at Sovereign Harbour, Eastbourne.

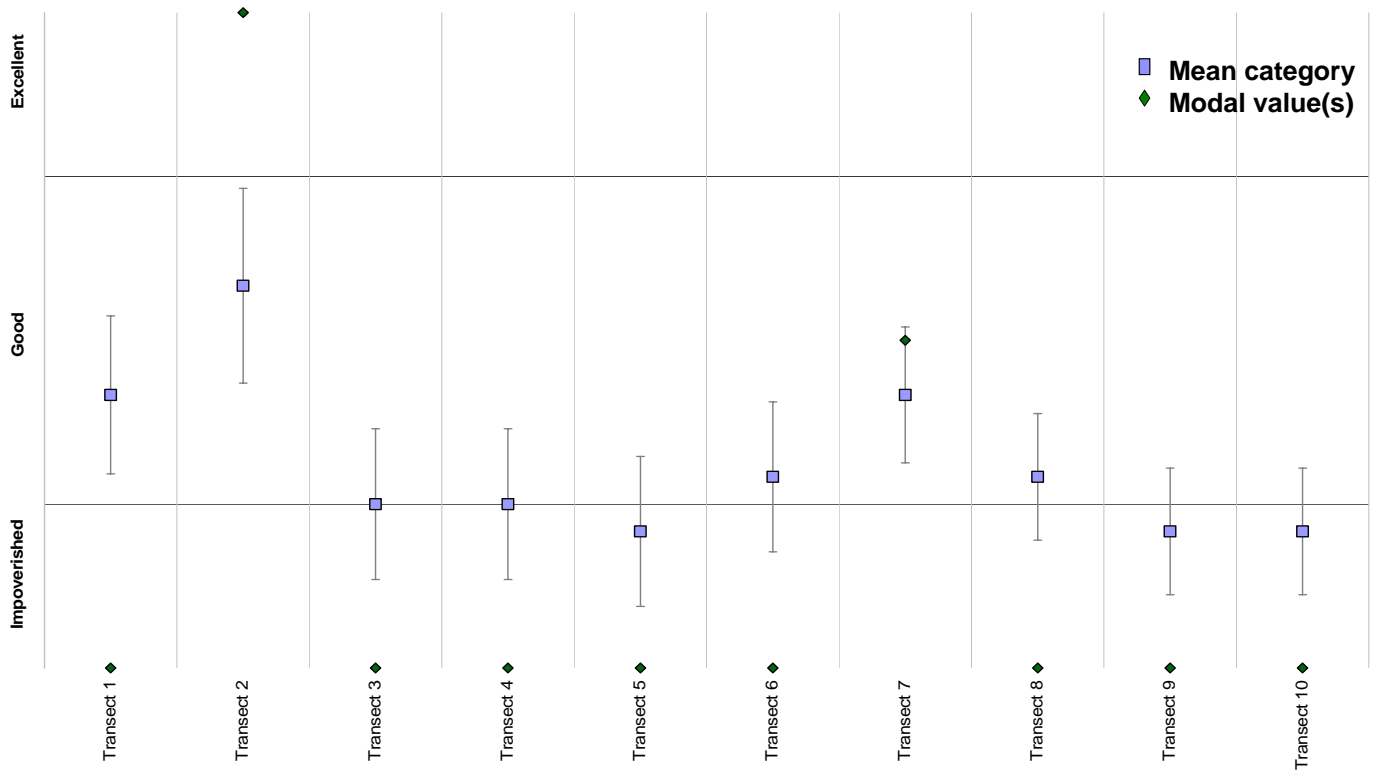
Figure E11.2 Biodiversity values for Sovereign Harbour shingle beach (Eastbourne) including mean category \pm SEM and modal value(s).

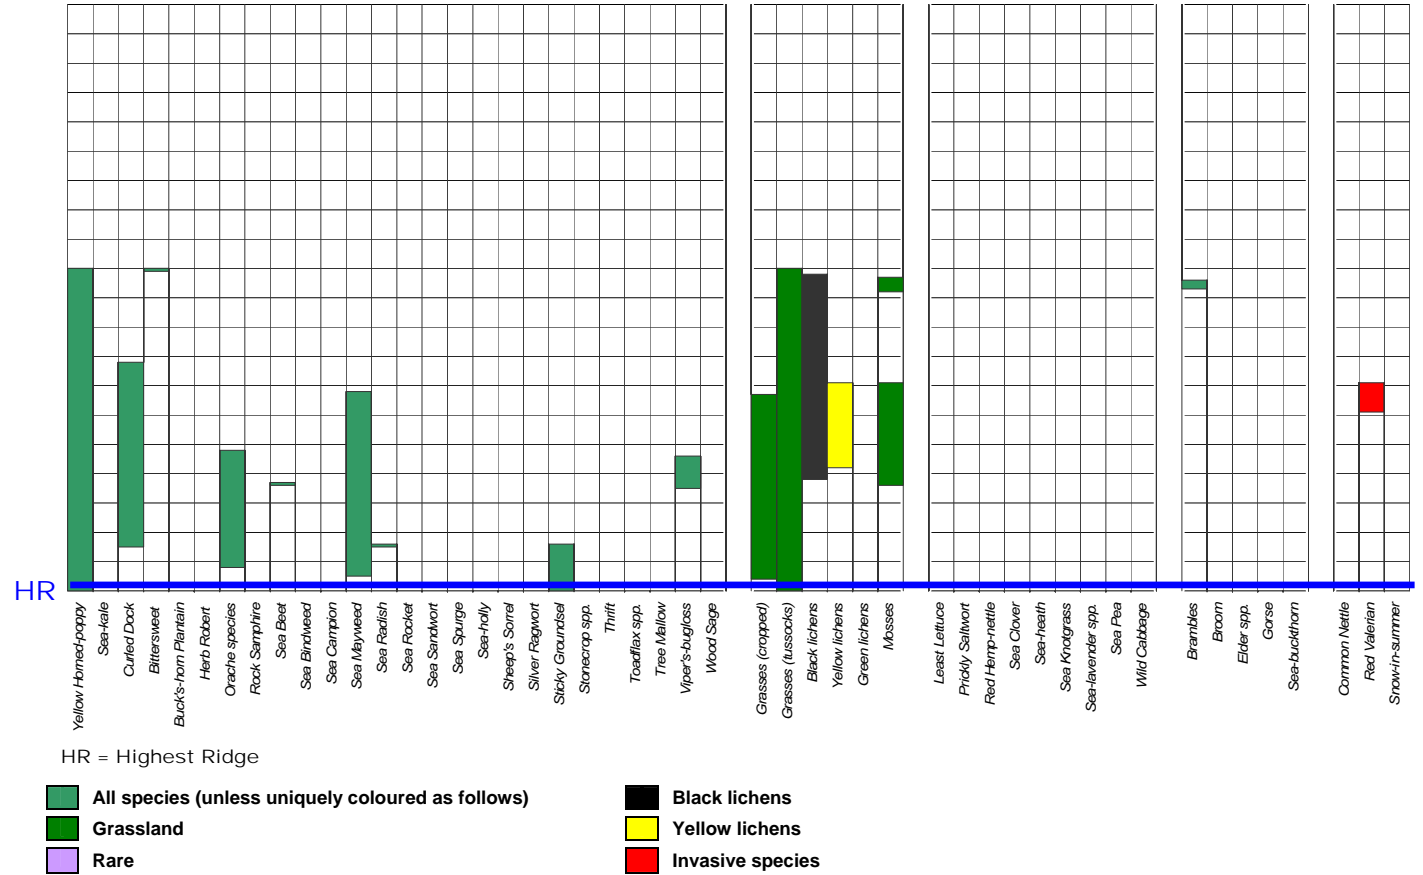
Figure E11.4 Distribution of species in 10m sections from seaward to landward side (transect information collected on 21/07/2008).

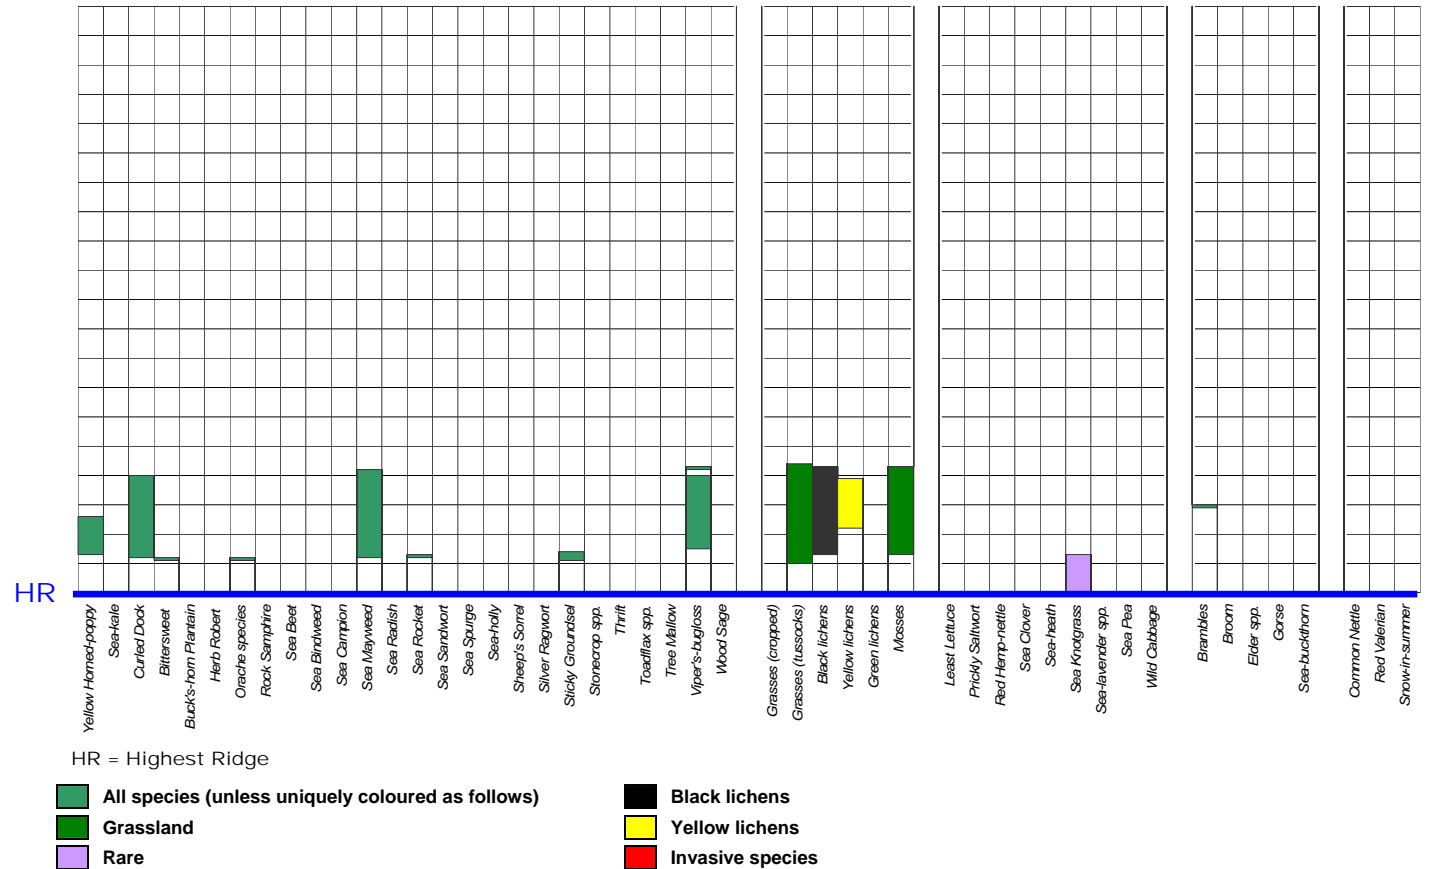
Figure E11.6 Distribution of species in 10m sections from seaward to landward side (transect information collected on 20/08/2008).

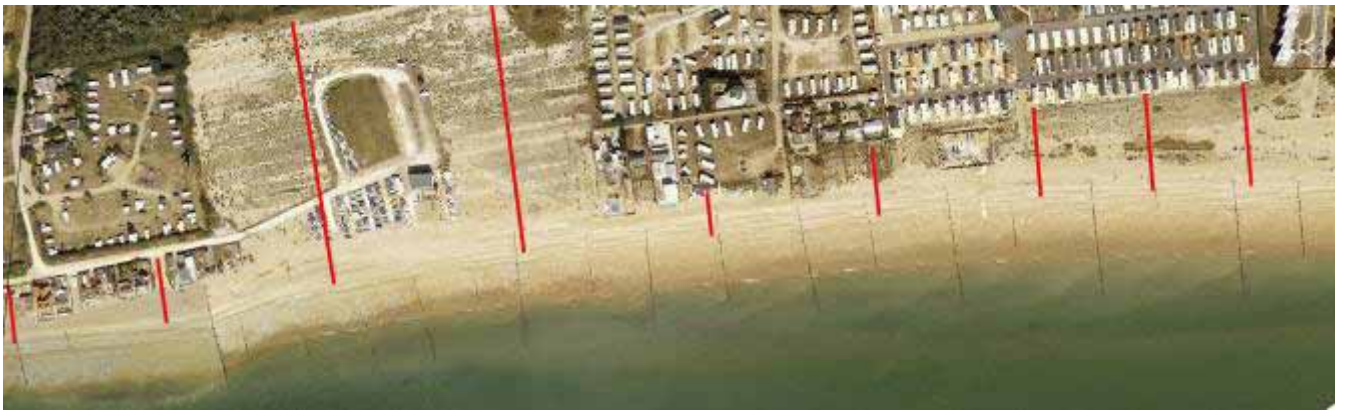
Figure E12.1 Shows the locations of the 2008 transect surveys carried out on Westham beach

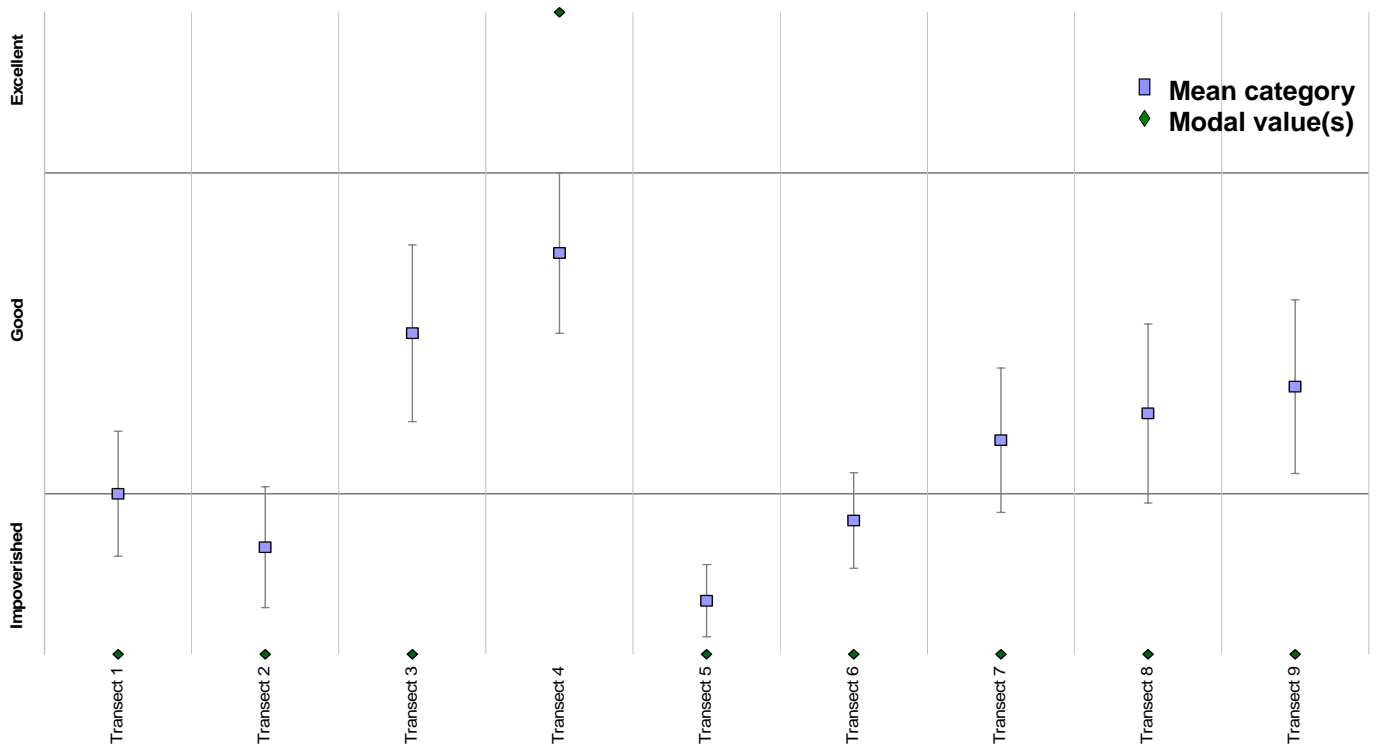
Figure E12.2 Biodiversity values for Westham shingle beach including mean category \pm SEM and modal value(s).

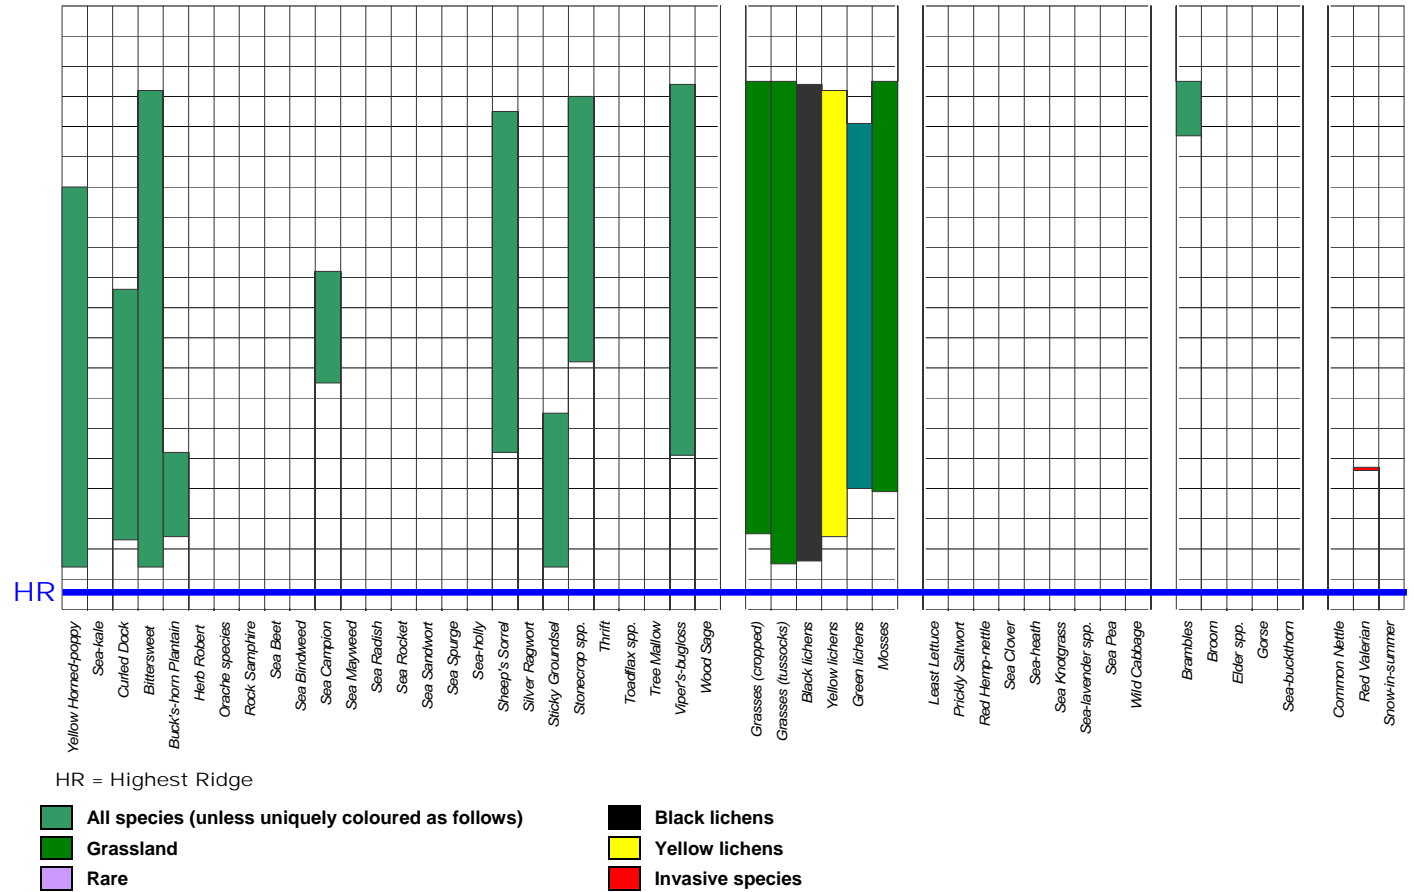
Figure E12.4 Distribution of species in 10m sections from seaward to landward side (transect information collected on 28/07/2008).

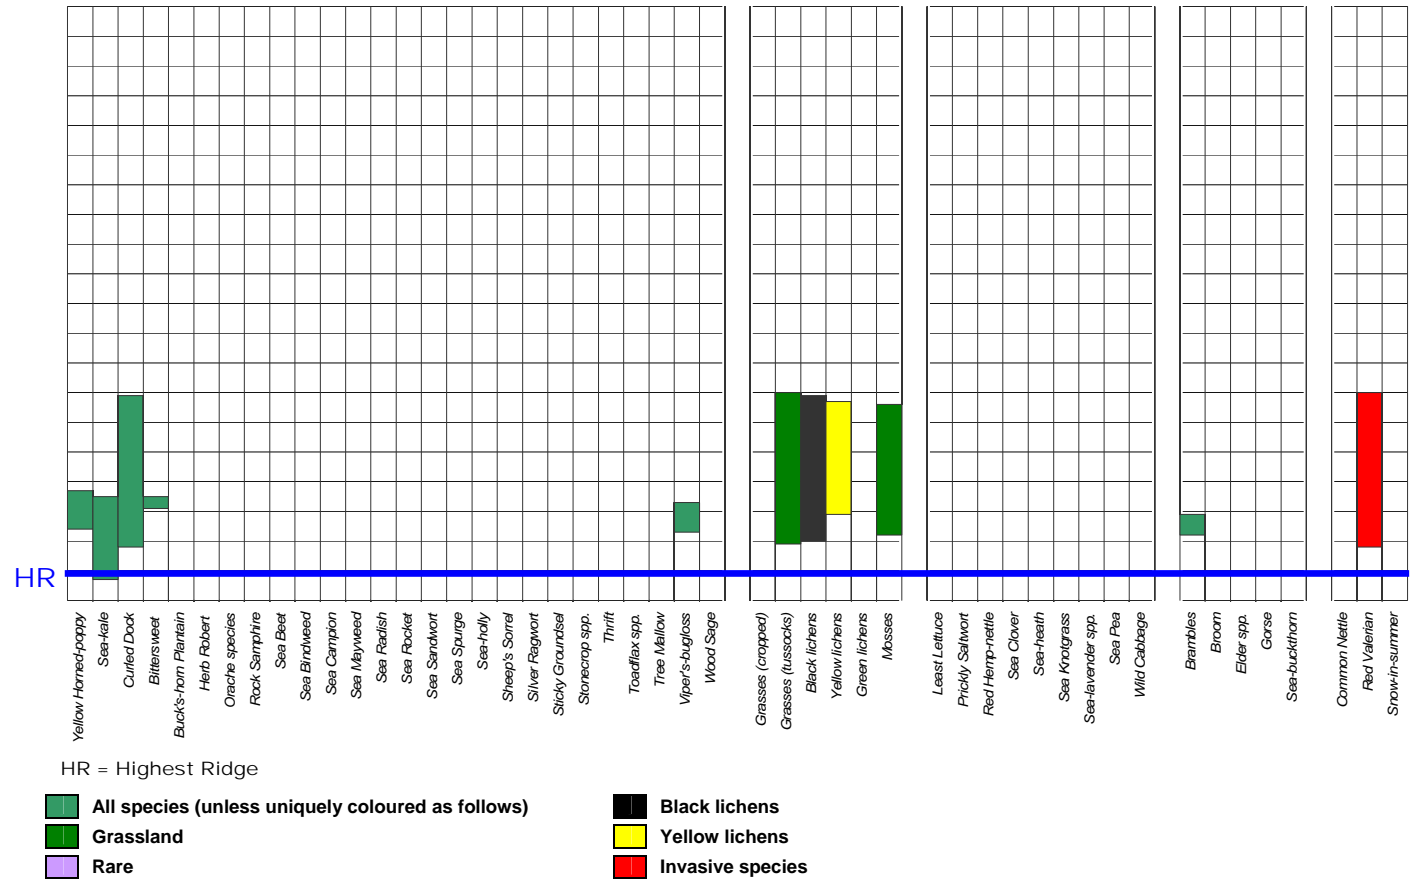
Figure E12.6 Distribution of species in 10m sections from seaward to landward side (transect information collected on 16/06/2008).

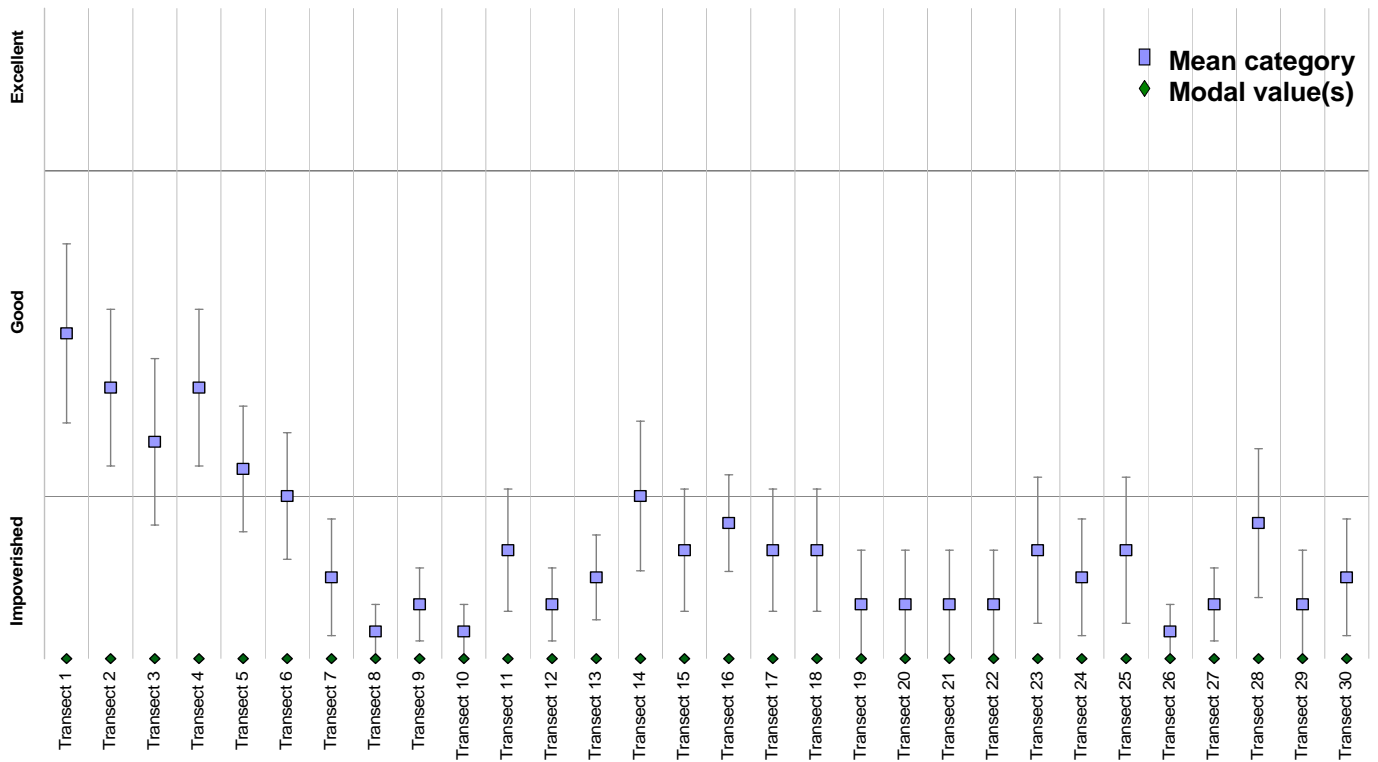
Figure E13.2 Biodiversity values for Pevensey shingle beach (Pevensey Bay) including mean category \pm SEM and modal value(s).

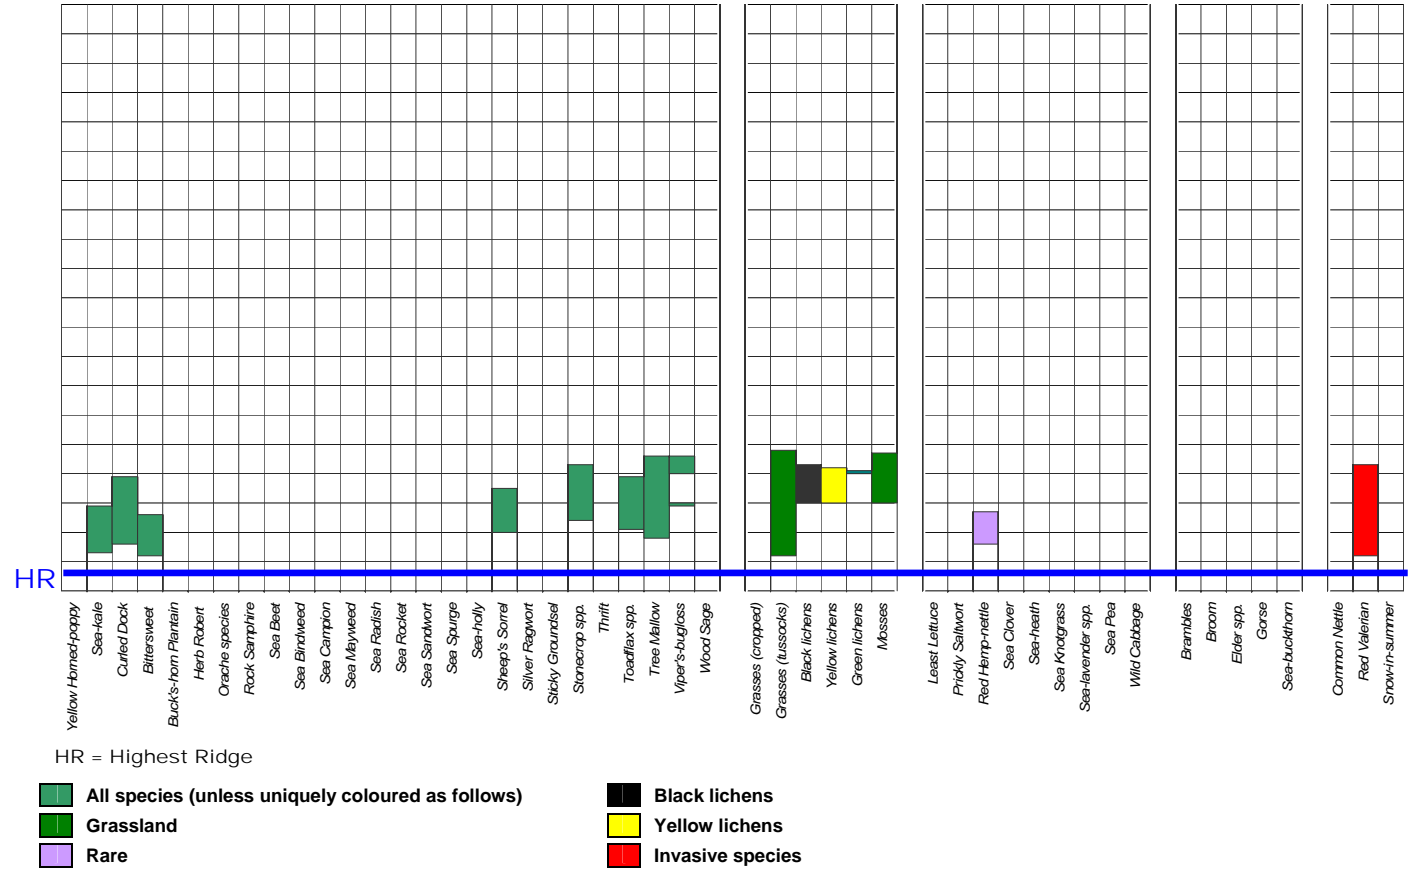
Figure E13.4 Distribution of species in 10m sections from seaward to landward side (transect information collected on 16/06/2008).

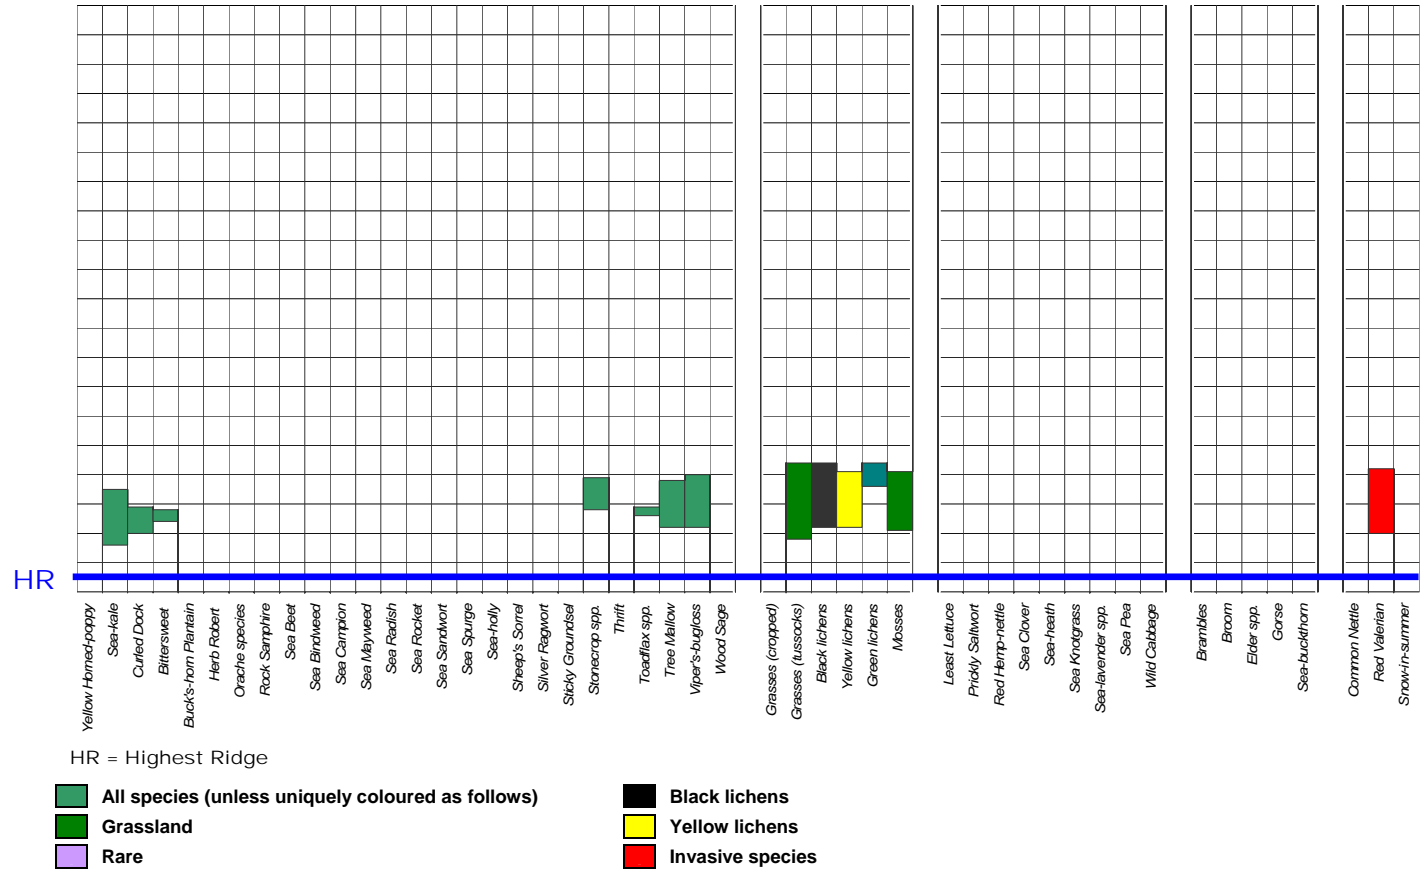
Figure E13.6 Distribution of species in 10m sections from seaward to landward side (transect information collected on 05/06/2008).

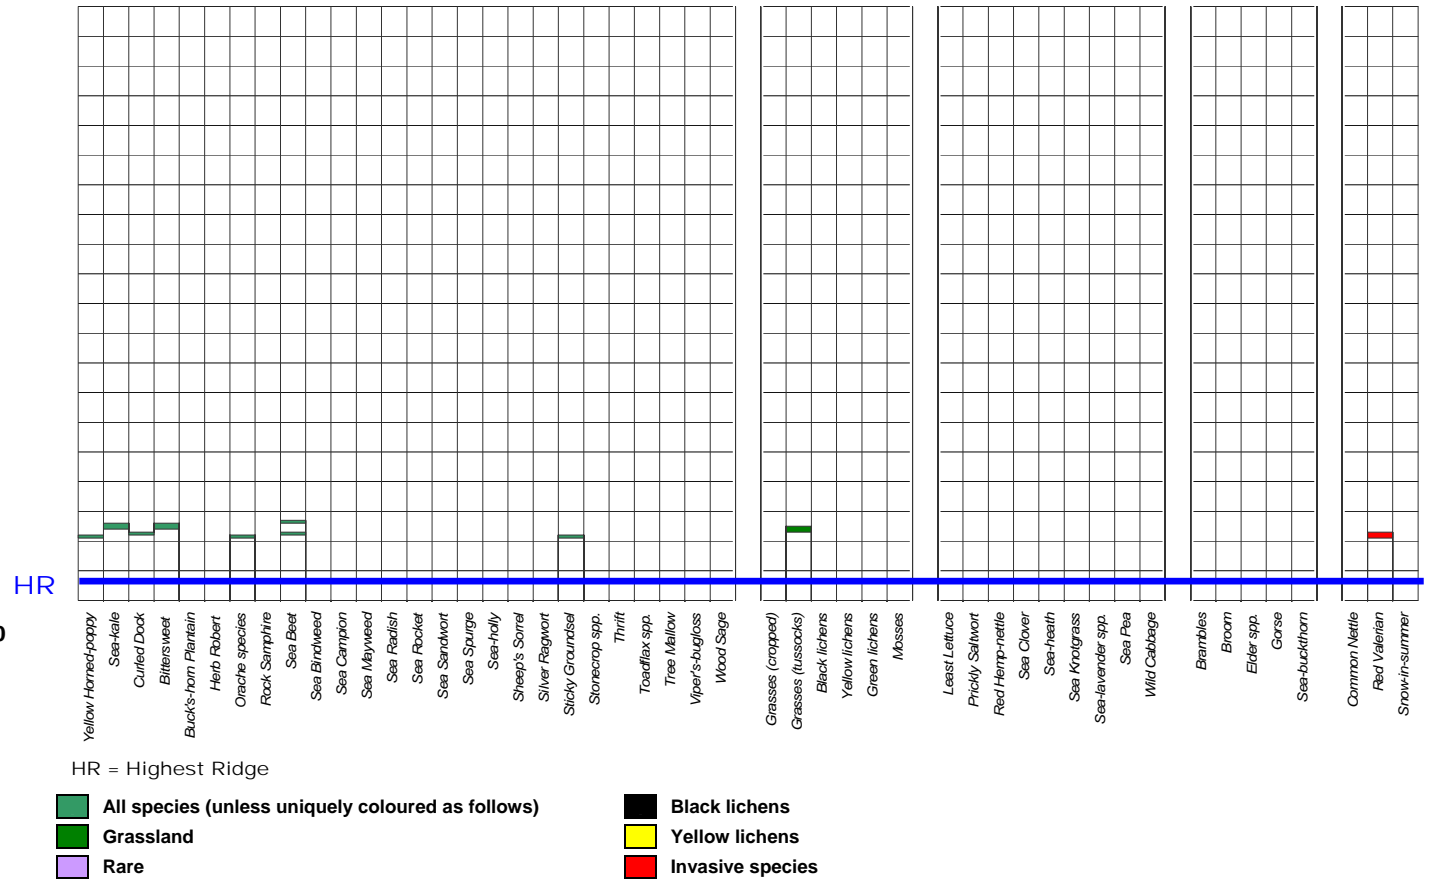
Figure E13.8 Distribution of species in 10m sections from seaward to landward side (transect information collected on 13/06/2008).

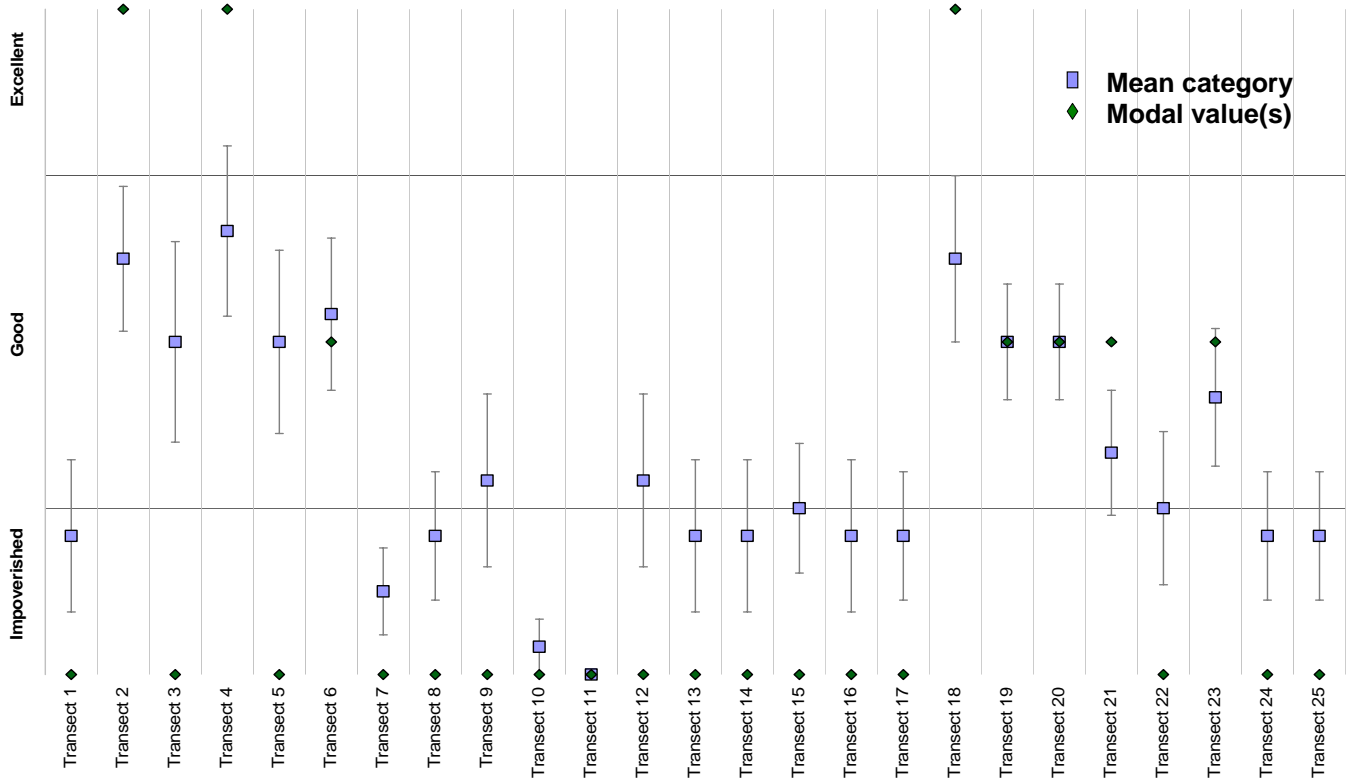
Figure E14.2 Biodiversity values for Normans Bay shingle beach (Bexhill) including mean category \pm SEM and modal value(s).
