Appendix C - Guidelines for Good Practice when working on beaches with Vegetated Shingle

Guidelines for Good Practice when working on beaches with Vegetated Shingle

Appendix D - Shingle beach “Cab Cards”

Appendix E - Site evaluation data (graphical representation)

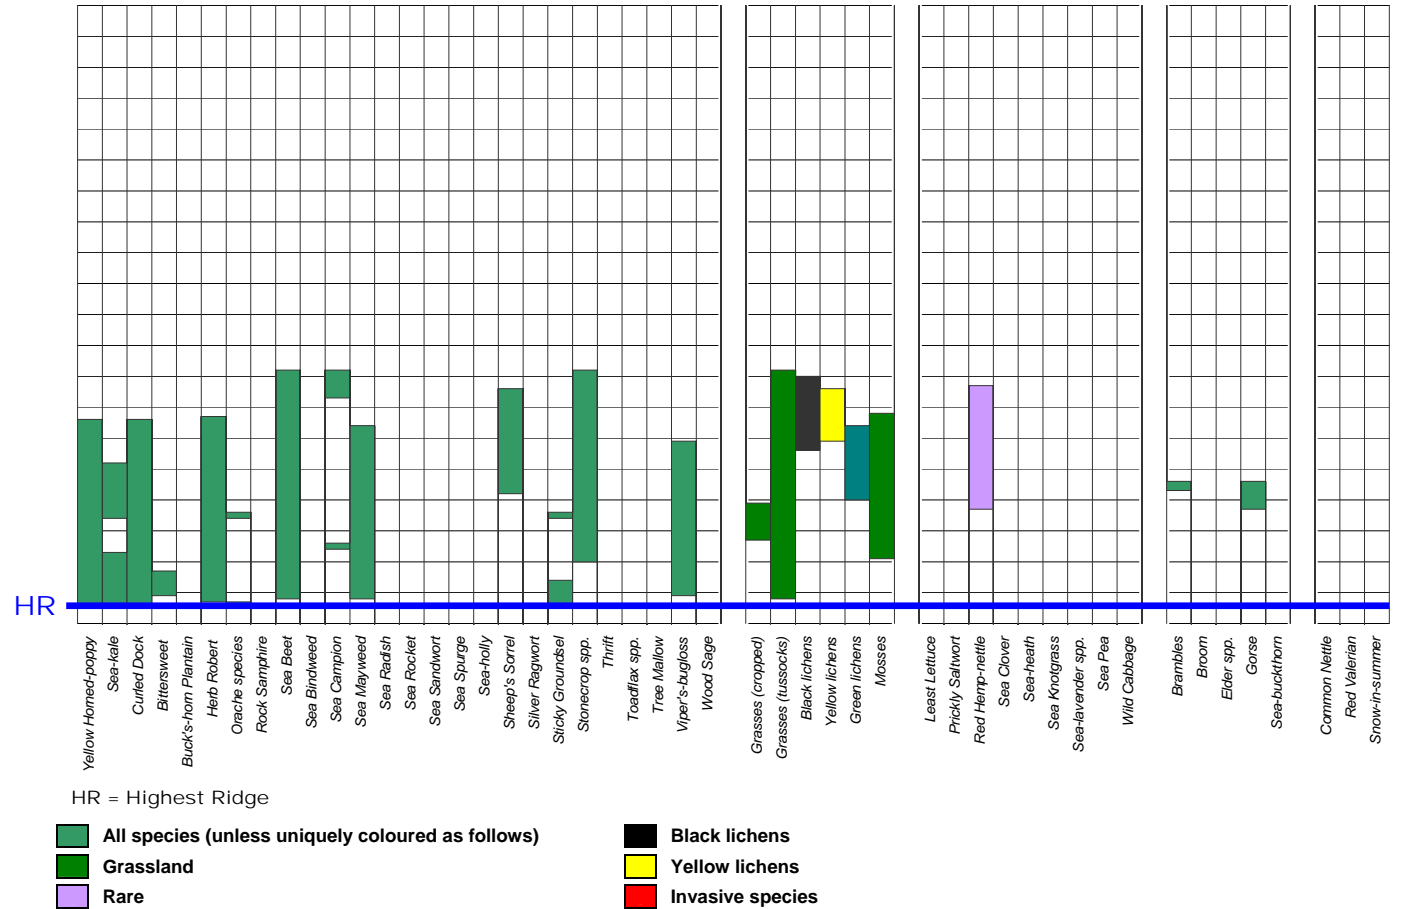
Figure E14.4 Distribution of species in 10m sections from seaward to landward side (transect information collected on 07/07/2008).

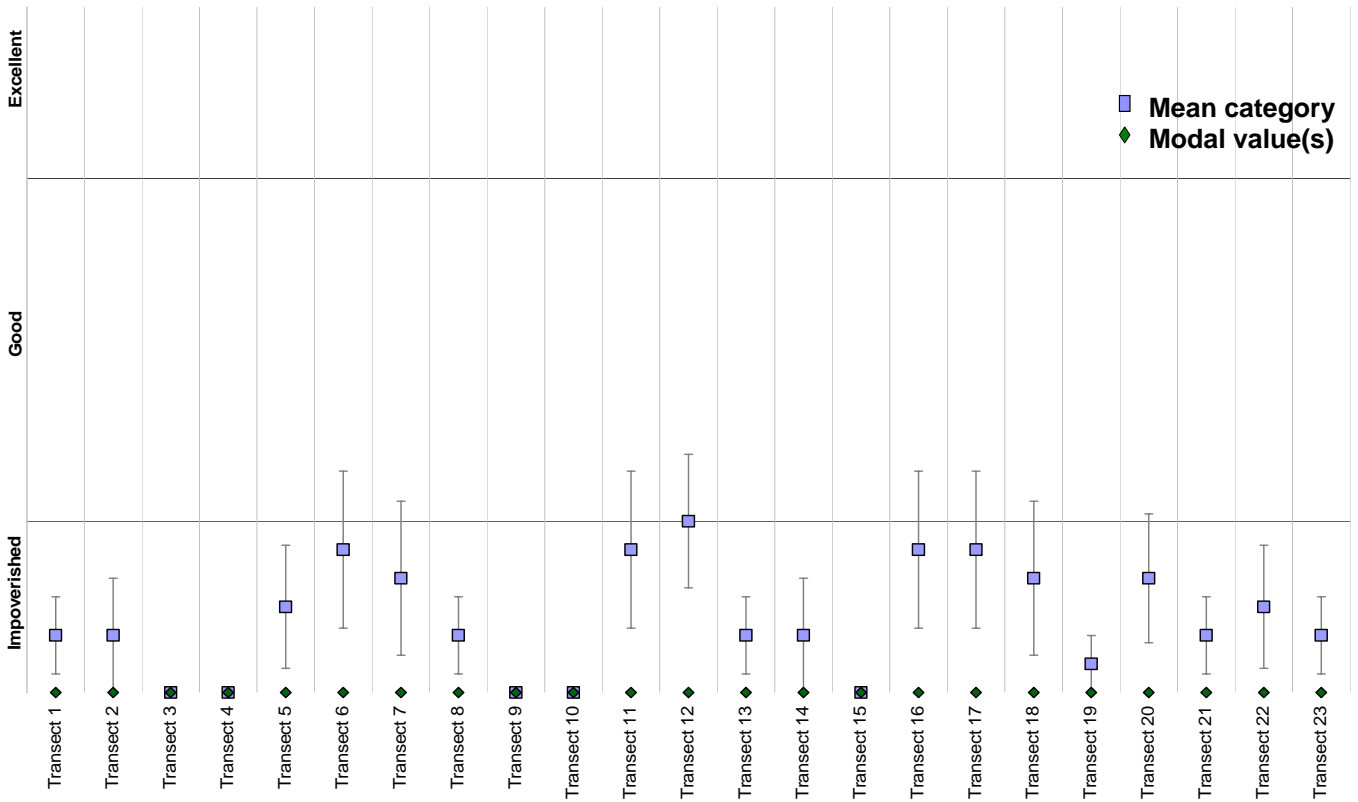
Figure E15.2 Biodiversity values for Cooden Beach shingle beach (Bexhill) including mean category \pm SEM and modal value(s).

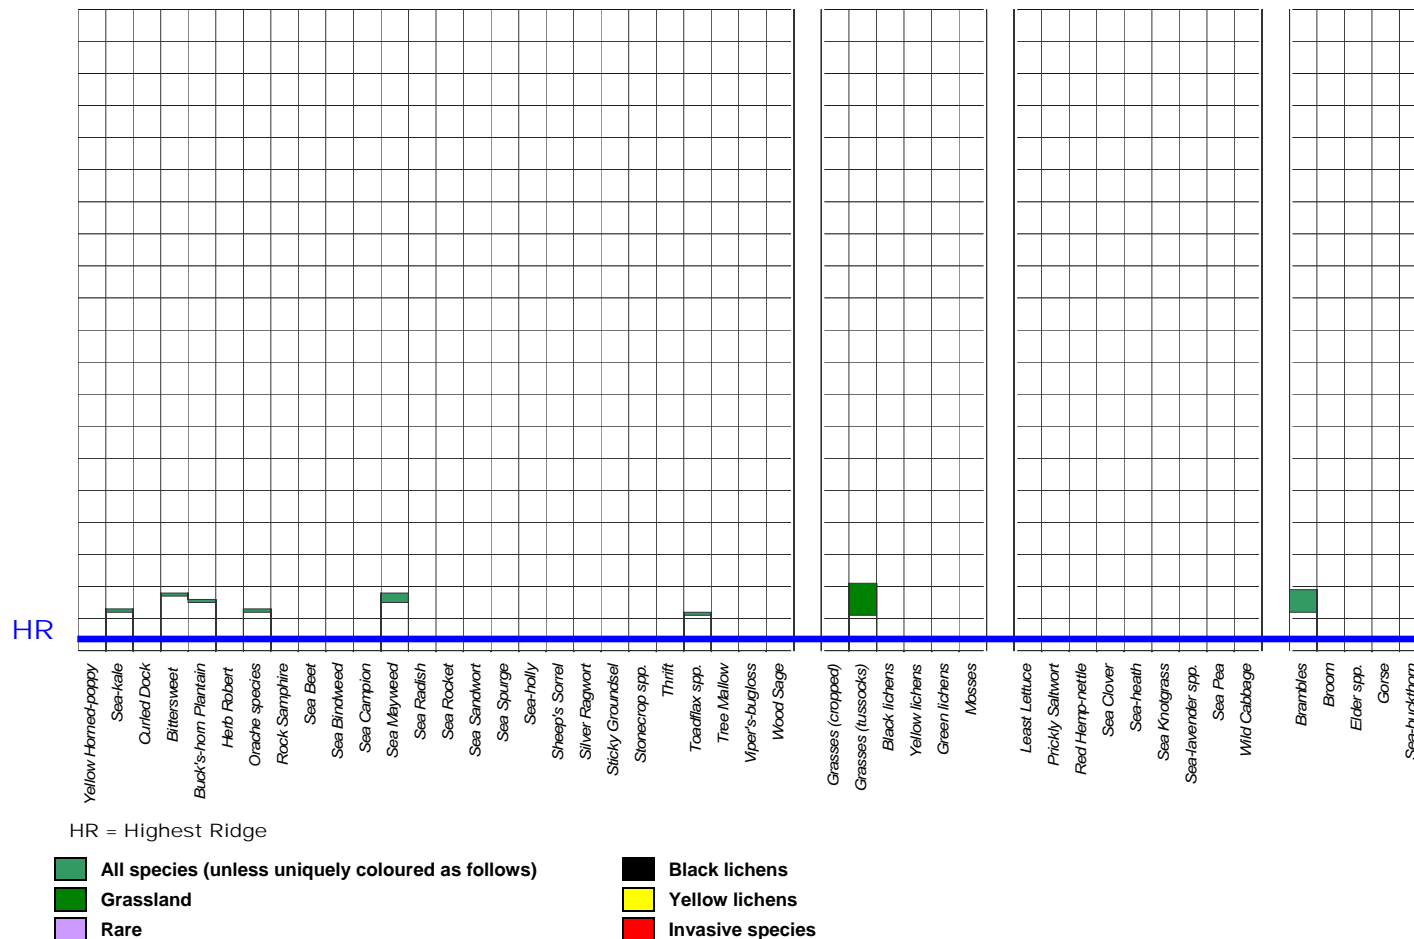
Figure E15.4 Distribution of species in 10m sections from seaward to landward side (transect information collected on 02/05/2008).

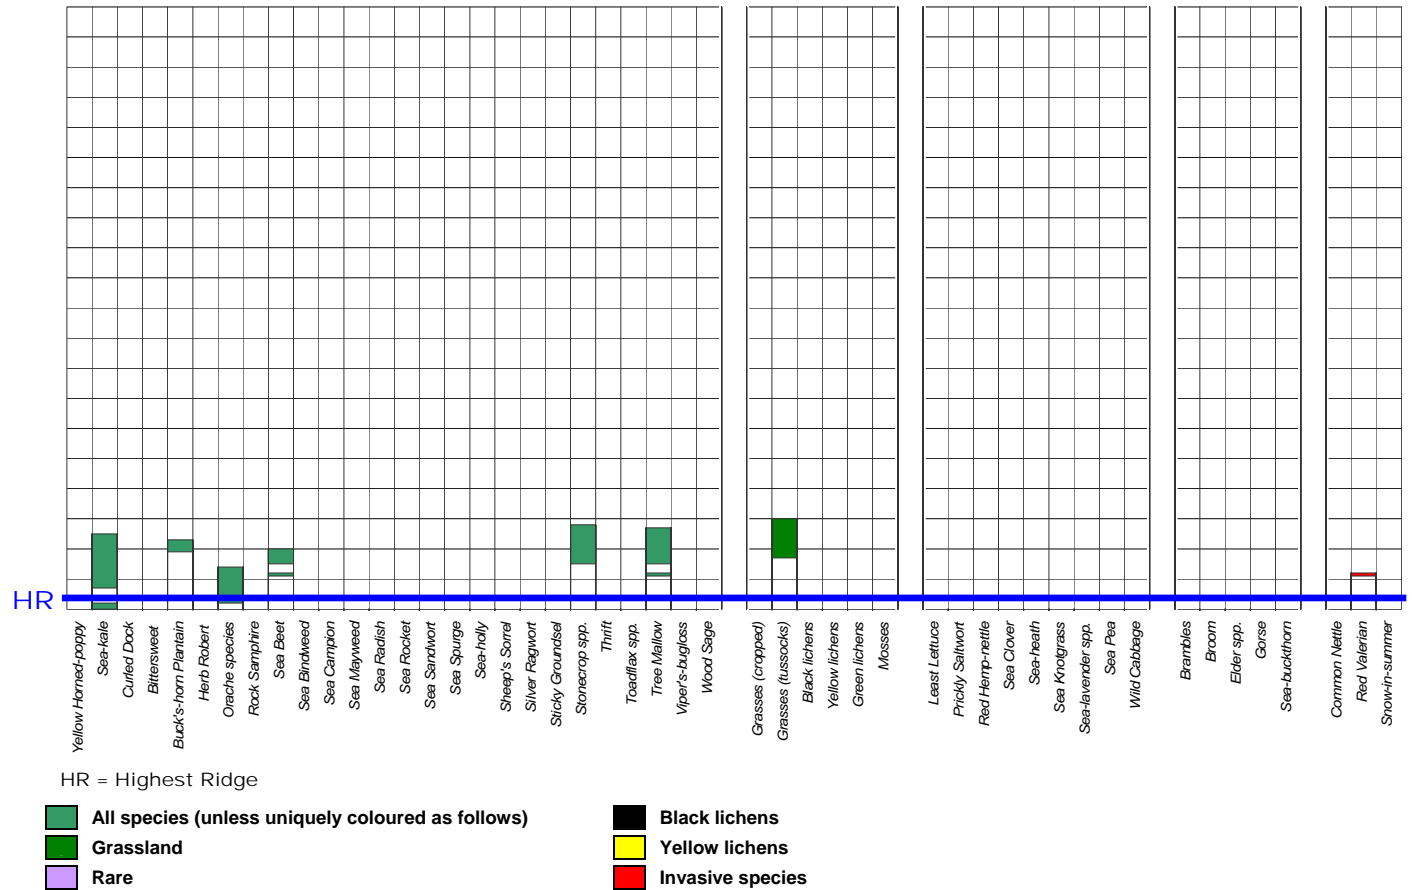
Figure E15.6 Distribution of species in 10m sections from seaward to landward side (transect information collected on 09/04/2008).

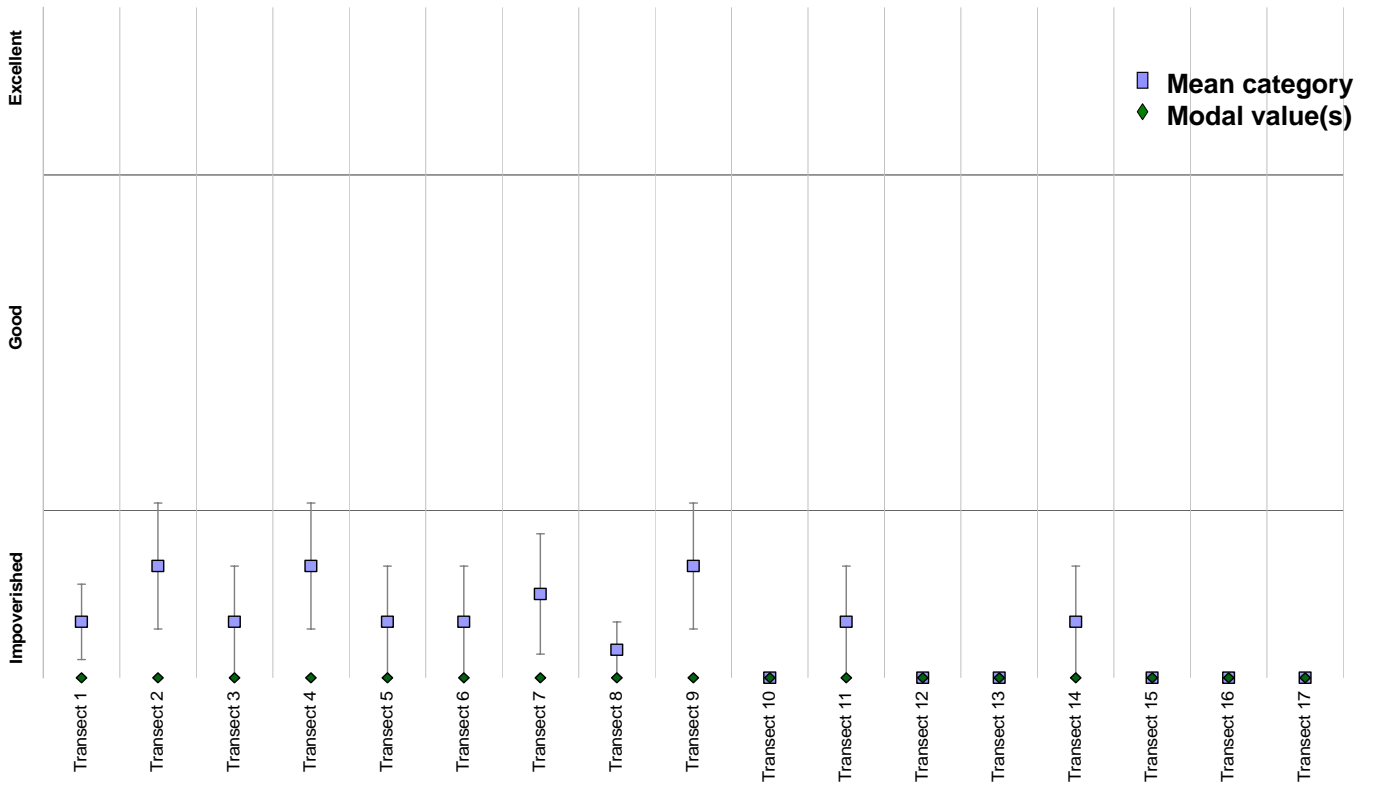
Figure E16.2 Biodiversity values for Veness Gap shingle beach (Bexhill) including mean category \pm SEM and modal value(s).

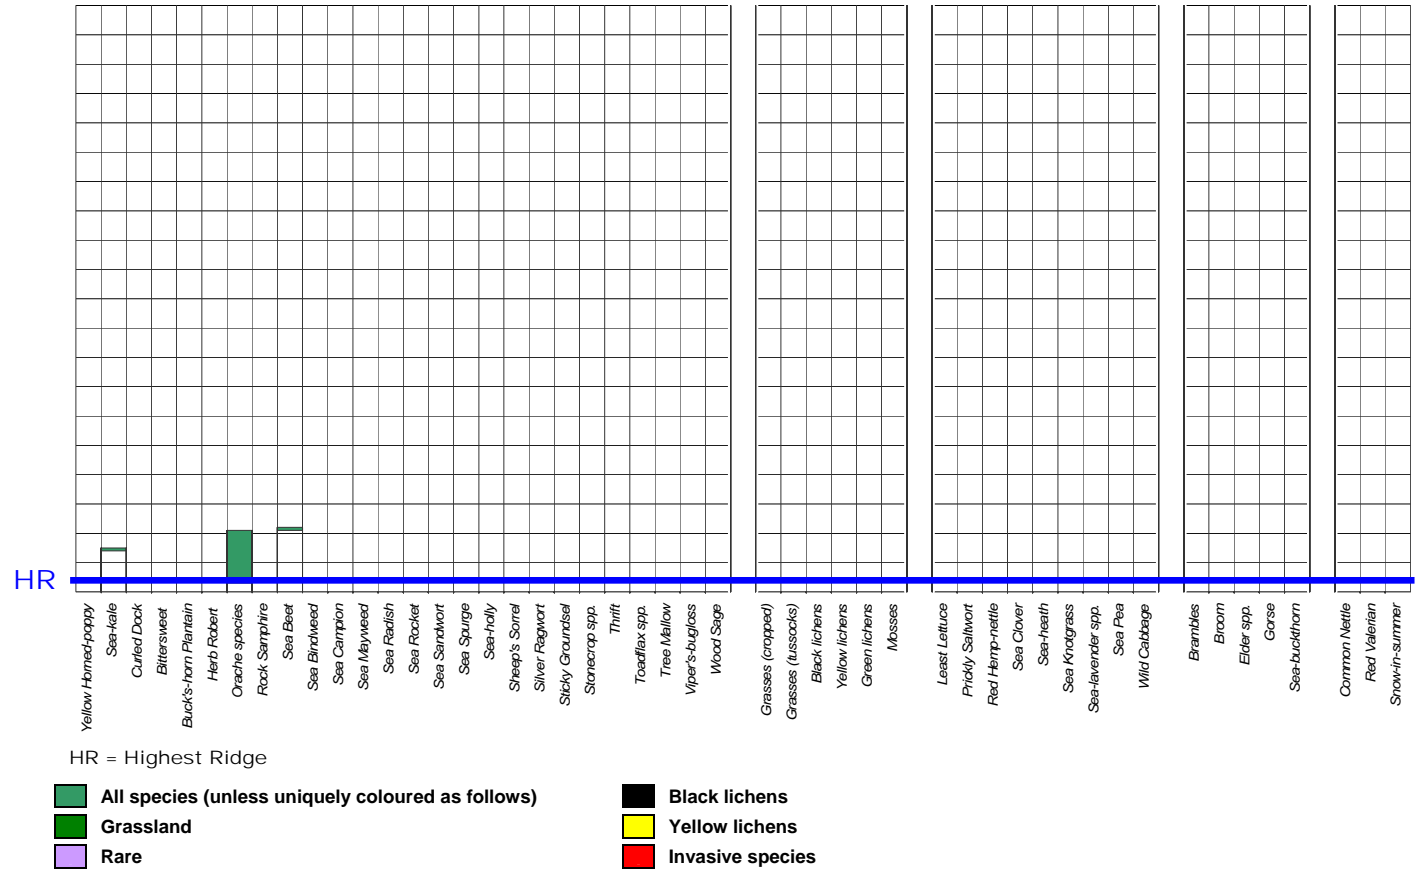
Figure E16.4 Distribution of species in 10m sections from seaward to landward side (transect information collected on 03/06/2008).

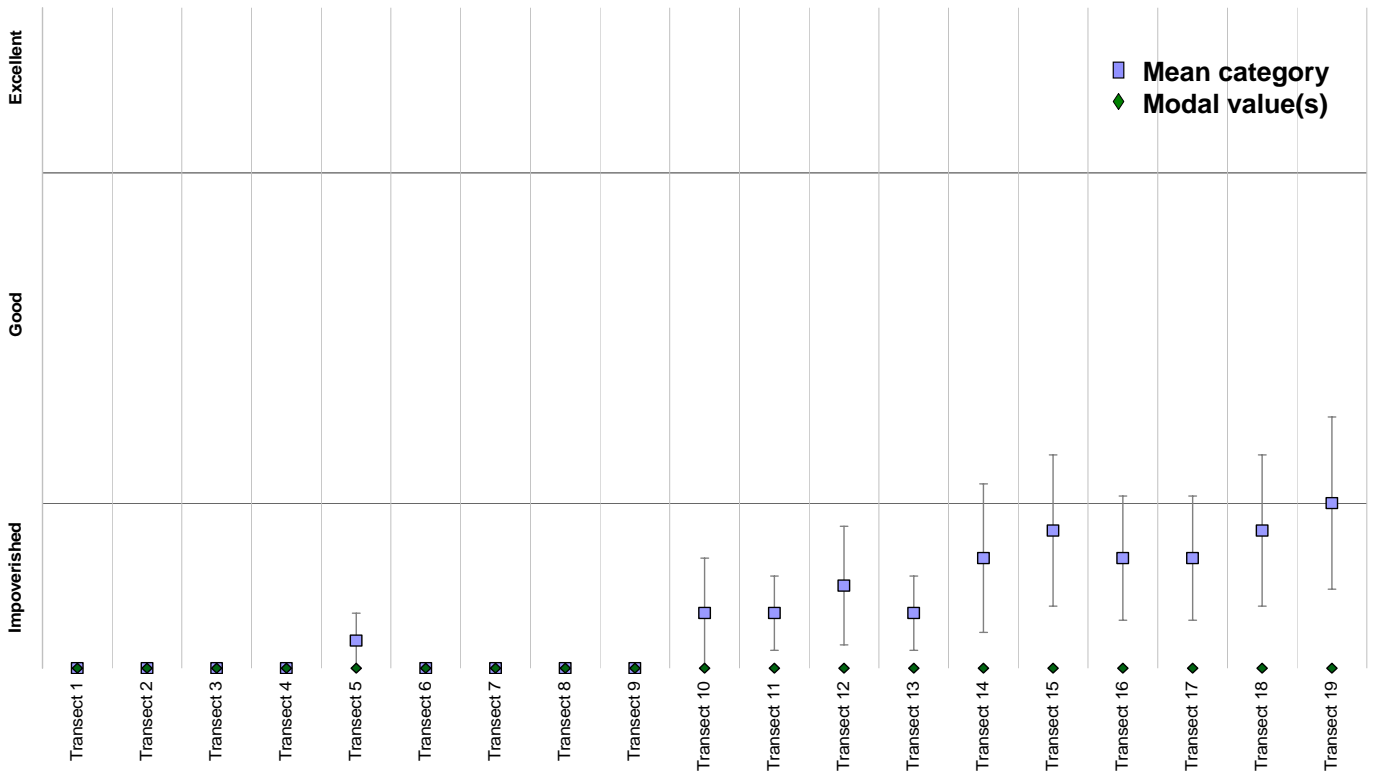
Figure E17.2 Biodiversity values for Bexhill-on-Sea shingle beach (Bexhill) including mean category \pm SEM and modal value(s).

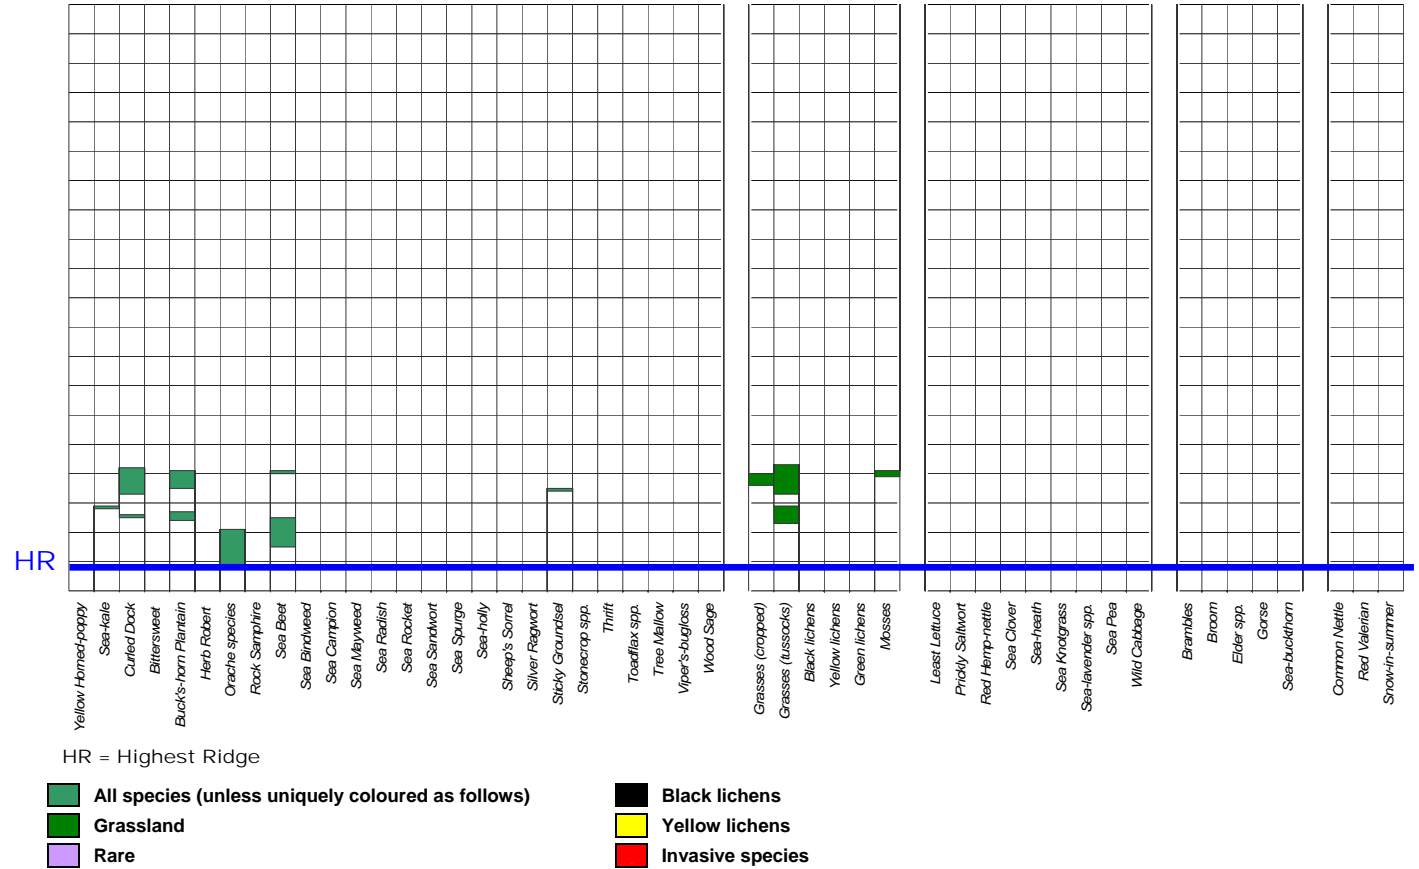
Figure E17.4 Distribution of species in 10m sections from seaward to landward side (transect information collected on 16/05/2008).

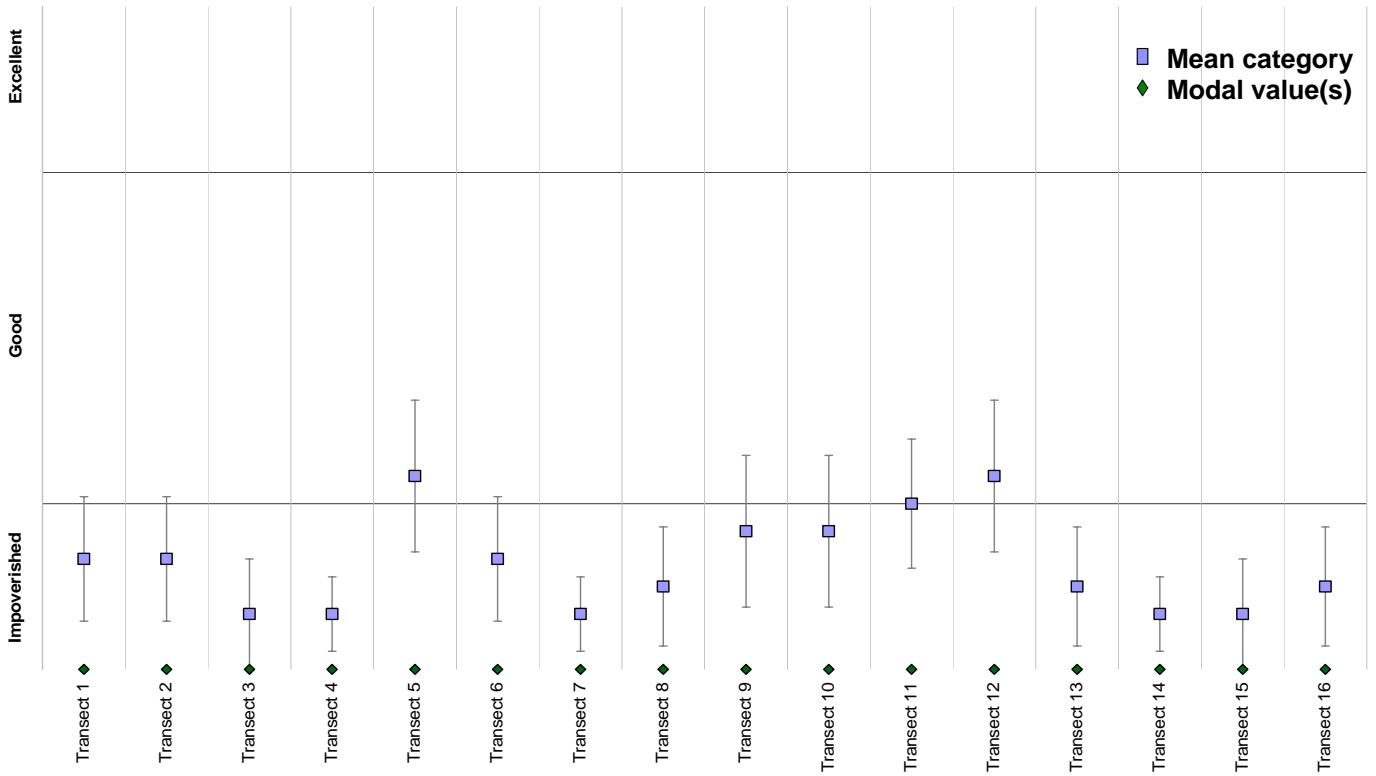
Figure E18.2 Biodiversity values for Bulverhythe shingle beach (Hastings) including mean category \pm SEM and modal value(s).

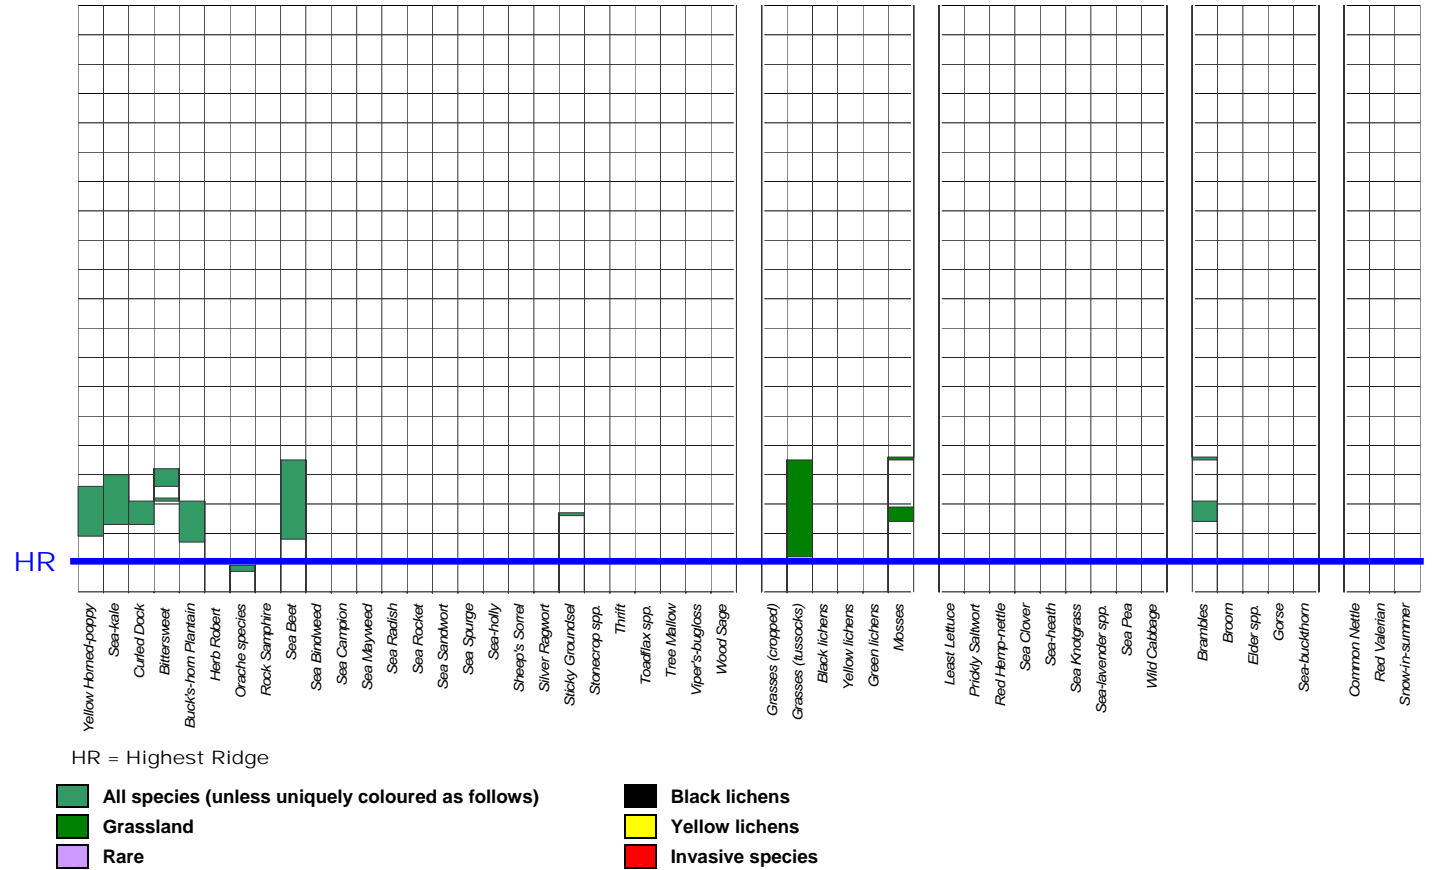
Figure E18.4 Distribution of species in 10m sections from seaward to landward side (transect information collected on 29/05/2008).

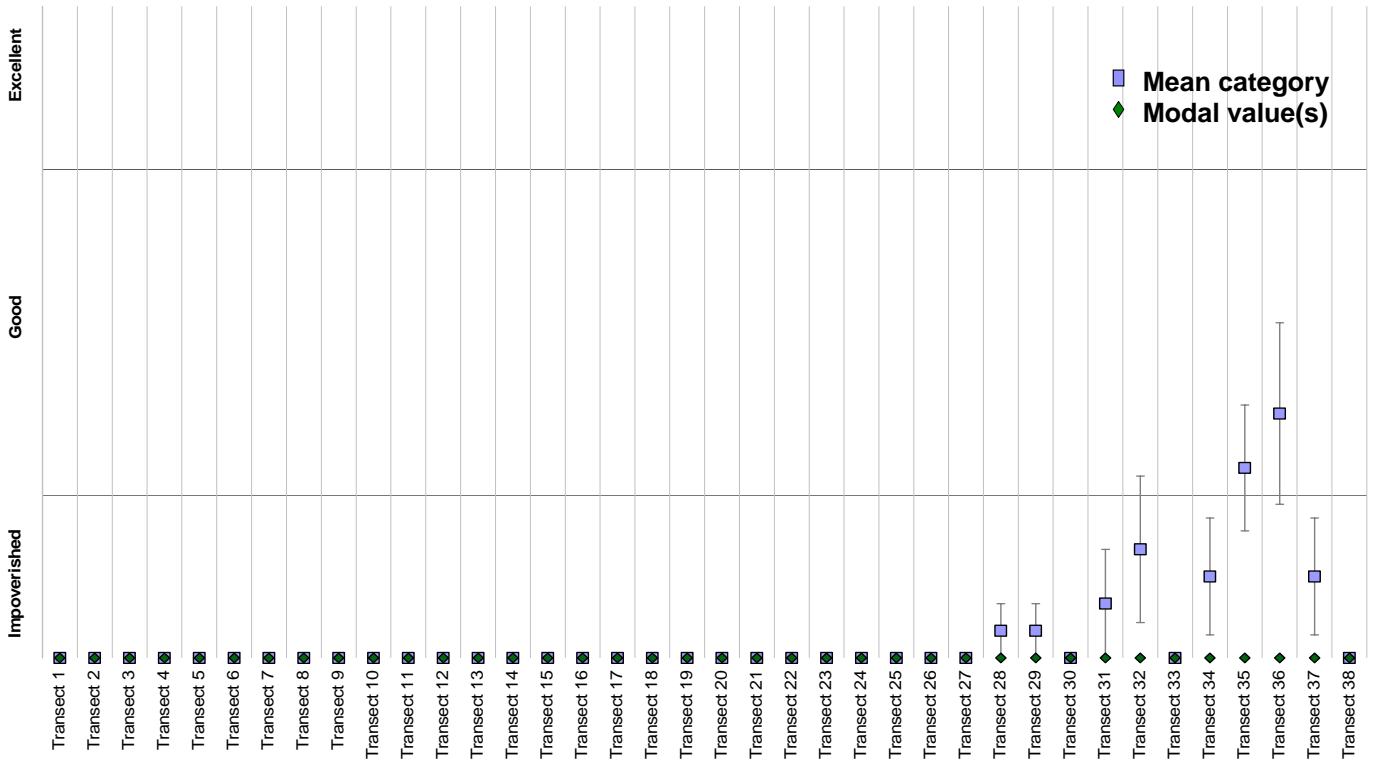
Figure E19.2 Biodiversity values for Hastings shingle beach including mean category ± SEM and modal value(s).

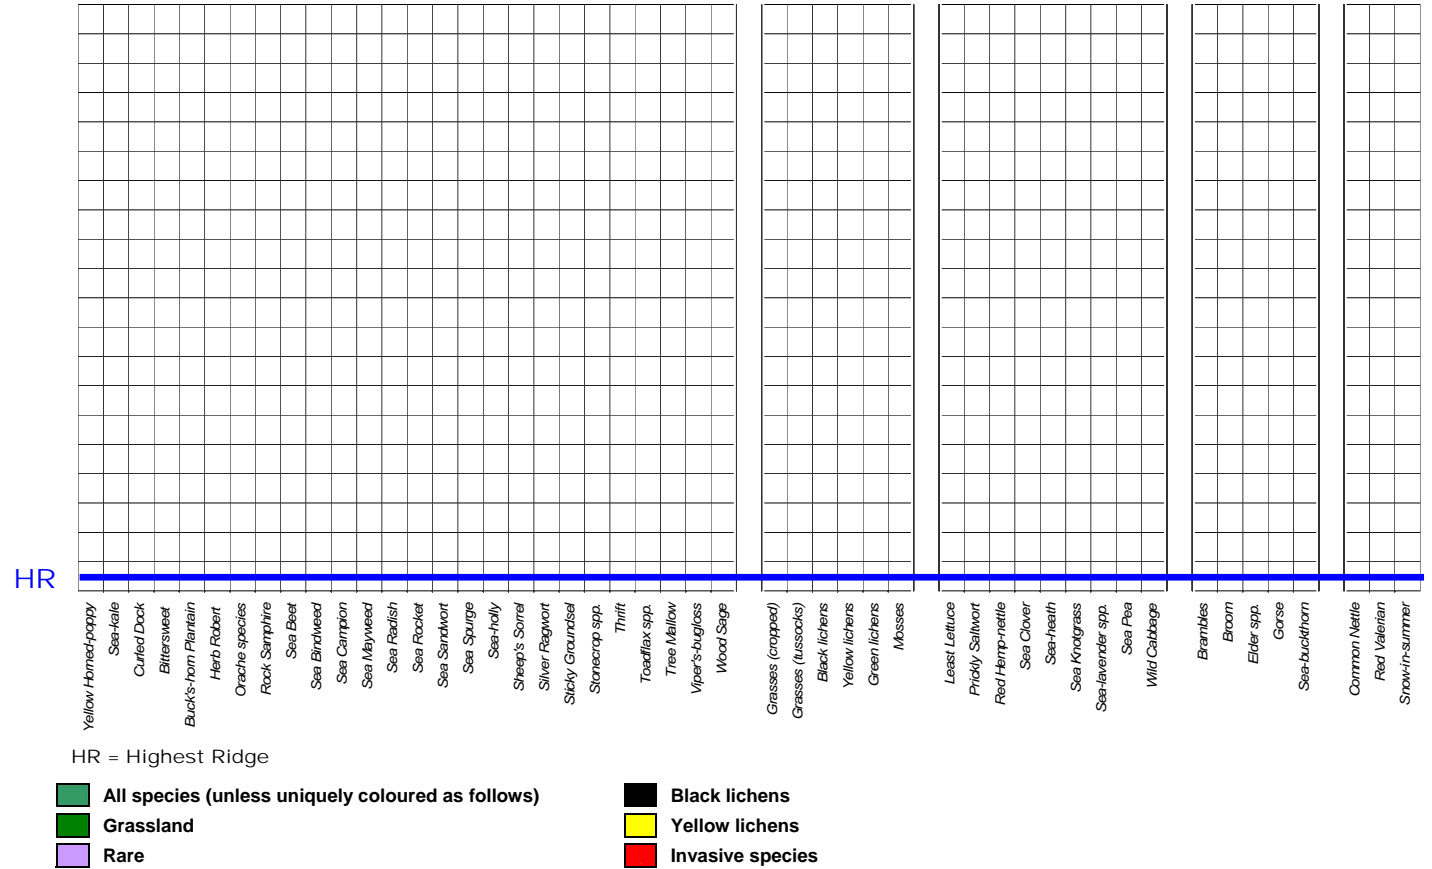
Figure E19.4 Distribution of species in 10m sections from seaward to landward side (transect information collected on 04/06/2008).

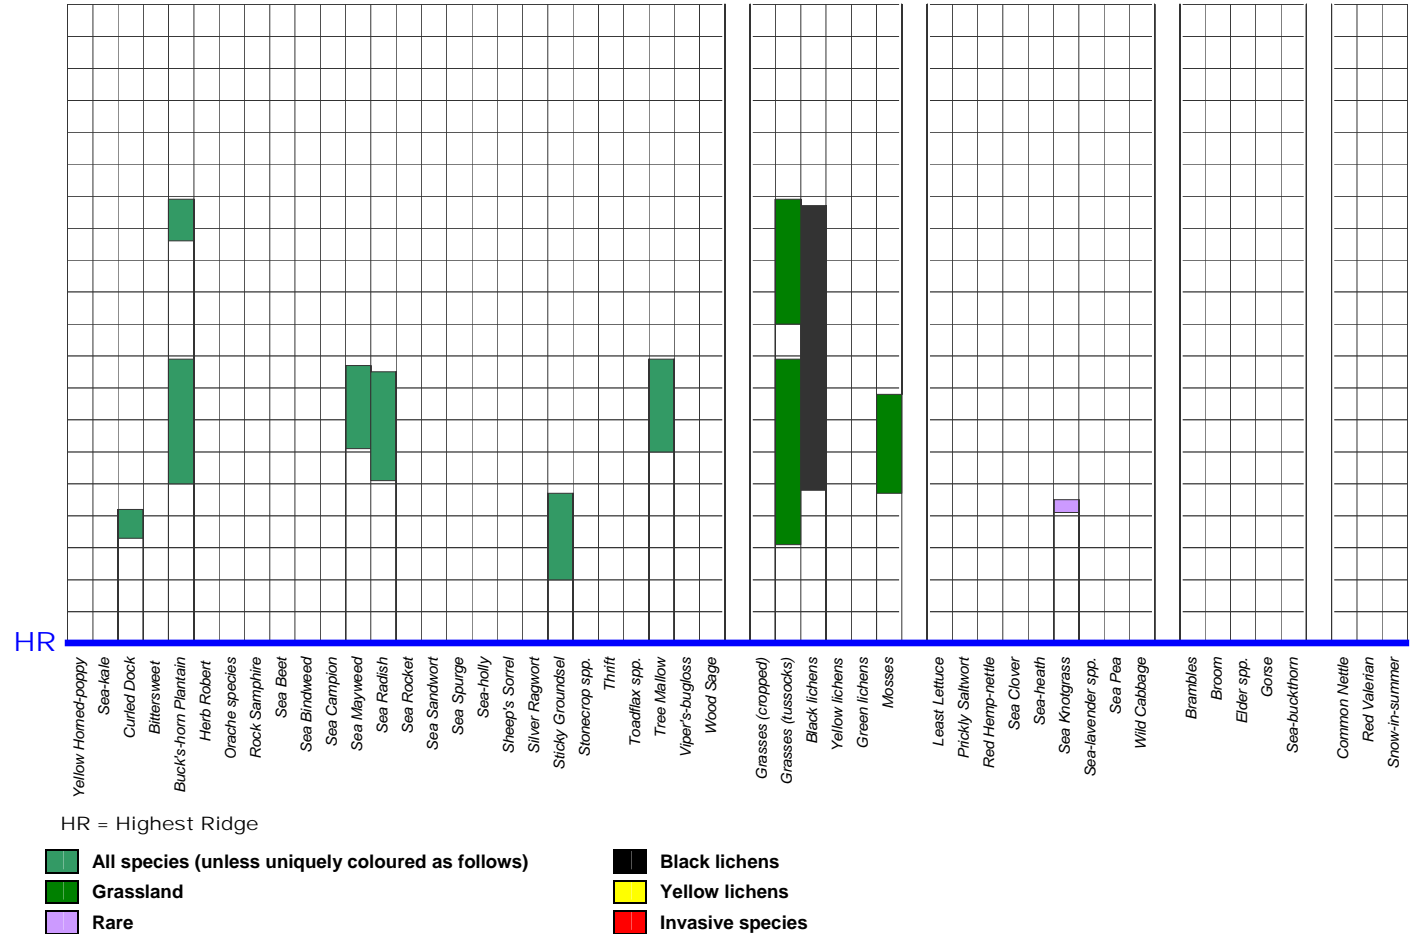
Figure E19.6 Distribution of species in 10m sections from seaward to landward side (transect information collected on 25/07/2008).

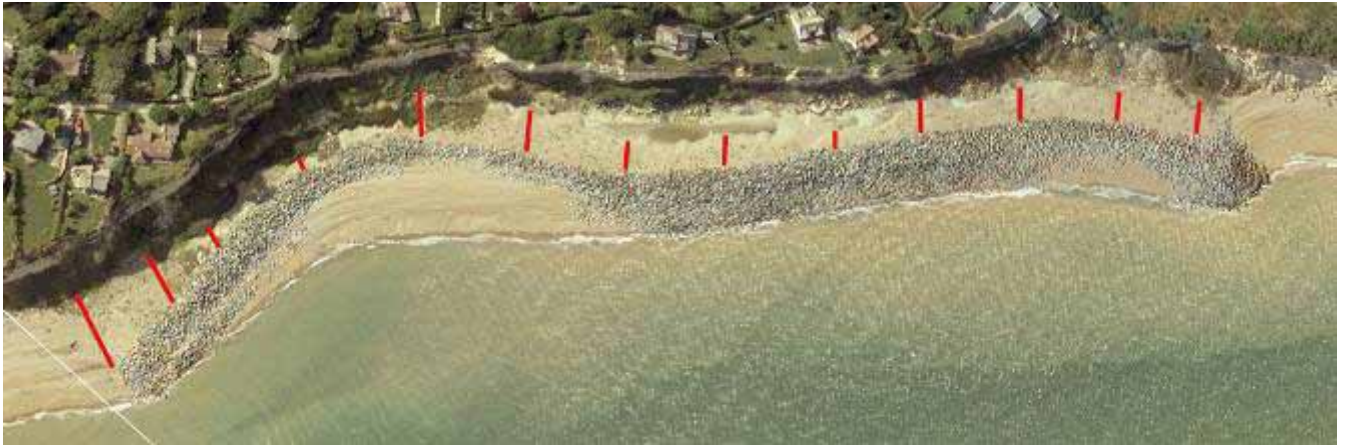
Figure E20.1 Shows the locations of the 2008 transect surveys carried out on Fairlight Cove beach.

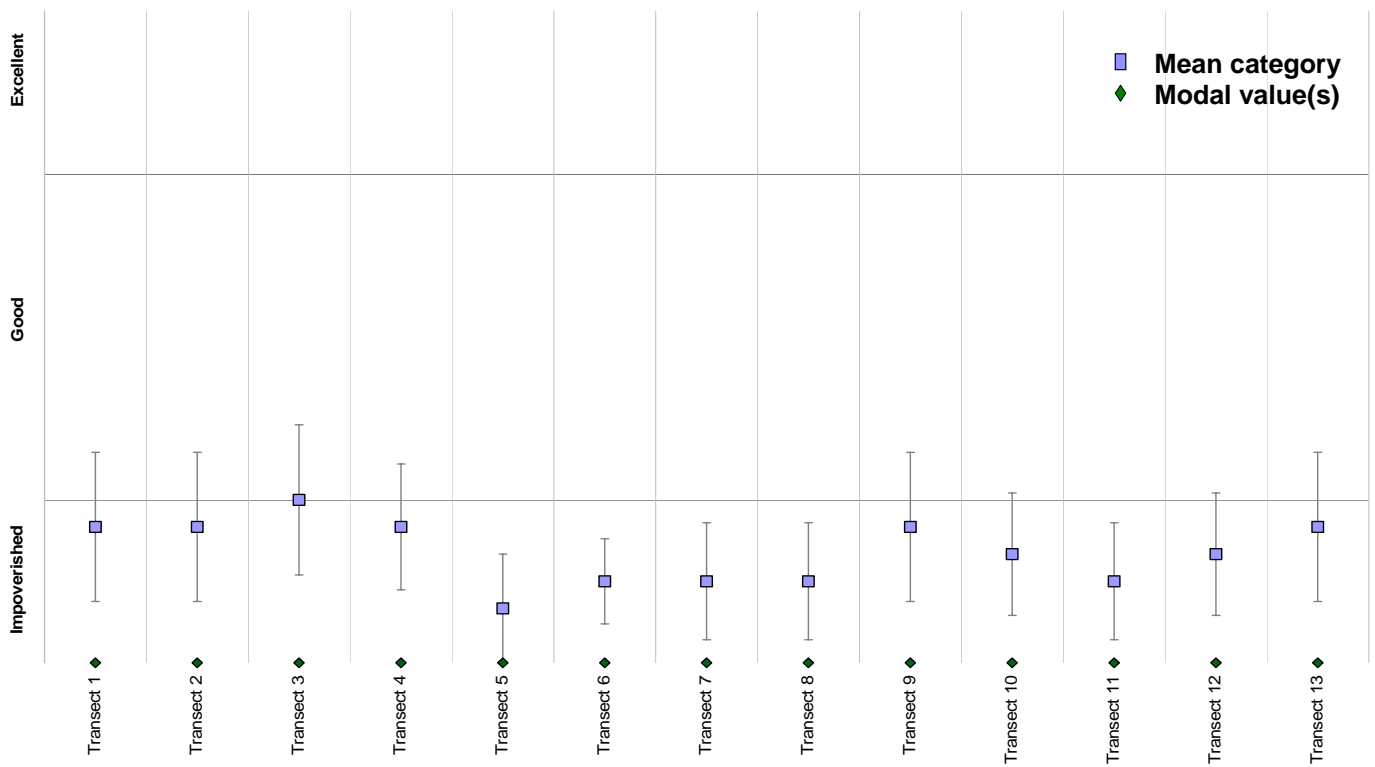
Figure E20.2 Biodiversity values for Fairlight shingle beach including mean category \pm SEM and modal value(s).

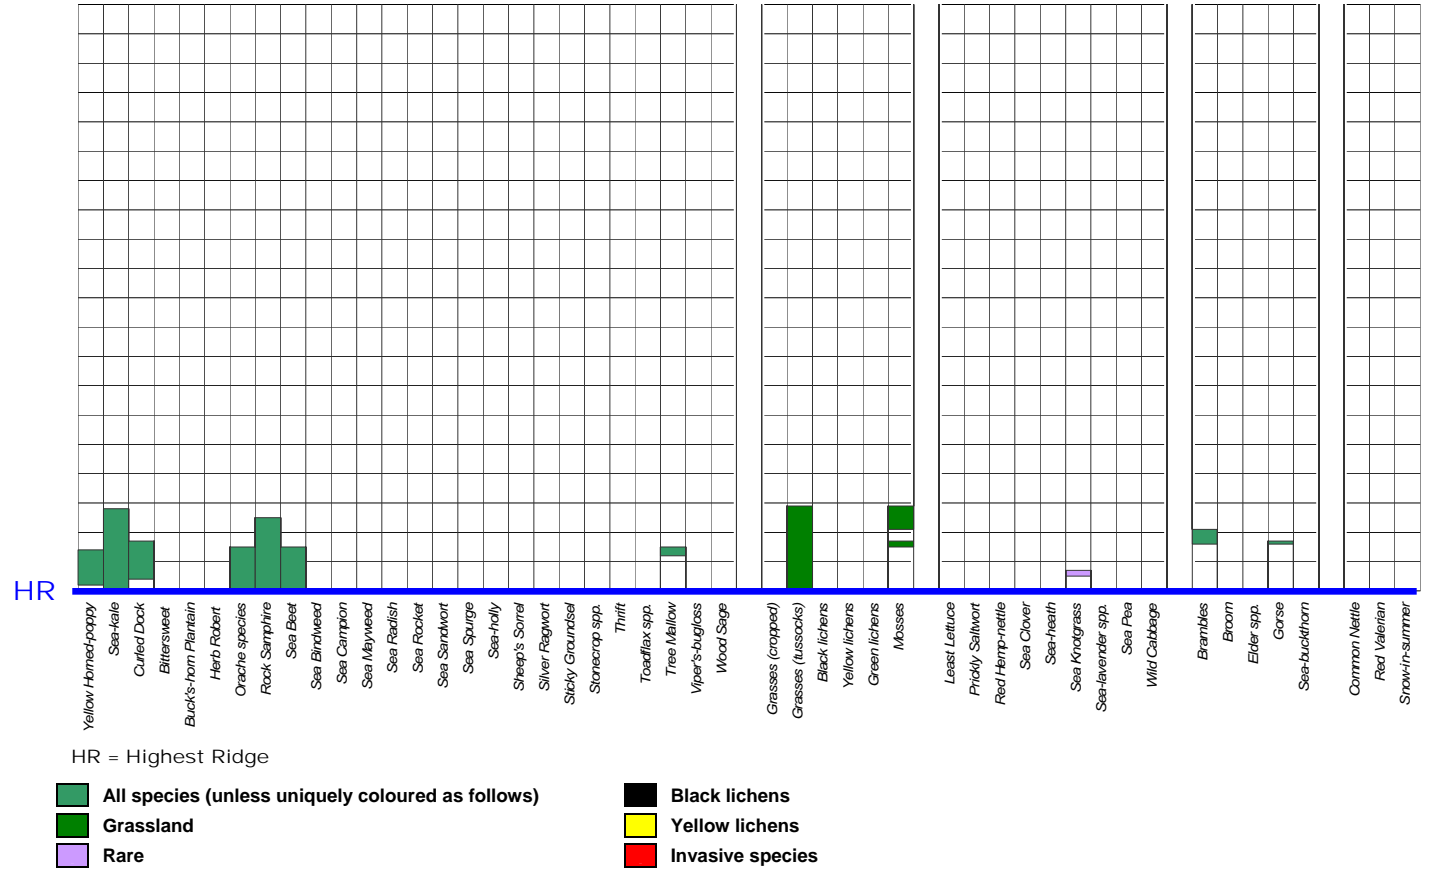
Figure E20.4 Distribution of species in 10m sections from seaward to landward side (transect information collected on 18/08/2008).

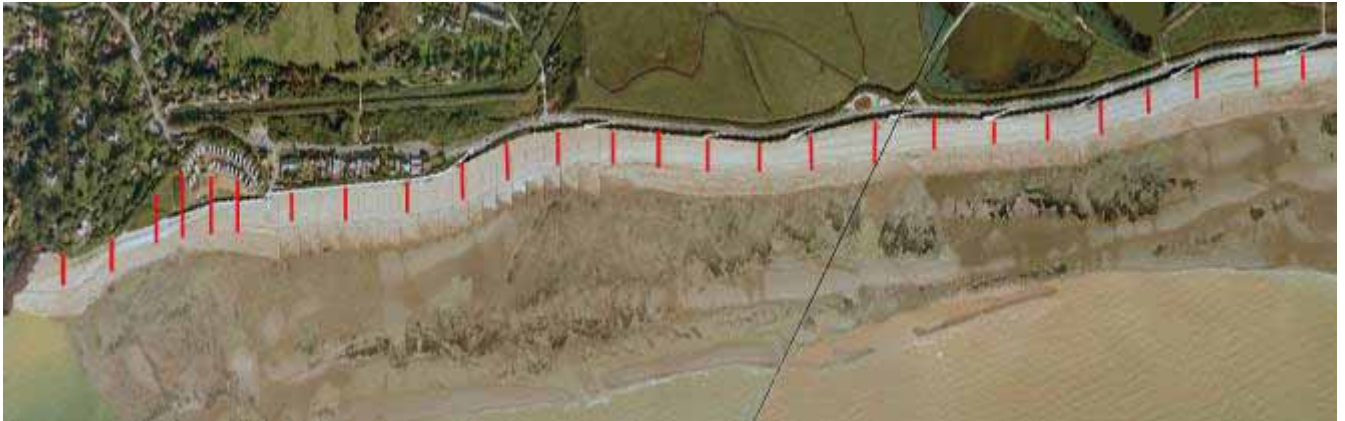
Figure E21.1 Shows the locations of the 2008 transect surveys carried out on Pett beach.

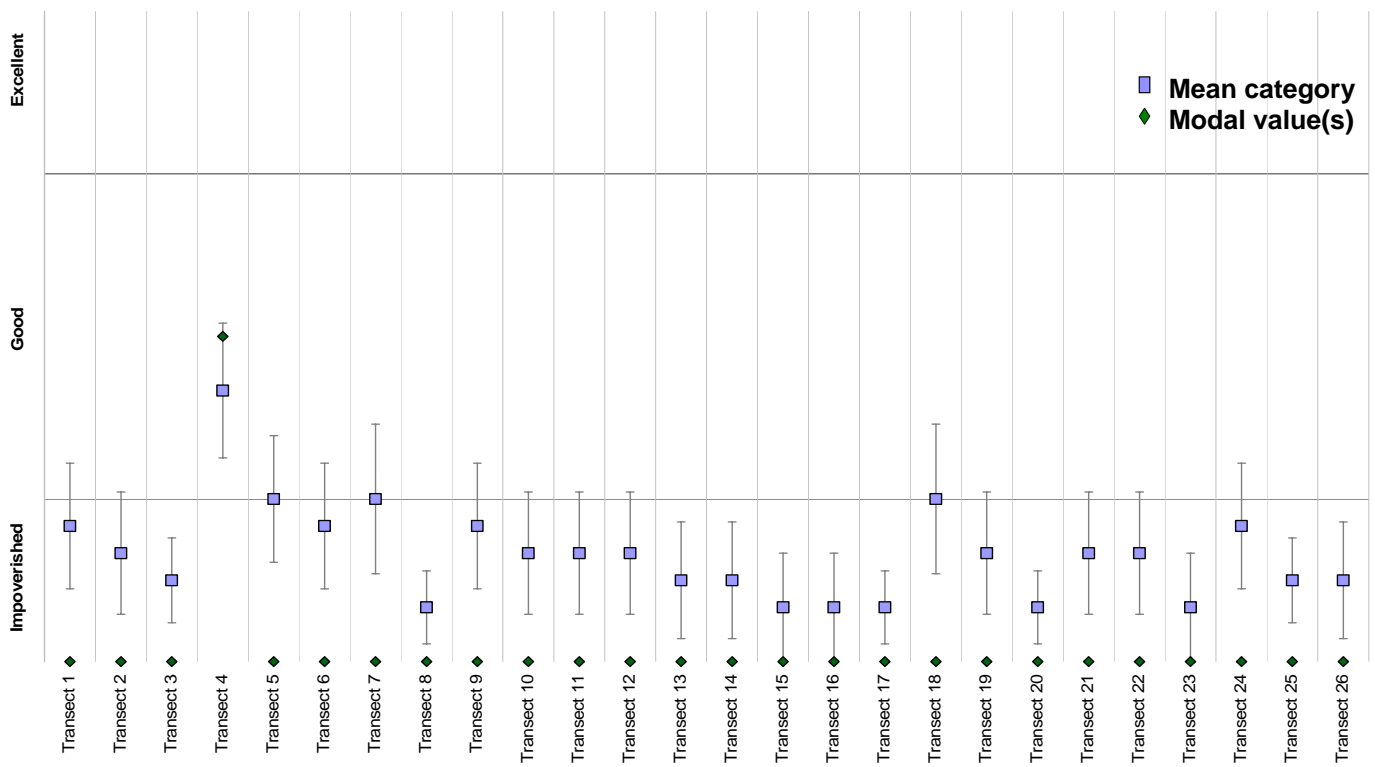
Figure E21.2 Biodiversity values for Pett shingle beach including mean category ± SEM and modal value(s).

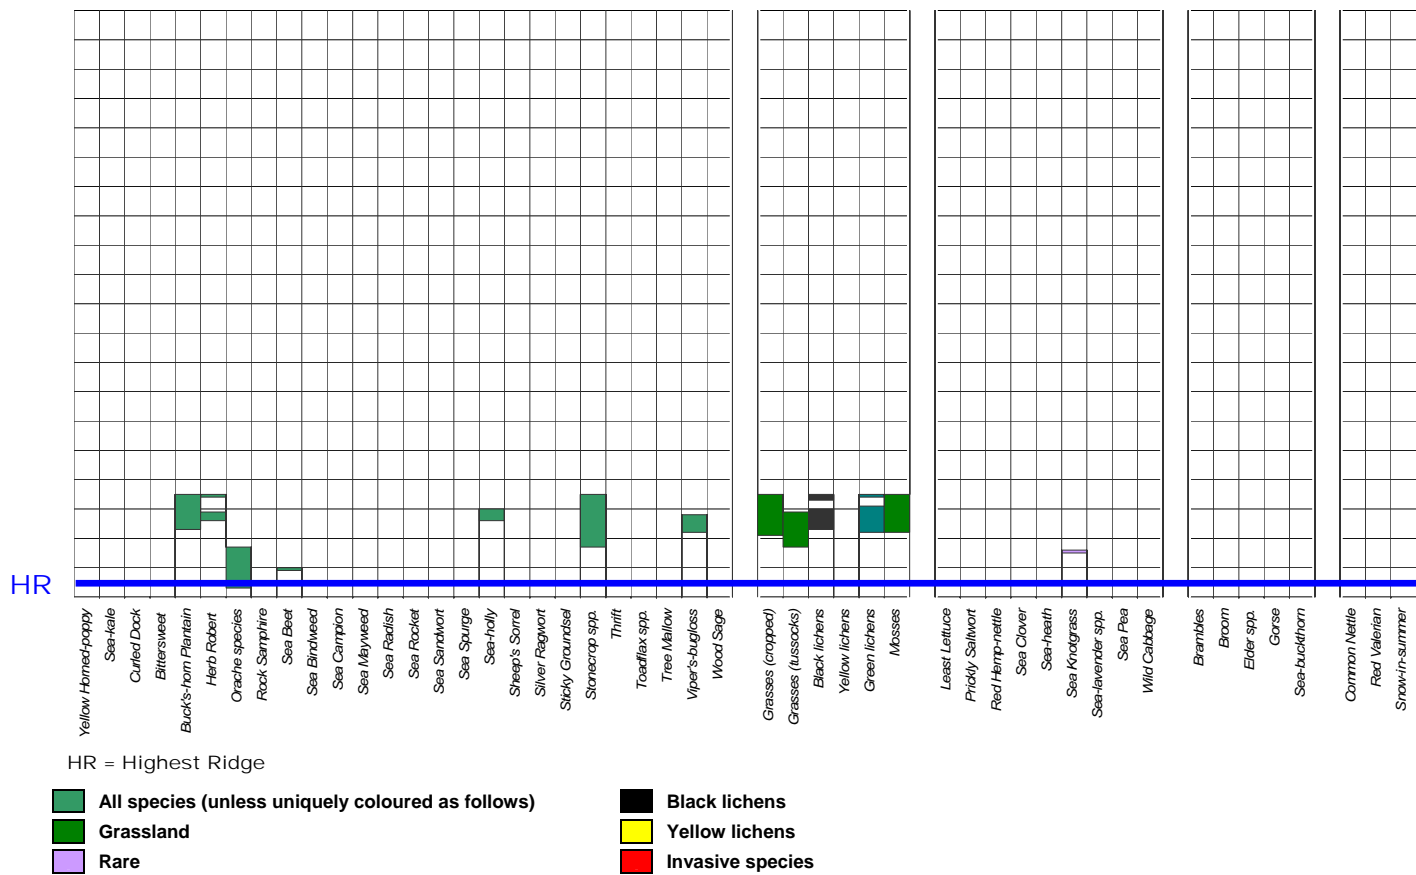
Figure E21.4 Distribution of species in 10m sections from seaward to landward side (transect information collected on 22/07/2008).

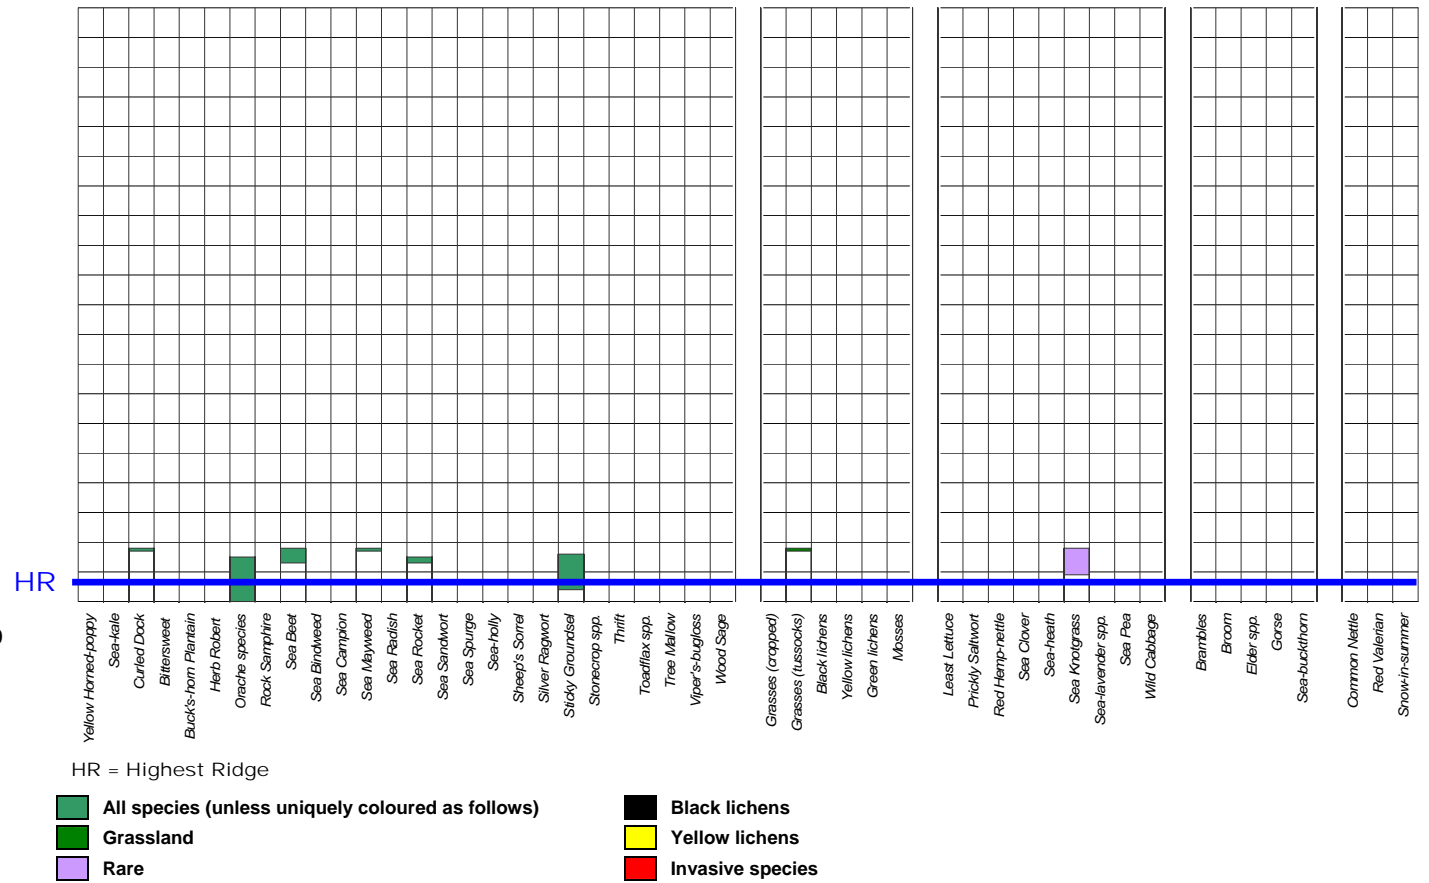
Figure E21.6 Distribution of species in 10m sections from seaward to landward side (transect information collected on 04/08/2008).
