Appendix C - Guidelines for Good Practice when working on beaches with Vegetated Shingle

Guidelines for Good Practice when working on beaches with Vegetated Shingle

Appendix D - Shingle beach “Cab Cards”

Appendix E - Site evaluation data (graphical representation)

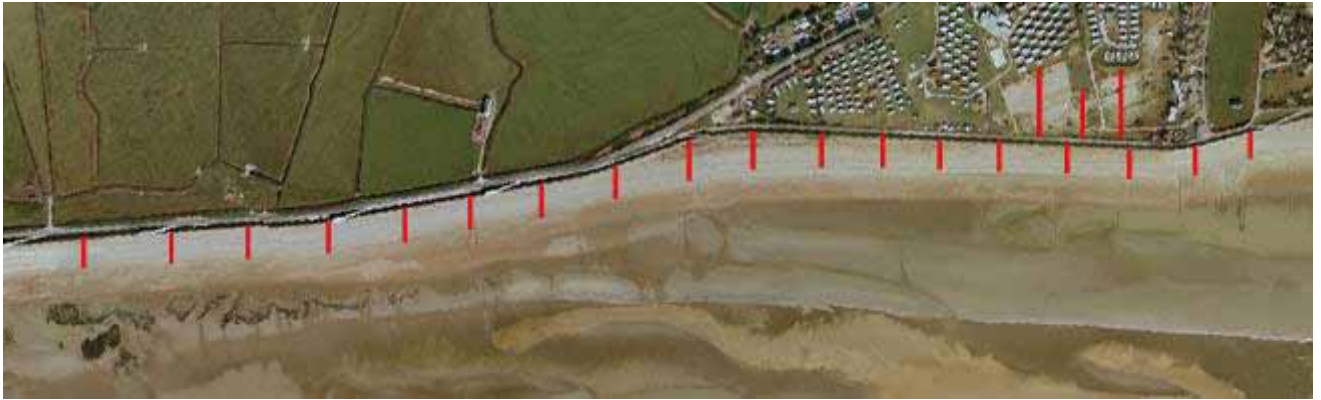
Figure E22.1 Shows the locations of the 2008 transect surveys carried out on Winchelsea beach.

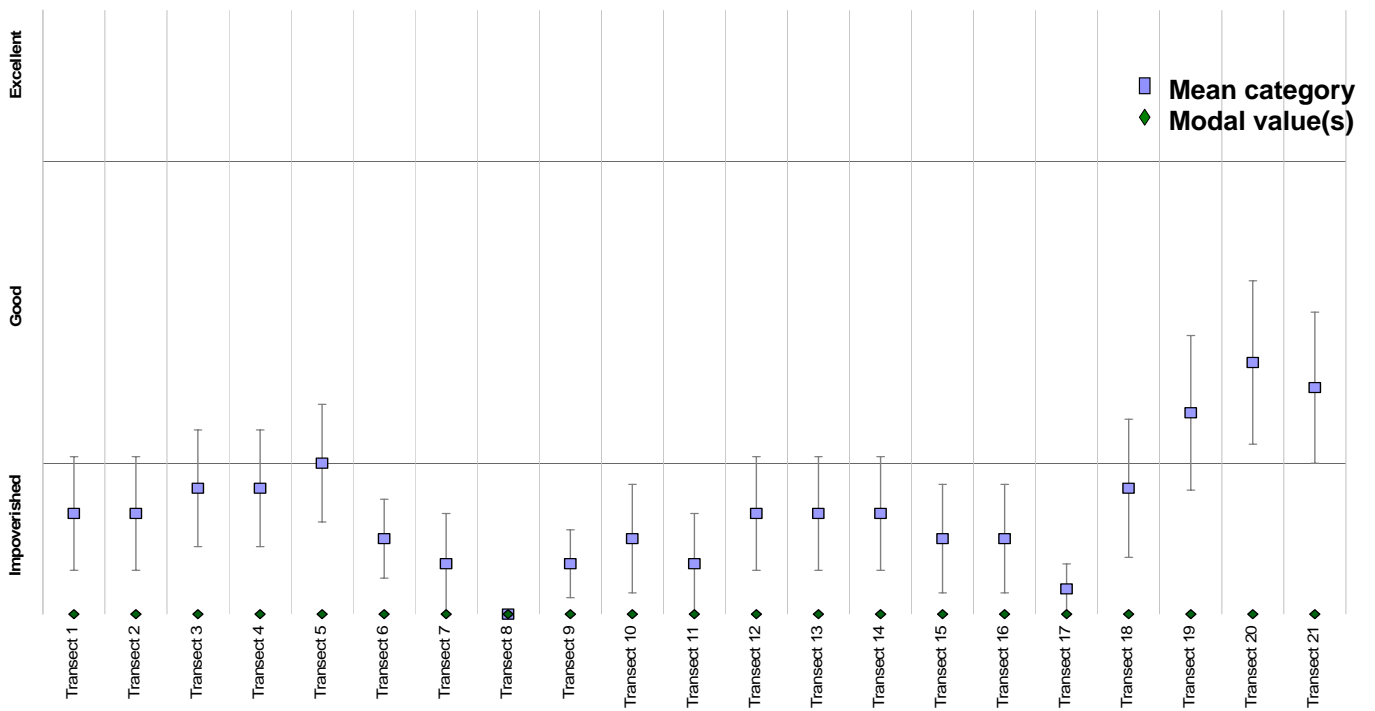
Figure E22.2 Biodiversity values for Winchelsea shingle beach including mean category \pm SEM and modal value(s).

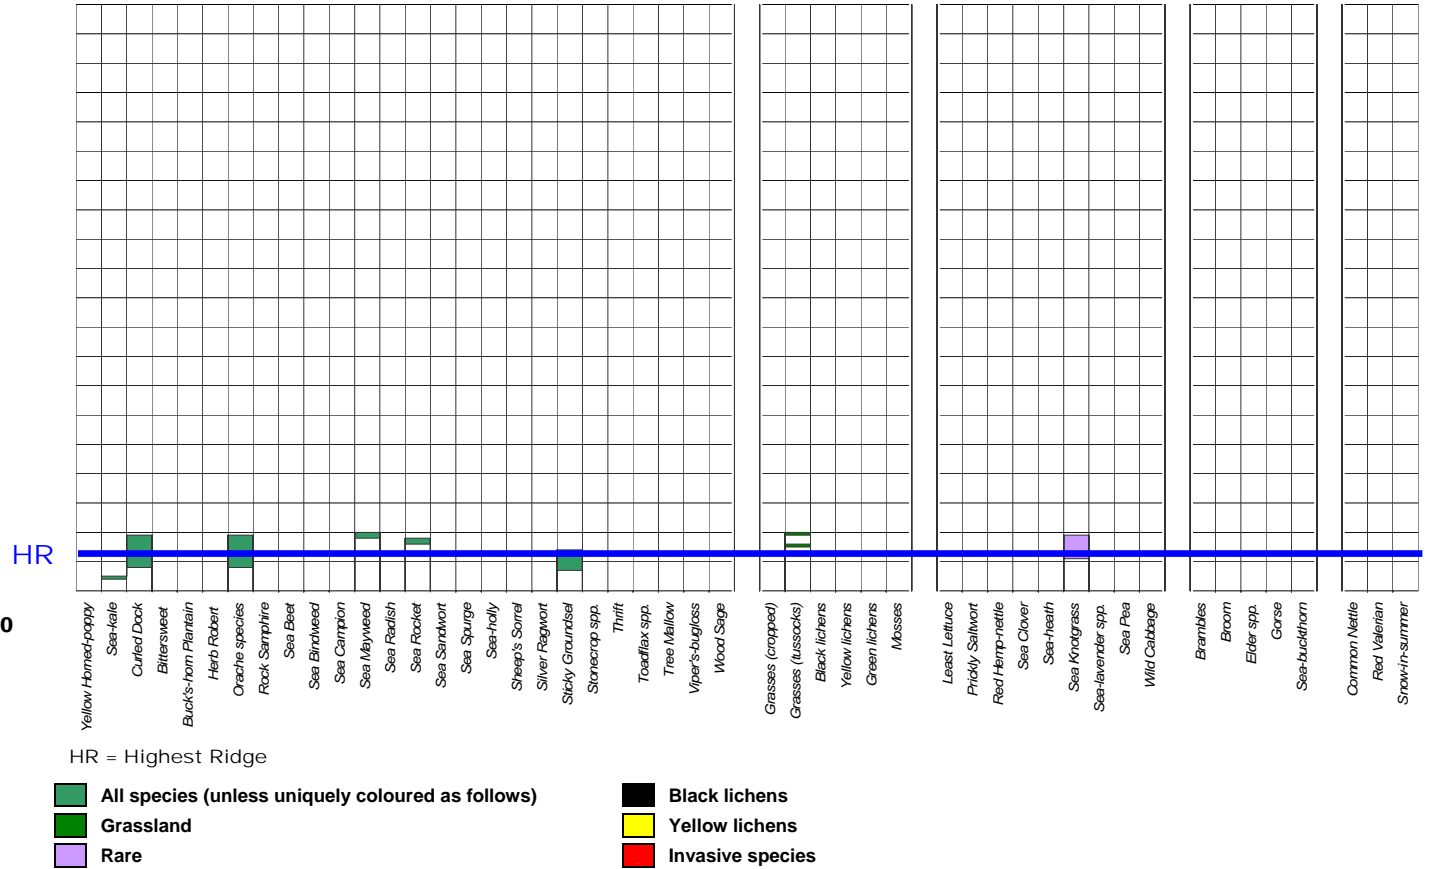
Figure E22.4 Distribution of species in 10m sections from seaward to landward side (transect information collected on 05/08/2008).

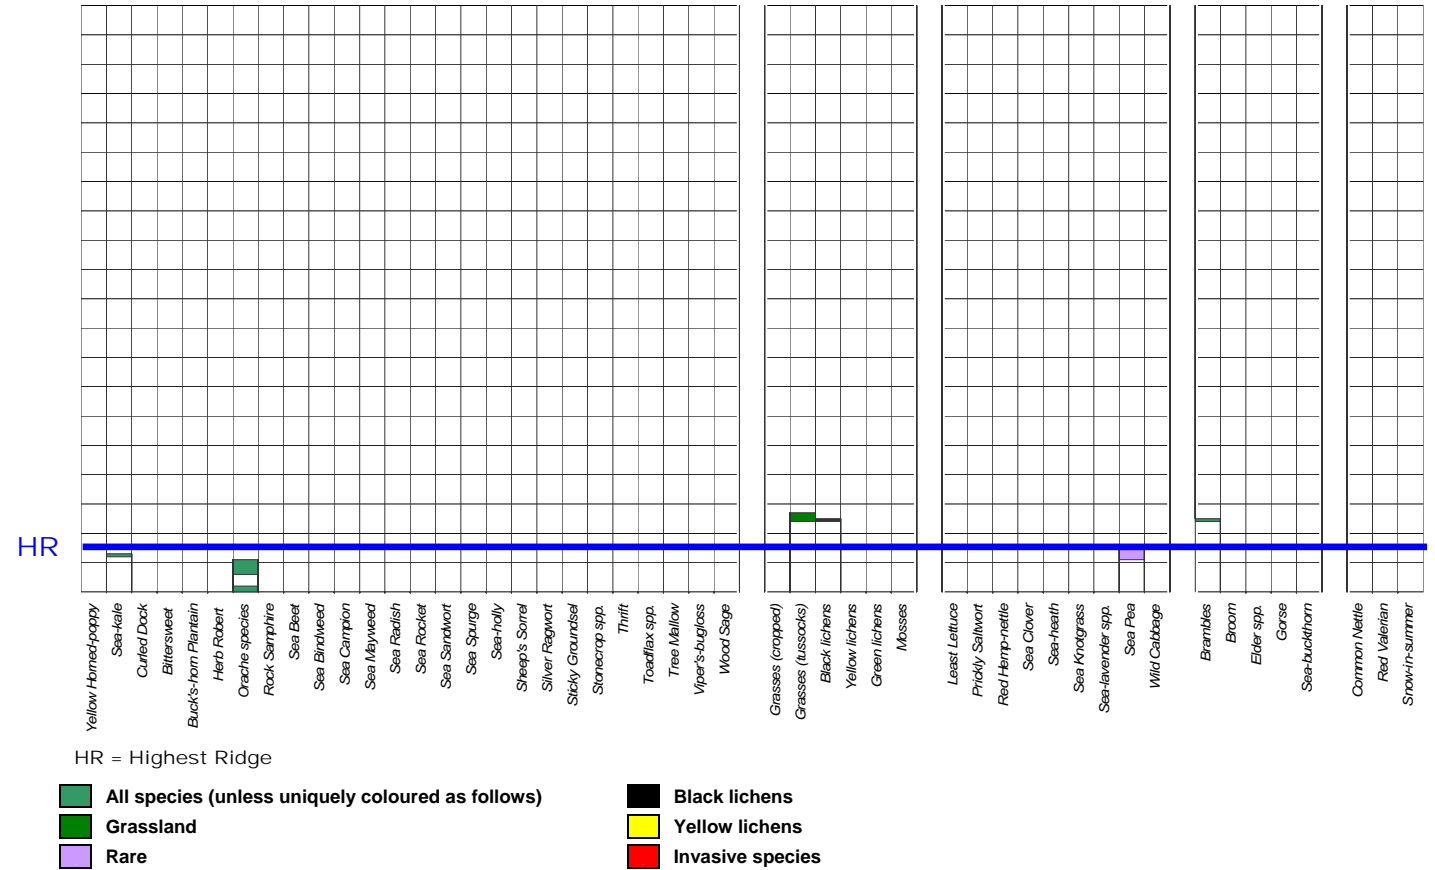
Figure E22.6 Distribution of species in 10m sections from seaward to landward side (transect information collected on 12/08/2008).

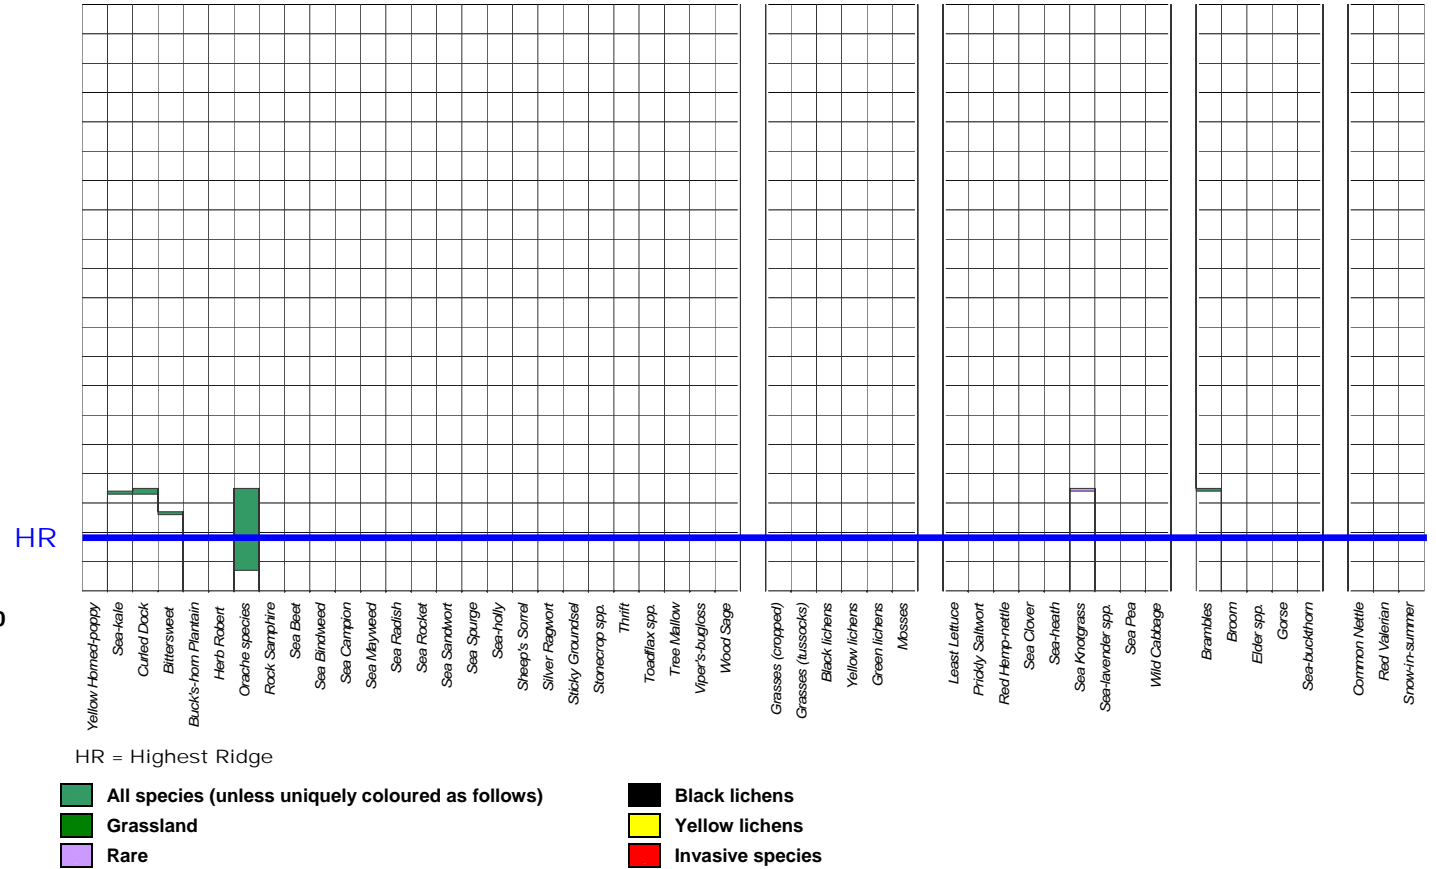
Figure E22.8 Distribution of species in 10m sections from seaward to landward side (transect information collected on 12/08/2008).
